Profile/Photo Observation Report

Date:	04/08/2018	Weather:		Coding:	PACP 6.0
Pipe Length (ft):	217.7	Owner:	NA	Pre Clean:	No Pre-Cleaning
P.O.#:		Surveyor:	Mark Ruby	PSR:	P-606-079-078
Customer:		Clean Date:	01/01/1900	Shape:	C

Street:	FOXCROFT STREET	Flow Control:	Not Controlled
City:	Hobart, IN	Year Renewed:	
Location:	Yard	Tape/Media #:	
Purpose:	Routine Assessment	Dia/Height:	10"
Use:	Sanitary	Material:	VCP
Drain Area:	NA	Lining:	
Category:	NA		
Comment:

Location Details:		Direction of Survey:	Upstream
US MH:	M-606-078	DS MH:	M-606-079
		Total Length Surveyed (ft):	77.3

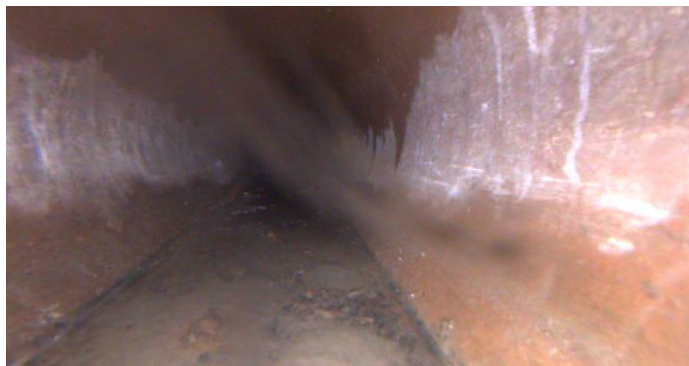
Code: **AMH**
 Description: **Manhole**

Distance (ft): **.0**
 Structural Grade: **0**
 O&M Grade: **0**
 Clock Start/From:
 Clock To:
 1st Value:
 2nd Value:
 Value Percent:
 Continuous Index:
 Within 8" of Joint: **NO**
 Remarks: **M-606-079**

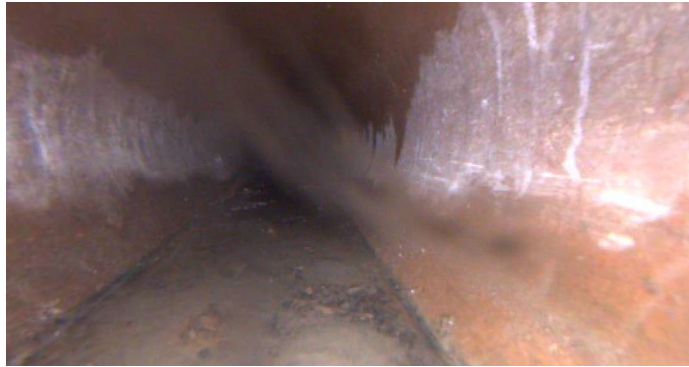
Code: **MWL**
Description: **Water Level**

Distance (ft): **.0**
Structural Grade: **0**
O&M Grade: **0**
Clock Start/From:
Clock To:
1st Value:
2nd Value:
Value Percent: **10.000**
Continuous Index:
Within 8" of Joint: **NO**
Remarks:

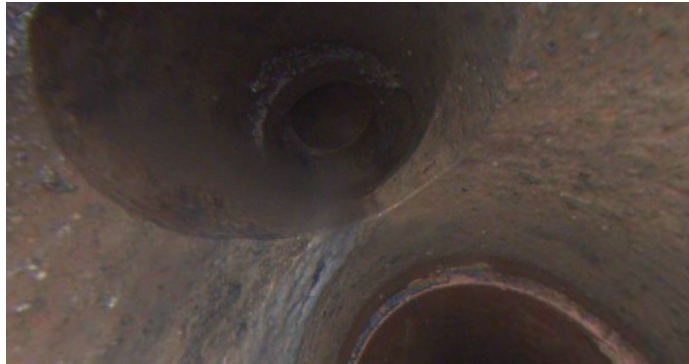
Code: **TF**
Description: **Tap Factory**

Distance (ft): **5.6**
Structural Grade: **0**
O&M Grade: **0**
Clock Start/From: **2**
Clock To:
1st Value: **4.000**
2nd Value:
Value Percent:
Continuous Index:
Within 8" of Joint:
Remarks:

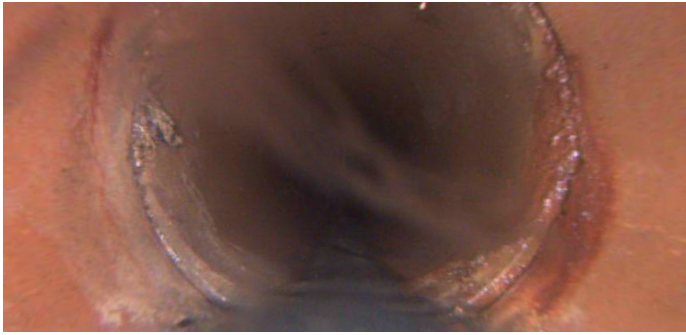
Code: **IW**
Description: **Infil Weeper**

Distance (ft): **13.8**
Structural Grade: **0**
O&M Grade: **2**
Clock Start/From: **8**
Clock To: **4**
1st Value:
2nd Value:
Value Percent:
Continuous Index:
Within 8" of Joint: **YES**
Remarks:

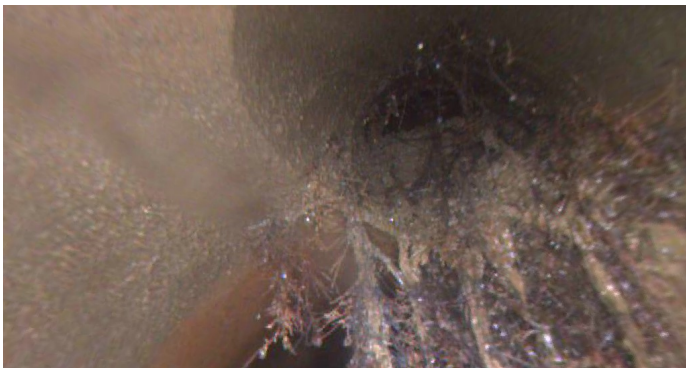
Code: **TFD**
Description: **Tap Factory Defective**

Distance (ft): **19.2**
Structural Grade: **0**
O&M Grade: **2**
Clock Start/From: **11**
Clock To:
1st Value: **4.000**
2nd Value:
Value Percent:
Continuous Index:
Within 8" of Joint:
Remarks: **RFL**

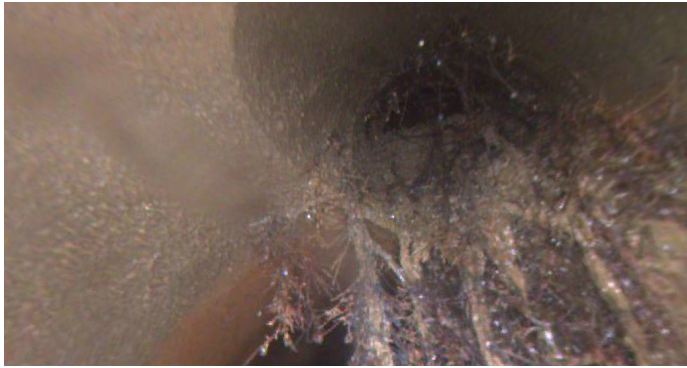
Code: **RFL**
Description: **Roots Fine Lateral**

Distance (ft): **19.2**
Structural Grade: **0**
O&M Grade: **1**
Clock Start/From: **11**
Clock To:
1st Value:
2nd Value:
Value Percent:
Continuous Index:
Within 8" of Joint: **NO**
Remarks:

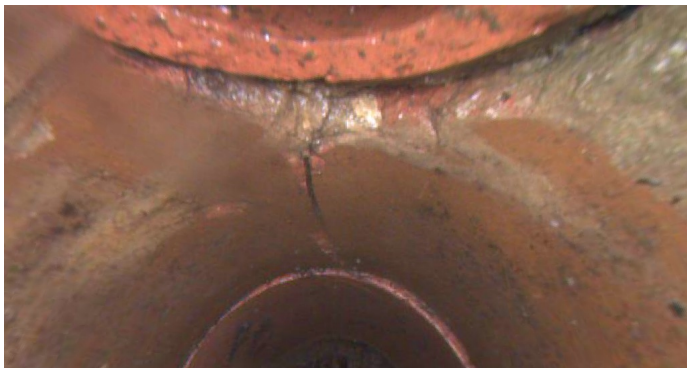
Code: **FM**
Description: **Fracture Multiple**

Distance (ft): **21.2**
Structural Grade: **4**
O&M Grade: **0**
Clock Start/From: **5**
Clock To: **7**
1st Value:
2nd Value:
Value Percent:
Continuous Index:
Within 8" of Joint:
Remarks:

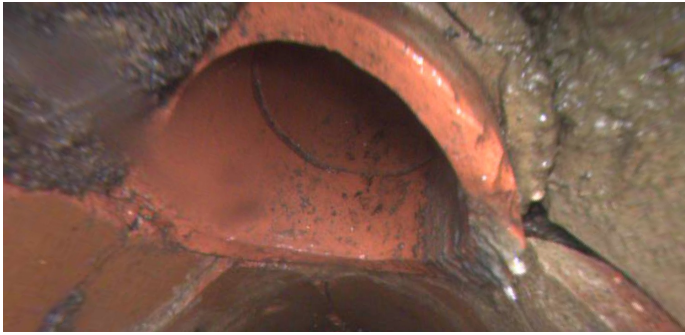
Code: **TBI**
Description: **Tap Break-in Intruding**

Distance (ft): **21.6**
Structural Grade: **0**
O&M Grade: **2**
Clock Start/From: **12**
Clock To:
1st Value: **4.000**
2nd Value: **1.000**
Value Percent:
Continuous Index:
Within 8" of Joint:
Remarks:

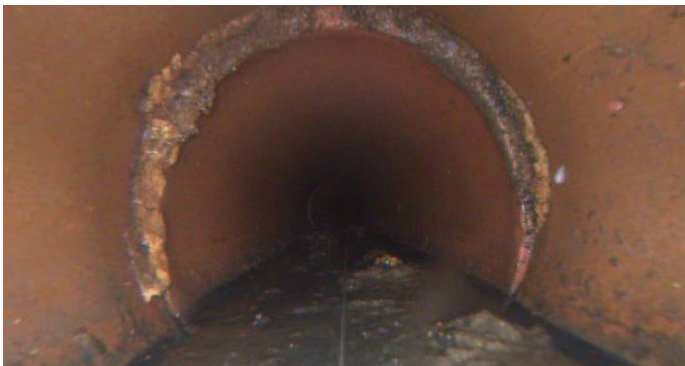
Code: **DAE**
Description: **Deposits Attached Encrustation**

Distance (ft): **36.6**
Structural Grade: **0**
O&M Grade: **2**
Clock Start/From: **5**
Clock To: **7**
1st Value:
2nd Value:
Value Percent: **5.000**
Continuous Index:
Within 8" of Joint: **YES**
Remarks:

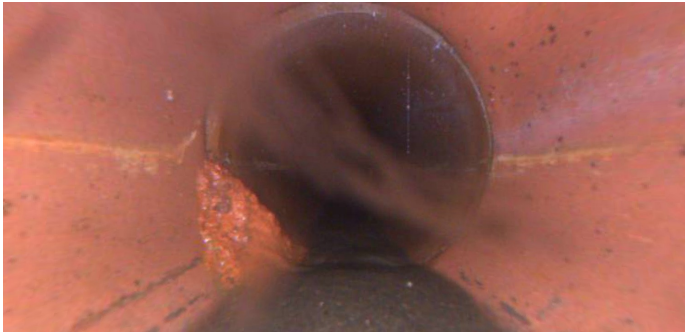
Code: **DAE**
Description: **Deposits Attached Encrustation**

Distance (ft): **43.0**
Structural Grade: **0**
O&M Grade: **2**
Clock Start/From: **7**
Clock To: **9**
1st Value:
2nd Value:
Value Percent: **10.000**
Continuous Index:
Within 8" of Joint: **YES**
Remarks:

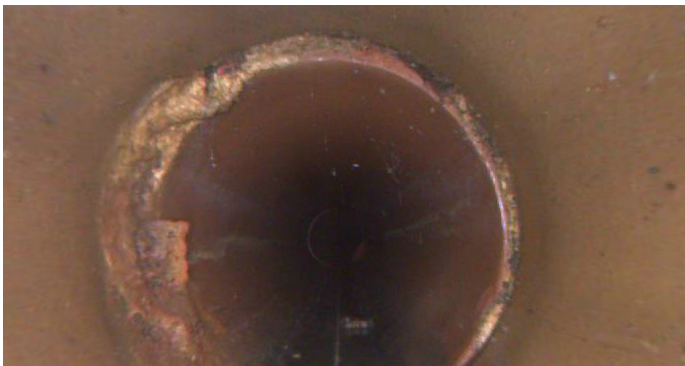
Code: **DAE**
Description: **Deposits Attached Encrustation**

Distance (ft): **48.4**
Structural Grade: **0**
O&M Grade: **2**
Clock Start/From: **5**
Clock To: **12**
1st Value:
2nd Value:
Value Percent: **10.000**
Continuous Index:
Within 8" of Joint: **NO**
Remarks:

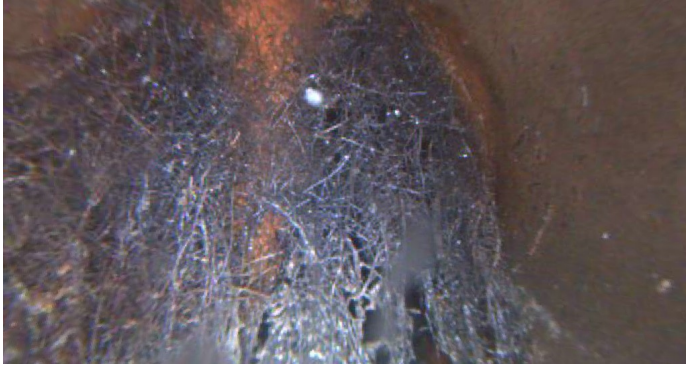
Code: **RBJ**
Description: **Roots Ball Joint**

Distance (ft): **60.3**
Structural Grade: **0**
O&M Grade: **4**
Clock Start/From: **12**
Clock To: **12**
1st Value:
2nd Value:
Value Percent: **95.000**
Continuous Index:
Within 8" of Joint: **YES**
Remarks:

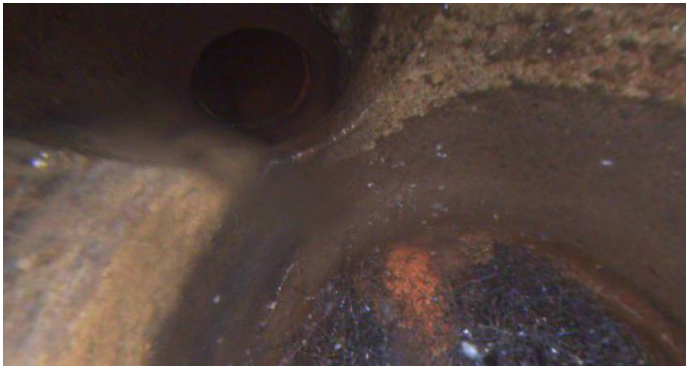
Code: **TF**
Description: **Tap Factory**

Distance (ft): **60.5**
Structural Grade: **0**
O&M Grade: **0**
Clock Start/From: **1**
Clock To:
1st Value: **4.000**
2nd Value:
Value Percent:
Continuous Index:
Within 8" of Joint:
Remarks:

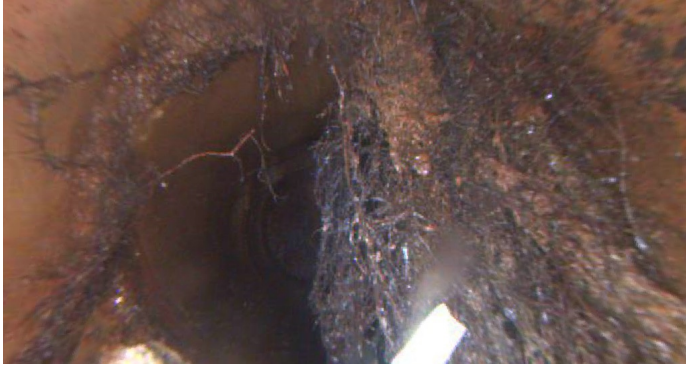
Code: **RBJ**
Description: **Roots Ball Joint**

Distance (ft): **62.2**
Structural Grade: **0**
O&M Grade: **4**
Clock Start/From: **5**
Clock To: **7**
1st Value:
2nd Value:
Value Percent: **60.000**
Continuous Index:
Within 8" of Joint: **YES**
Remarks:

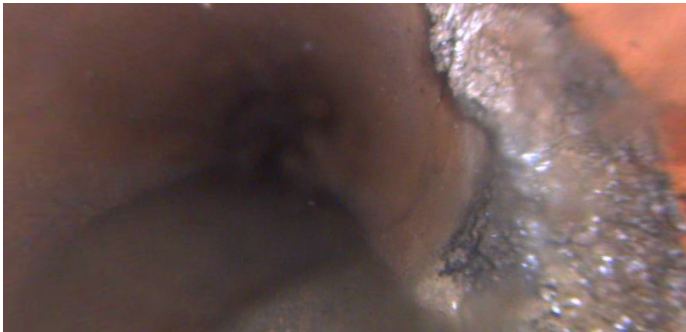
Code: **DAE**
Description: **Deposits Attached Encrustation**

Distance (ft): **73.3**
Structural Grade: **0**
O&M Grade: **2**
Clock Start/From: **1**
Clock To: **4**
1st Value:
2nd Value:
Value Percent: **10.000**
Continuous Index:
Within 8" of Joint: **YES**
Remarks:

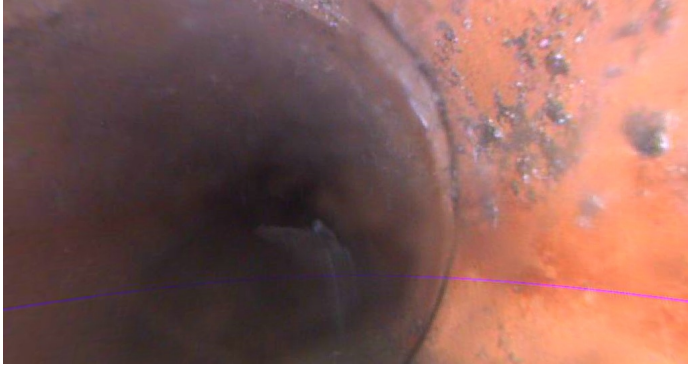
Code:	MSA
Description:	Abandoned Survey
Distance (ft):	77.3
Structural Grade:	0
O&M Grade:	0
Clock Start/From:	
Clock To:	
1st Value:	
2nd Value:	
Value Percent:	
Continuous Index:	
Within 8" of Joint:	NO
Remarks:	No blockage
