Profile/Photo Observation Report

Date:	04/08/2018	Weather:		Coding:	PACP 6.0
Pipe Length (ft):	132.1	Owner:	NA	Pre Clean:	No Pre-Cleaning
P.O.#:		Surveyor:	Jen Costello	PSR:	P-606-080-078
Customer:		Clean Date:	01/01/1900	Shape:	C

Street:	S PENNSYLVANIA ST	Flow Control:	Not Controlled
City:	Hobart, IN	Year Renewed:	
Location:	Yard	Tape/Media #:	
Purpose:	Routine Assessment	Dia/Height:	10"
Use:	Sanitary	Material:	VCP
Drain Area:	NA	Lining:	
Category:	NA		
Comment:	Flow direction is marked wrong.		
Location Details:		Direction of Survey:	Upstream
US MH:	M-606-078	DS MH:	M-606-080
		Total Length Surveyed (ft):	17.2

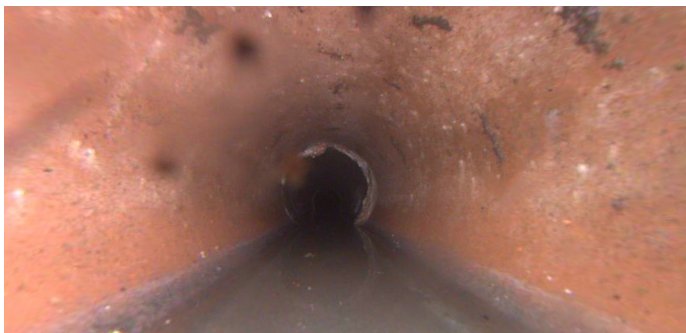
Code: **AMH**
Description: **Manhole**

Distance (ft): **.0**
Structural Grade: **0**
O&M Grade: **0**
Clock Start/From:
Clock To:
1st Value:
2nd Value:
Value Percent:
Continuous Index:
Within 8" of Joint: **NO**
Remarks: **M-606-080**

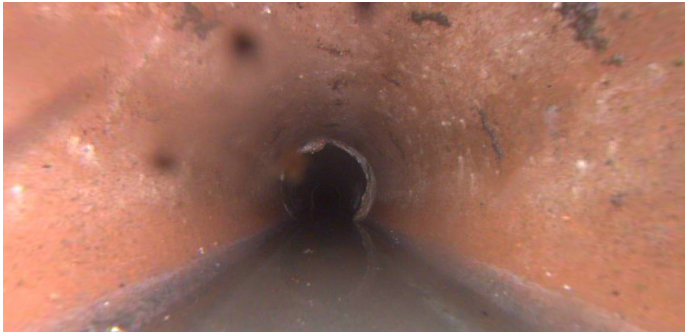
Code:	MWL
Description:	Water Level

Distance (ft):	.0
Structural Grade:	0
O&M Grade:	0
Clock Start/From:	
Clock To:	
1st Value:	
2nd Value:	
Value Percent:	10.000
Continuous Index:	
Within 8" of Joint:	NO
Remarks:

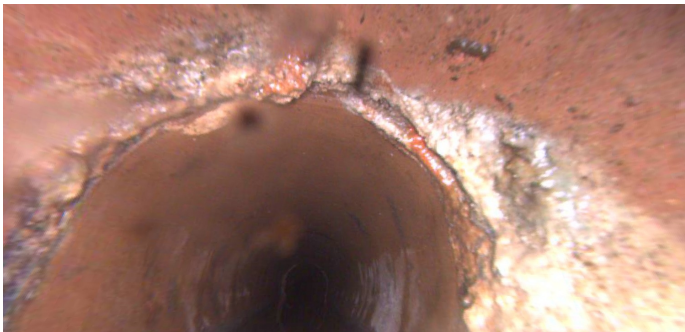
Code:	DAE
Description:	Deposits Attached Encrustation

Distance (ft):	2.8
Structural Grade:	0
O&M Grade:	2
Clock Start/From:	8
Clock To:	4
1st Value:	
2nd Value:	
Value Percent:	10.000
Continuous Index:	
Within 8" of Joint:	YES
Remarks:

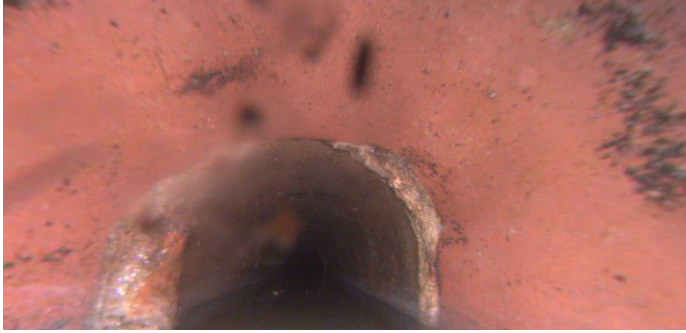
Code: **DAE**
Description: **Deposits Attached Encrustation**

Distance (ft): **6.3**
Structural Grade: **0**
O&M Grade: **2**
Clock Start/From: **8**
Clock To: **4**
1st Value:
2nd Value:
Value Percent: **10.000**
Continuous Index:
Within 8" of Joint: **YES**
Remarks:

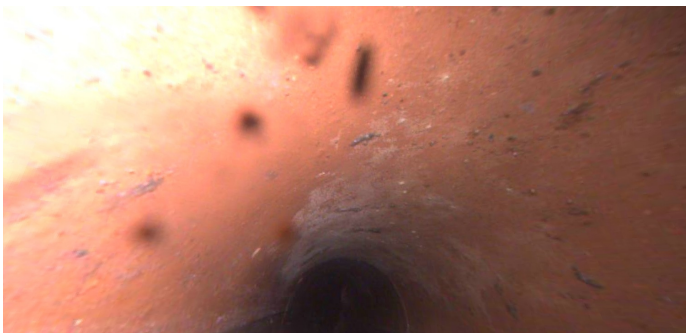
Code: **MSA**
Description: **Abandoned Survey**

Distance (ft): **17.2**
Structural Grade: **0**
O&M Grade: **0**
Clock Start/From:
Clock To:
1st Value:
2nd Value:
Value Percent:
Continuous Index:
Within 8" of Joint: **NO**
Remarks: **debris**
