## Profile/Photo Observation Report

Date:	<b>04/08/2018</b>	Weather:		Coding:	<b>PACP 6.0</b>
Pipe Length (ft):	<b>132.1</b>	Owner:	<b>NA</b>	Pre Clean:	<b>No Pre-Cleaning</b>
P.O.#:		Surveyor:	<b>Jen Costello</b>	PSR:	<b>P-606-080-078</b>
Customer:		Clean Date:	<b>01/01/1900</b>	Shape:	<b>C</b>

Street:	<b>FOXCROFT STREET</b>	Flow Control:	<b>Not Controlled</b>
City:	<b>Hobart, IN</b>	Year Renewed:	
Location:	<b>Yard</b>	Tape/Media #:	
Purpose:	<b>Routine Assessment</b>	Dia/Height:	<b>10"</b>
Use:	<b>Sanitary</b>	Material:	<b>VCP</b>
Drain Area:	<b>NA</b>	Lining:	
Category:	<b>NA</b>		
Comment:	<b>Flow direction is marked wrong.</b>		
Location Details:		Direction of Survey:	<b>Upstream</b>
US MH:	<b>M-606-078</b>	DS MH:	<b>M-606-080</b>
		Total Length Surveyed (ft):	<b>17.2</b>

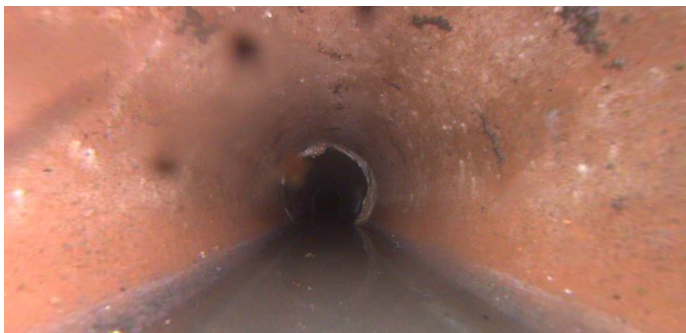
Code: **AMH**  
Description: **Manhole**

Distance (ft): **.0**  
Structural Grade: **0**  
O&M Grade: **0**  
Clock Start/From:  
Clock To:  
1st Value:  
2nd Value:  
Value Percent:  
Continuous Index:  
Within 8" of Joint: **NO**  
Remarks: **M-606-080**

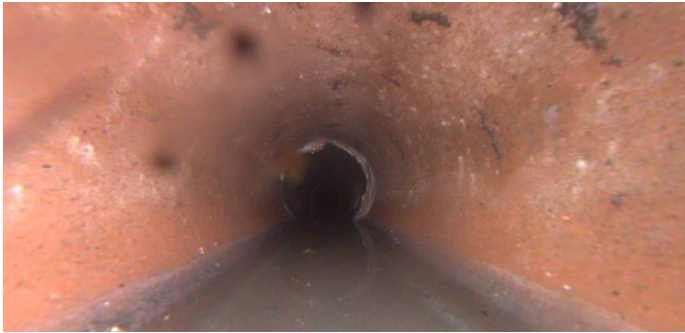
Code:	<b>MWL</b>
Description:	<b>Water Level</b>

Distance (ft):	<b>.0</b>
Structural Grade:	<b>0</b>
O&M Grade:	<b>0</b>
Clock Start/From:	
Clock To:	
1st Value:	
2nd Value:	
Value Percent:	<b>10.000</b>
Continuous Index:	
Within 8" of Joint:	<b>NO</b>
Remarks:

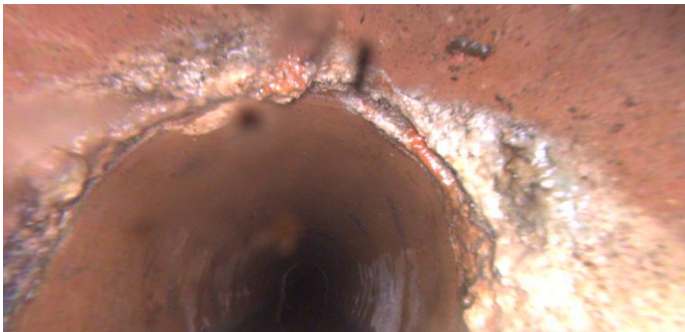
Code:	<b>DAE</b>
Description:	<b>Deposits Attached Encrustation</b>

Distance (ft):	<b>2.8</b>
Structural Grade:	<b>0</b>
O&M Grade:	<b>2</b>
Clock Start/From:	<b>8</b>
Clock To:	<b>4</b>
1st Value:	
2nd Value:	
Value Percent:	<b>10.000</b>
Continuous Index:	
Within 8" of Joint:	<b>YES</b>
Remarks:

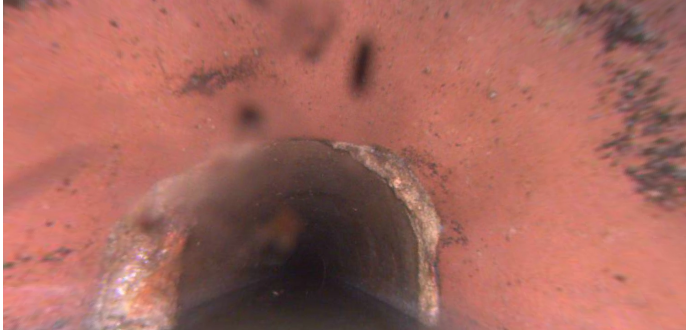
Code: **DAE**  
Description: **Deposits Attached Encrustation**

Distance (ft): **6.3**  
Structural Grade: **0**  
O&M Grade: **2**  
Clock Start/From: **8**  
Clock To: **4**  
1st Value:  
2nd Value:  
Value Percent: **10.000**  
Continuous Index:  
Within 8" of Joint: **YES**  
Remarks:

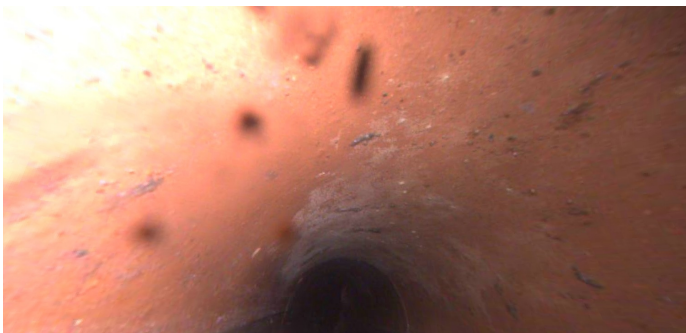
Code: **MSA**  
Description: **Abandoned Survey**

Distance (ft): **17.2**  
Structural Grade: **0**  
O&M Grade: **0**  
Clock Start/From:  
Clock To:  
1st Value:  
2nd Value:  
Value Percent:  
Continuous Index:  
Within 8" of Joint: **NO**  
Remarks: **debris**
