Profile/Photo Observation Report

Date:	02/24/2024	Weather:		Coding:	PACP 7.0
Pipe Length (ft):	132.0	Owner:	City of Hobart	Pre Clean:	Heavy Cleaning
P.O.#:	YES502259	Surveyor:	S. Bucklin	PSR:	P-606-080-078
Customer:	City of Hobart	Clean Date:	12/01/2023	Shape:	C

Street:	S PENNSYLVANIA ST	Flow Control:	Not Controlled
City:	Hobart, IN	Year Renewed:	
Location:	Easement/Right of Way	Tape/Media #:	
Purpose:	Sewer System Evaluation Survey (SS	Dia/Height:	10"
Use:	Sanitary Sewage Pipe	Material:	VCP
Drain Area:		Lining:	None
Category:	NA		
Comment:			
Location Details:		Direction of Survey:	Downstream
US MH:	M-606-078	DS MH:	M-606-080
		Total Length Surveyed (ft):	72.2

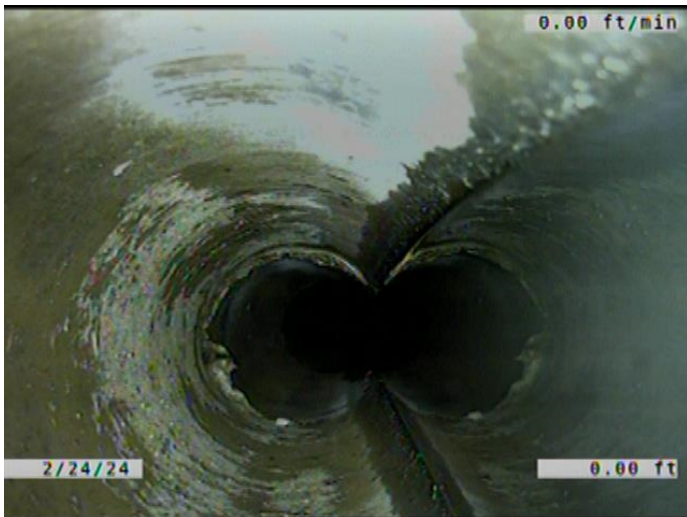
Code: **MWLS**
Description: **Miscellaneous Water Level Sag**

Distance (ft): **.0**
Structural Grade: **2**
O&M Grade: **0**
Clock Start/From:
Clock To:
1st Value:
2nd Value:
Value Percent: **30.000**
Continuous Index: **S01**
Within 8" of Joint: **NO**
Remarks:

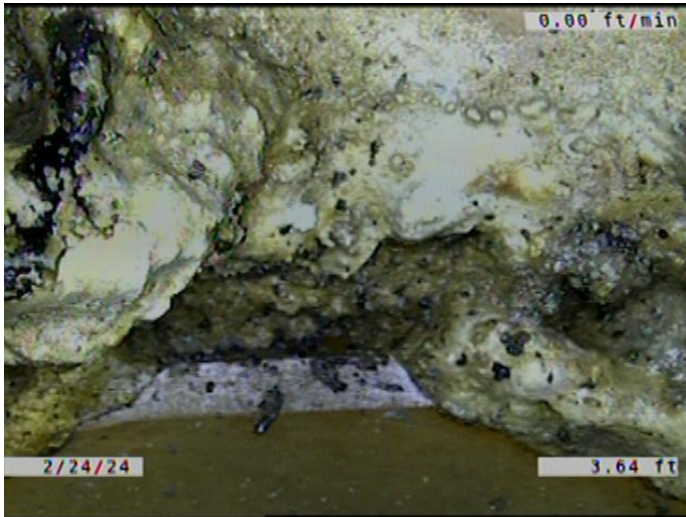
Code: **DAE**
Description: **Deposits Attached Encrustation**

Distance (ft): **3.6**
Structural Grade: **0**
O&M Grade: **2**
Clock Start/From: **7**
Clock To: **5**
1st Value:
2nd Value:
Value Percent: **5.000**
Continuous Index: **S02**
Within 8" of Joint: **YES**
Remarks:

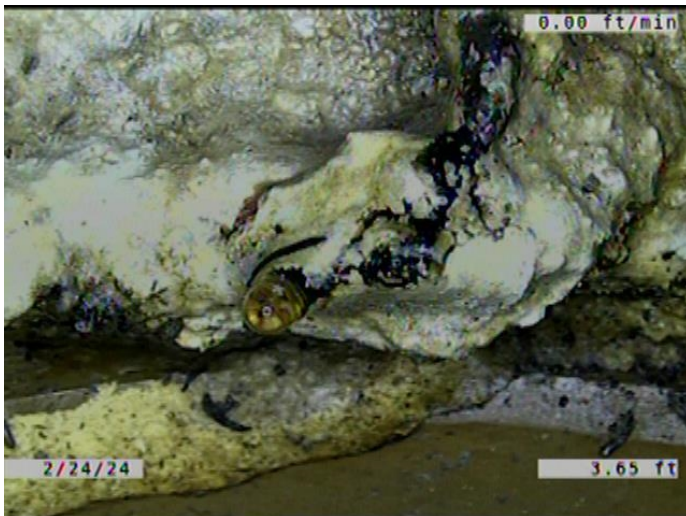
Code: **IWJ**
Description: **Infiltration Weeper Joint**

Distance (ft): **3.6**
Structural Grade: **0**
O&M Grade: **2**
Clock Start/From: **11**
Clock To: **12**
1st Value:
2nd Value:
Value Percent:
Continuous Index:
Within 8" of Joint: **YES**
Remarks:

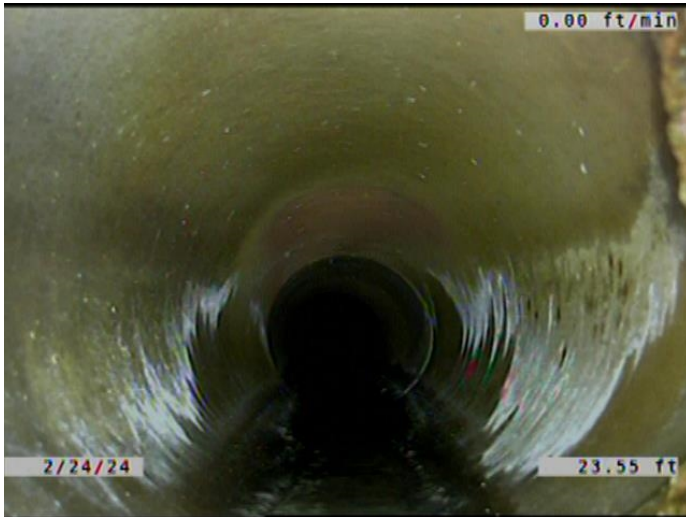
Code: **MWLS**
Description: **Miscellaneous Water Level Sag**

Distance (ft): **23.5**
Structural Grade: **2**
O&M Grade: **0**
Clock Start/From:
Clock To:
1st Value:
2nd Value:
Value Percent: **30.000**
Continuous Index: **F01**
Within 8" of Joint: **NO**
Remarks:

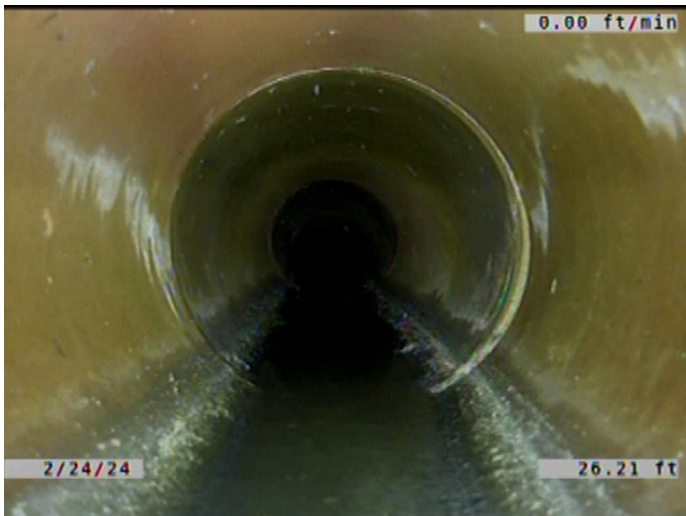
Code: **MWLS**
Description: **Miscellaneous Water Level Sag**

Distance (ft): **26.2**
Structural Grade: **2**
O&M Grade: **0**
Clock Start/From:
Clock To:
1st Value:
2nd Value:
Value Percent: **15.000**
Continuous Index: **S03**
Within 8" of Joint: **NO**
Remarks:

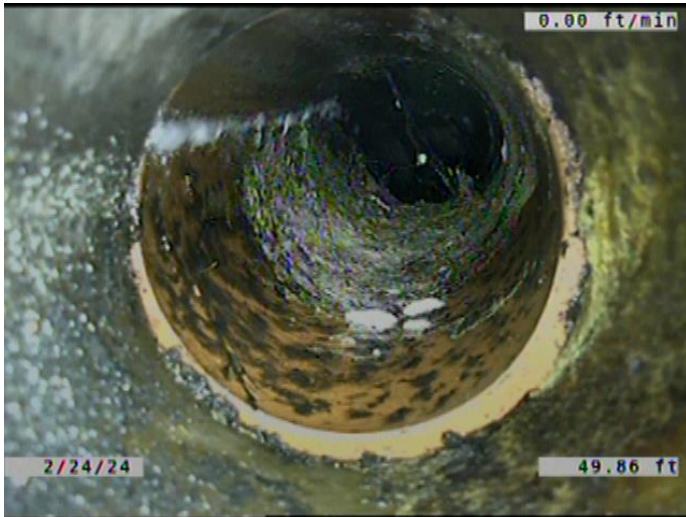
Code:	TF
Description:	Tap Factory
Distance (ft):	49.9
Structural Grade:	0
O&M Grade:	0
Clock Start/From:	11
Clock To:	
1st Value:	6.000
2nd Value:	
Value Percent:	
Continuous Index:	
Within 8" of Joint:	YES
Remarks:	ROOTS GROWING AND ENCRUSTATION COMING FROM THE

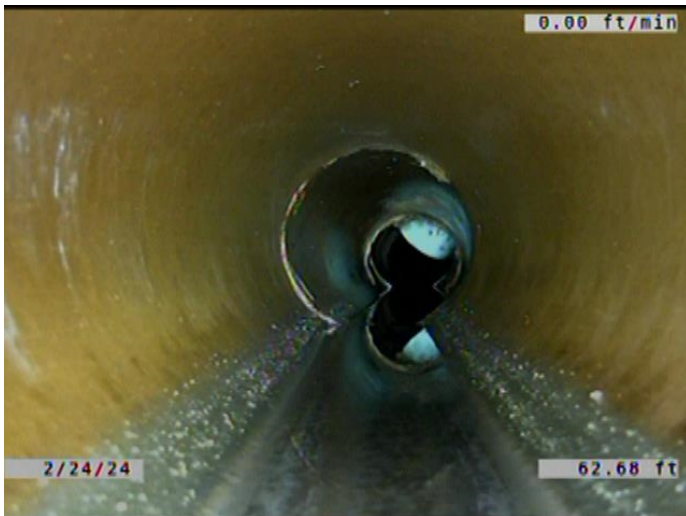
Code:	MWLS
Description:	Miscellaneous Water Level Sag
Distance (ft):	62.7
Structural Grade:	2
O&M Grade:	0
Clock Start/From:	
Clock To:	
1st Value:	
2nd Value:	
Value Percent:	15.000
Continuous Index:	F03
Within 8" of Joint:	NO
Remarks:

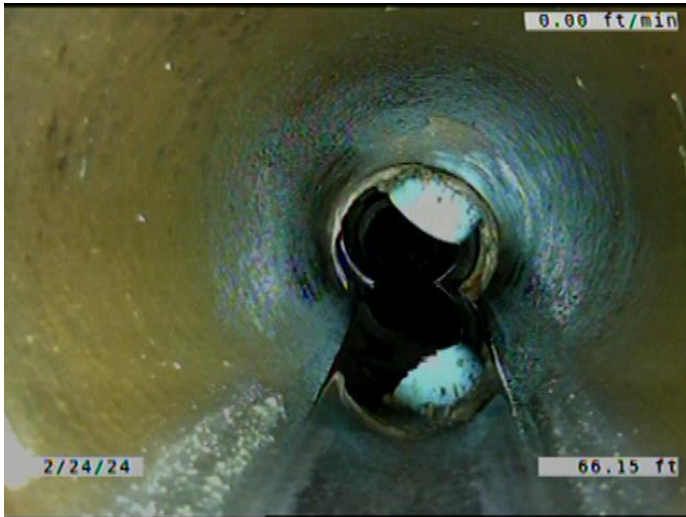
Code: **LR**
Description: **Line Right**

Distance (ft): **66.1**
Structural Grade: **0**
O&M Grade: **1**
Clock Start/From:
Clock To:
1st Value:
2nd Value:
Value Percent: **5.000**
Continuous Index:
Within 8" of Joint: **NO**
Remarks:

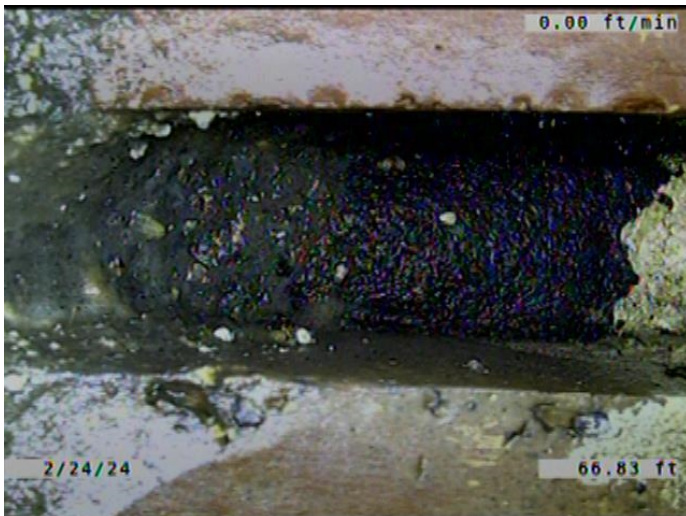
Code: **JAM**
Description: **Joint Angular Medium**

Distance (ft): **66.8**
Structural Grade: **3**
O&M Grade: **0**
Clock Start/From:
Clock To:
1st Value:
2nd Value:
Value Percent:
Continuous Index:
Within 8" of Joint: **NO**
Remarks:

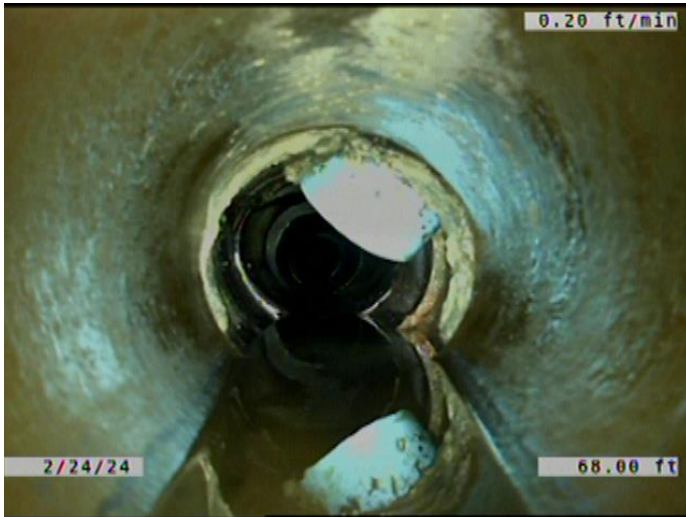
Code:	MWLS
Description:	Miscellaneous Water Level Sag
Distance (ft):	68.0
Structural Grade:	2
O&M Grade:	0
Clock Start/From:	
Clock To:	
1st Value:	
2nd Value:	
Value Percent:	10.000
Continuous Index:	
Within 8" of Joint:	NO
Remarks:

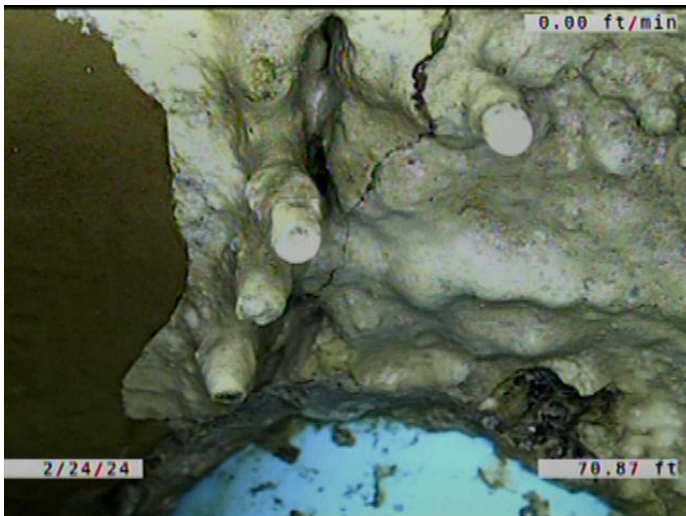
Code:	IWB
Description:	Infiltration Weeper Barrel
Distance (ft):	70.9
Structural Grade:	0
O&M Grade:	2
Clock Start/From:	11
Clock To:	1
1st Value:	
2nd Value:	
Value Percent:	
Continuous Index:	
Within 8" of Joint:	YES
Remarks:

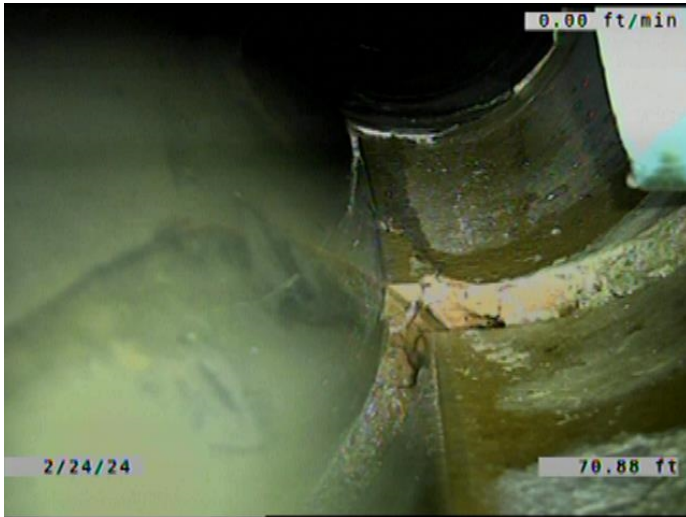
Code:	BSV
Description:	Broken Soil Visible
Distance (ft):	70.9
Structural Grade:	5
O&M Grade:	0
Clock Start/From:	12
Clock To:	12
1st Value:	
2nd Value:	
Value Percent:	
Continuous Index:	
Within 8" of Joint:	YES
Remarks:	SOIL VISIBLE. ALSO. WATER EXITING THE PIPE.

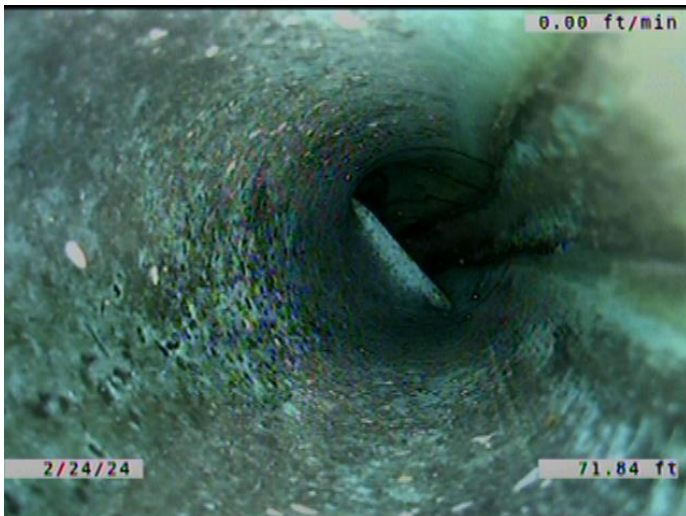
Code:	TBI
Description:	Tap Break-in Intruding
Distance (ft):	71.8
Structural Grade:	0
O&M Grade:	2
Clock Start/From:	1
Clock To:	
1st Value:	6.000
2nd Value:	4.000
Value Percent:	
Continuous Index:	
Within 8" of Joint:	YES
Remarks:	CONSTANTLY DRIPPING WATER. ACTIVITY.

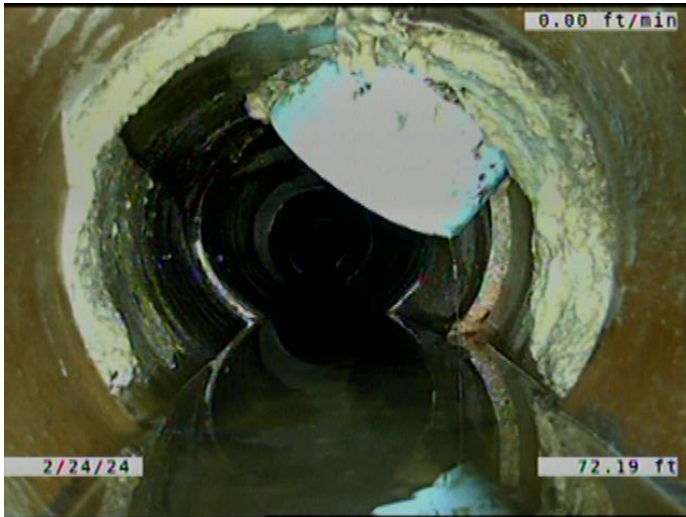
Code: **DAE**
Description: **Deposits Attached Encrustation**

Distance (ft): **72.2**
Structural Grade: **0**
O&M Grade: **2**
Clock Start/From: **7**
Clock To: **5**
1st Value:
2nd Value:
Value Percent: **5.000**
Continuous Index: **F02**
Within 8" of Joint: **YES**
Remarks:

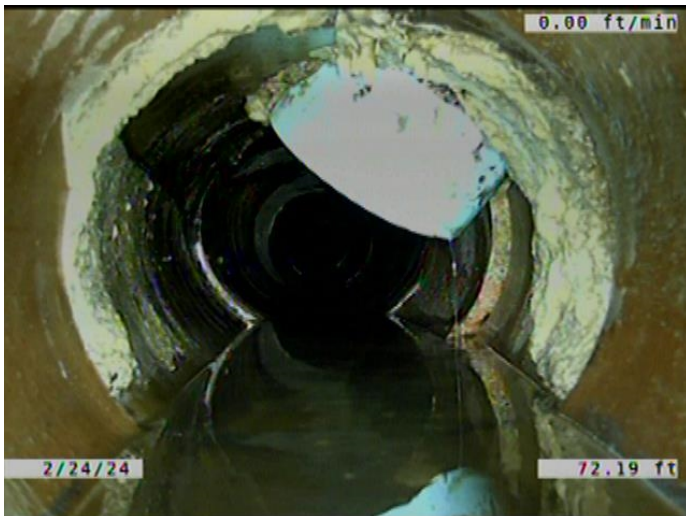
Code: **MSA**
Description: **Miscellaneous Survey Abandoned**

Distance (ft): **72.2**
Structural Grade: **0**
O&M Grade: **0**
Clock Start/From:
Clock To:
1st Value:
2nd Value:
Value Percent:
Continuous Index:
Within 8" of Joint: **NO**
Remarks: **CAMERA CANT MAKE IT PAST PROTRUDING TAP.**
