## Profile/Photo Observation Report

Date:	<b>02/29/2024</b>	Weather:		Coding:	<b>PACP 7.0</b>
Pipe Length (ft):	<b>132.0</b>	Owner:	<b>City of Hobart</b>	Pre Clean:	<b>Heavy Cleaning</b>
P.O.#:		Surveyor:	<b>S. Bucklin</b>	PSR:	<b>P-606-080-078</b>
Customer:	<b>City of Hobart</b>	Clean Date:	<b>12/01/2023</b>	Shape:	<b>C</b>

Street:	<b>S PENNSYLVANIA ST</b>	Flow Control:	<b>Not Controlled</b>
City:	<b>Hobart, IN</b>	Year Renewed:	
Location:	<b>Easement/Right of Way</b>	Tape/Media #:	
Purpose:	<b>Sewer System Evaluation Survey (SS</b>	Dia/Height:	<b>10"</b>
Use:	<b>Sanitary Sewage Pipe</b>	Material:	<b>VCP</b>
Drain Area:		Lining:	<b>None</b>
Category:	<b>NA</b>		
Comment:			
Location Details:		Direction of Survey:	<b>Upstream</b>
US MH:	<b>M-606-078</b>	DS MH:	<b>M-606-080</b>
		Total Length Surveyed (ft):	<b>60.0</b>

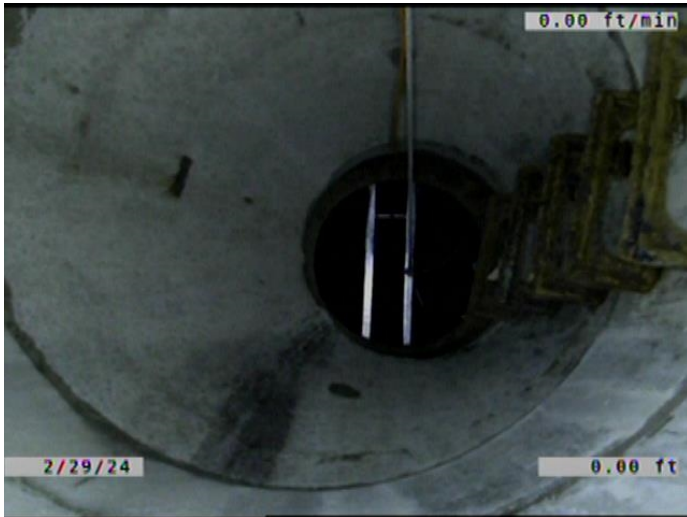
Code: **AMH**  
Description: **Manhole**

Distance (ft): **.0**  
Structural Grade: **0**  
O&M Grade: **0**  
Clock Start/From:  
Clock To:  
1st Value:  
2nd Value:  
Value Percent:  
Continuous Index:  
Within 8" of Joint: **NO**  
Remarks: **M-606-080**

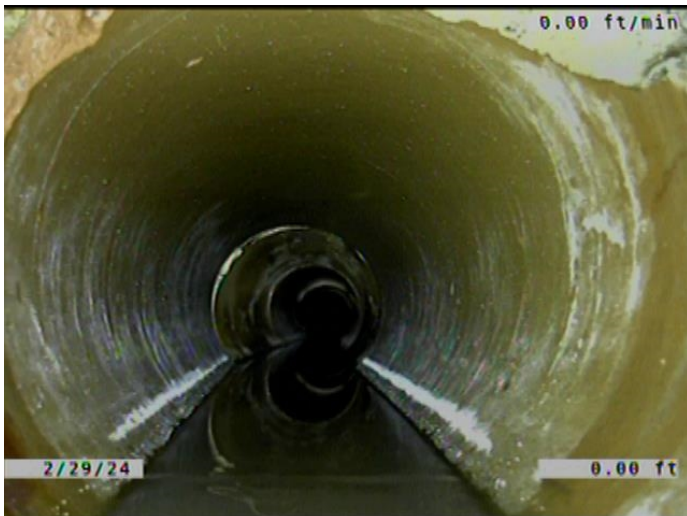
Code: **MWL**  
Description: **Miscellaneous Water Level**

Distance (ft): **.0**  
Structural Grade: **0**  
O&M Grade: **0**  
Clock Start/From:  
Clock To:  
1st Value:  
2nd Value:  
Value Percent: **5.000**  
Continuous Index:  
Within 8" of Joint: **NO**  
Remarks:

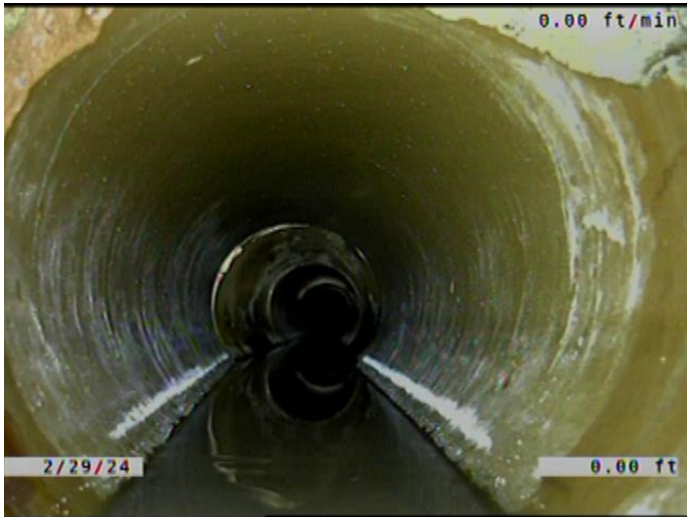
Code: **MWLS**  
Description: **Miscellaneous Water Level Sag**

Distance (ft): **.0**  
Structural Grade: **2**  
O&M Grade: **0**  
Clock Start/From:  
Clock To:  
1st Value:  
2nd Value:  
Value Percent: **10.000**  
Continuous Index: **S01**  
Within 8" of Joint: **NO**  
Remarks:

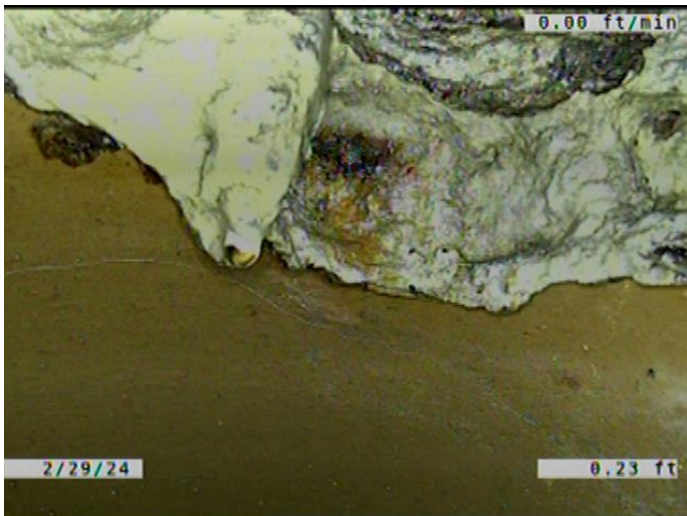
Code: **IWJ**  
Description: **Infiltration Weeper Joint**

Distance (ft): **.2**  
Structural Grade: **0**  
O&M Grade: **2**  
Clock Start/From: **12**  
Clock To:  
1st Value:  
2nd Value:  
Value Percent:  
Continuous Index:  
Within 8" of Joint: **YES**  
Remarks:

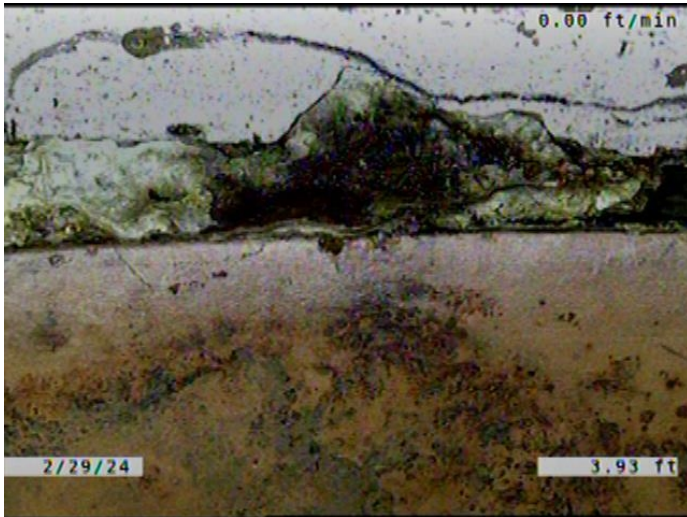
Code: **DAE**  
Description: **Deposits Attached Encrustation**

Distance (ft): **3.9**  
Structural Grade: **0**  
O&M Grade: **2**  
Clock Start/From: **7**  
Clock To: **5**  
1st Value:  
2nd Value:  
Value Percent: **5.000**  
Continuous Index: **S02**  
Within 8" of Joint: **YES**  
Remarks:

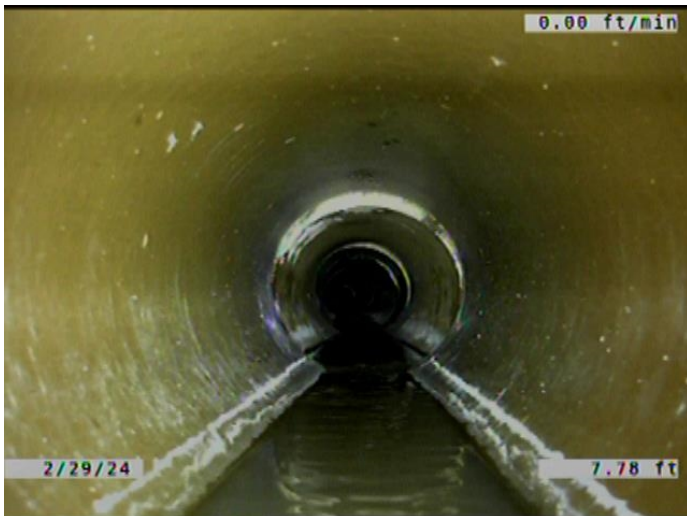
Code: **MWLS**  
Description: **Miscellaneous Water Level Sag**

Distance (ft): **7.8**  
Structural Grade: **2**  
O&M Grade: **0**  
Clock Start/From:  
Clock To:  
1st Value:  
2nd Value:  
Value Percent: **10.000**  
Continuous Index: **F01**  
Within 8" of Joint: **NO**  
Remarks:

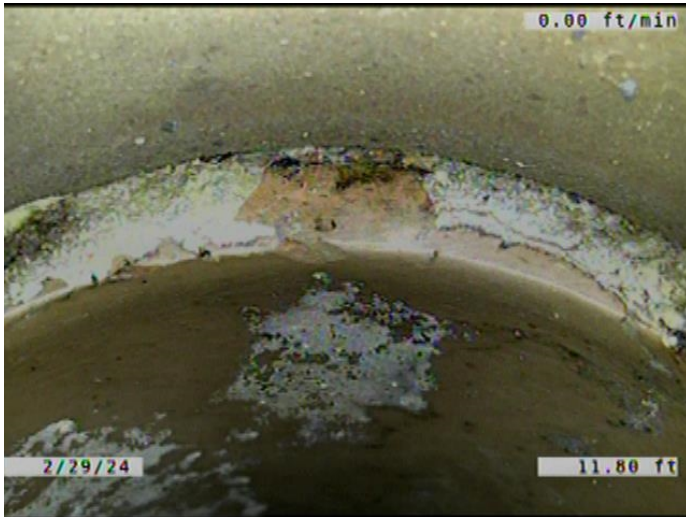
Code: **JOMD**  
Description: **Joint Offset Medium Defective**

Distance (ft): **11.8**  
Structural Grade: **3**  
O&M Grade: **0**  
Clock Start/From:  
Clock To:  
1st Value:  
2nd Value:  
Value Percent:  
Continuous Index:  
Within 8" of Joint: **NO**  
Remarks:

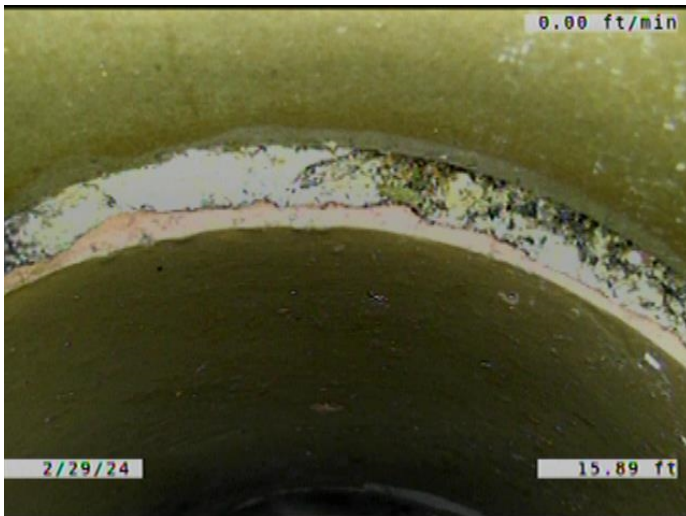
Code: **JOMD**  
Description: **Joint Offset Medium Defective**

Distance (ft): **15.9**  
Structural Grade: **3**  
O&M Grade: **0**  
Clock Start/From:  
Clock To:  
1st Value:  
2nd Value:  
Value Percent:  
Continuous Index:  
Within 8" of Joint: **NO**  
Remarks:

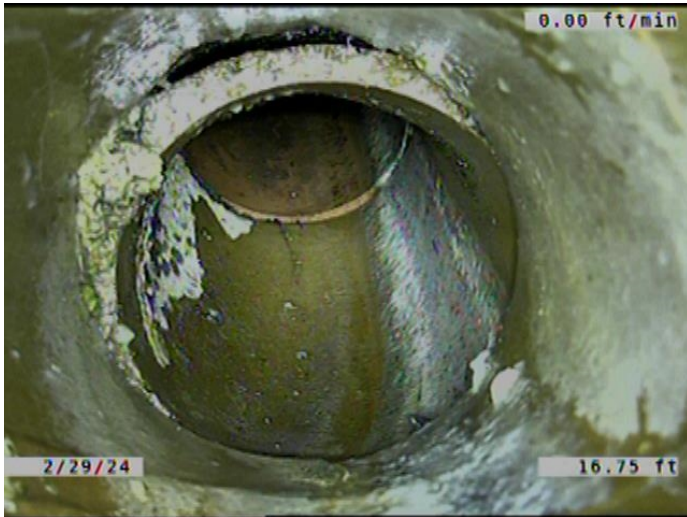
Code: **TFD**  
Description: **Tap Factory Defective**

Distance (ft): **16.7**  
Structural Grade: **0**  
O&M Grade: **3**  
Clock Start/From: **1**  
Clock To:  
1st Value: **6.000**  
2nd Value:  
Value Percent:  
Continuous Index:  
Within 8" of Joint: **YES**  
Remarks: **SERVICE OFFSET. ACTIVITY.**

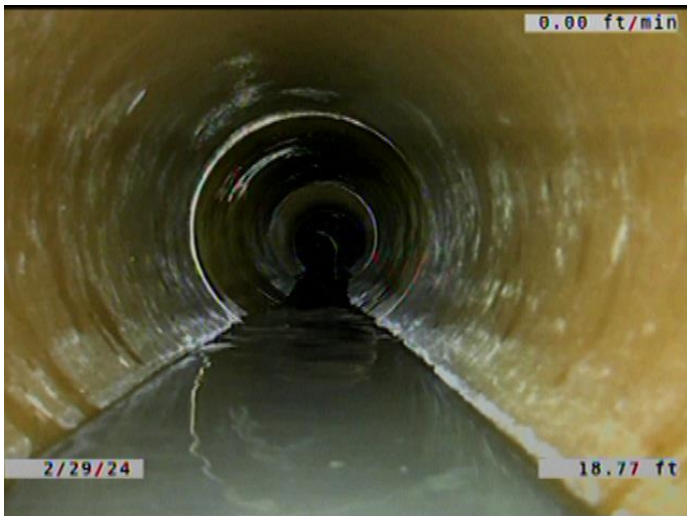
Code: **MWLS**  
Description: **Miscellaneous Water Level Sag**

Distance (ft): **18.8**  
Structural Grade: **2**  
O&M Grade: **0**  
Clock Start/From:  
Clock To:  
1st Value:  
2nd Value:  
Value Percent: **10.000**  
Continuous Index: **S03**  
Within 8" of Joint: **NO**  
Remarks:

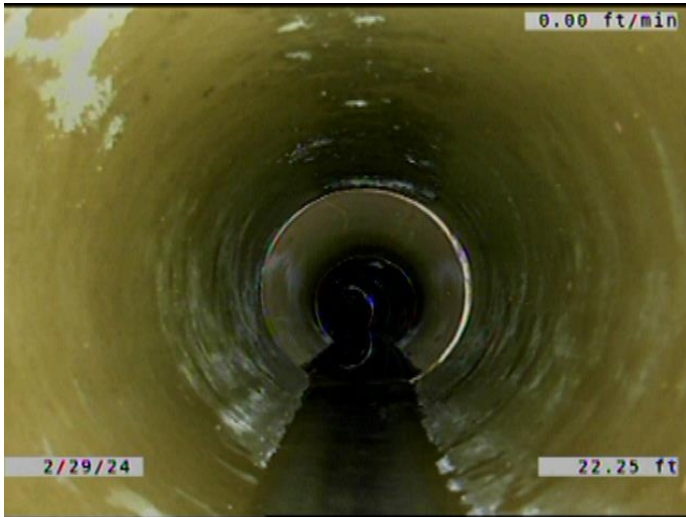
Code: **MWLS**  
Description: **Miscellaneous Water Level Sag**

Distance (ft): **22.2**  
Structural Grade: **2**  
O&M Grade: **0**  
Clock Start/From:  
Clock To:  
1st Value:  
2nd Value:  
Value Percent: **10.000**  
Continuous Index: **F03**  
Within 8" of Joint: **NO**  
Remarks:

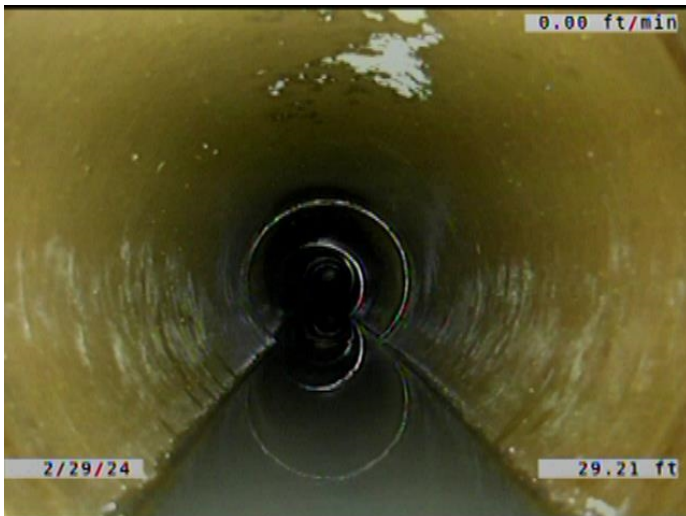
Code: **MWLS**  
Description: **Miscellaneous Water Level Sag**

Distance (ft): **29.2**  
Structural Grade: **2**  
O&M Grade: **0**  
Clock Start/From:  
Clock To:  
1st Value:  
2nd Value:  
Value Percent: **10.000**  
Continuous Index: **S04**  
Within 8" of Joint: **NO**  
Remarks:

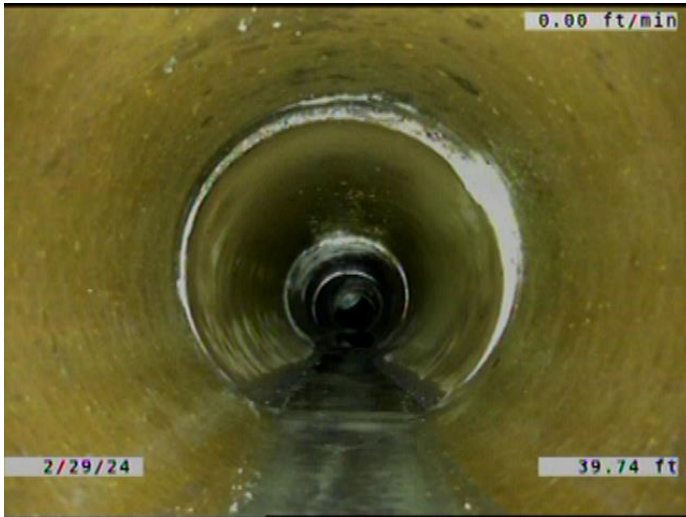
Code: **MWLS**  
Description: **Miscellaneous Water Level Sag**

Distance (ft): **39.7**  
Structural Grade: **2**  
O&M Grade: **0**  
Clock Start/From:  
Clock To:  
1st Value:  
2nd Value:  
Value Percent: **10.000**  
Continuous Index: **F04**  
Within 8" of Joint: **NO**  
Remarks:

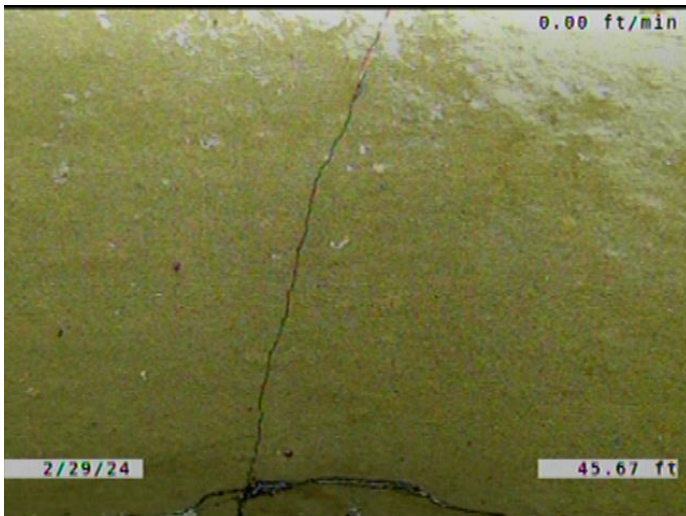
Code: **CS**  
Description: **Crack Spiral**

Distance (ft): **45.7**  
Structural Grade: **2**  
O&M Grade: **0**  
Clock Start/From: **1**  
Clock To: **3**  
1st Value:  
2nd Value:  
Value Percent:  
Continuous Index:  
Within 8" of Joint: **YES**  
Remarks:

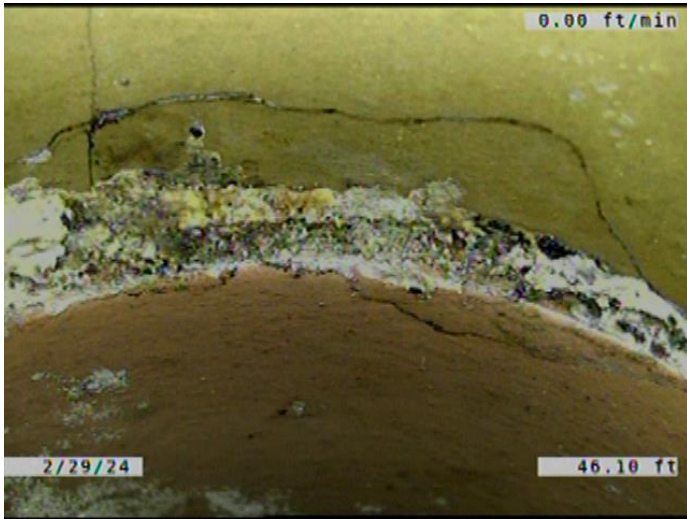
Code: **JOMD**  
Description: **Joint Offset Medium Defective**

Distance (ft): **46.1**  
Structural Grade: **3**  
O&M Grade: **0**  
Clock Start/From:  
Clock To:  
1st Value:  
2nd Value:  
Value Percent:  
Continuous Index:  
Within 8" of Joint: **NO**  
Remarks:

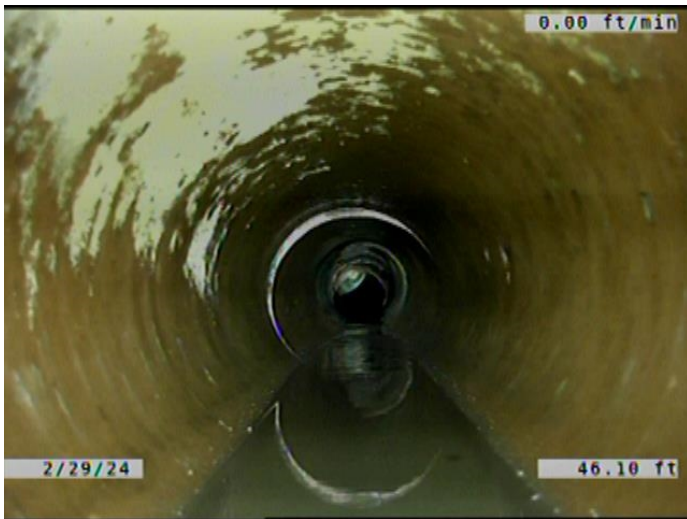
Code: **MWLS**  
Description: **Miscellaneous Water Level Sag**

Distance (ft): **46.1**  
Structural Grade: **2**  
O&M Grade: **0**  
Clock Start/From:  
Clock To:  
1st Value:  
2nd Value:  
Value Percent: **10.000**  
Continuous Index: **S05**  
Within 8" of Joint: **NO**  
Remarks:

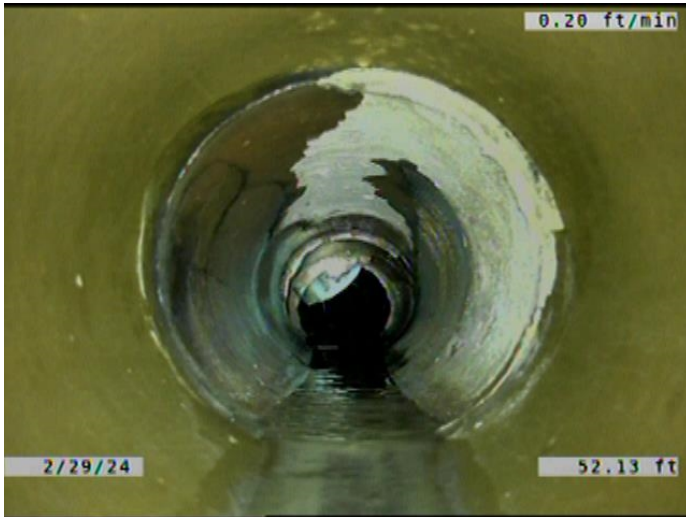
Code: **MWLS**  
Description: **Miscellaneous Water Level Sag**

Distance (ft): **52.1**  
Structural Grade: **2**  
O&M Grade: **0**  
Clock Start/From:  
Clock To:  
1st Value:  
2nd Value:  
Value Percent: **10.000**  
Continuous Index: **F05**  
Within 8" of Joint: **NO**  
Remarks:

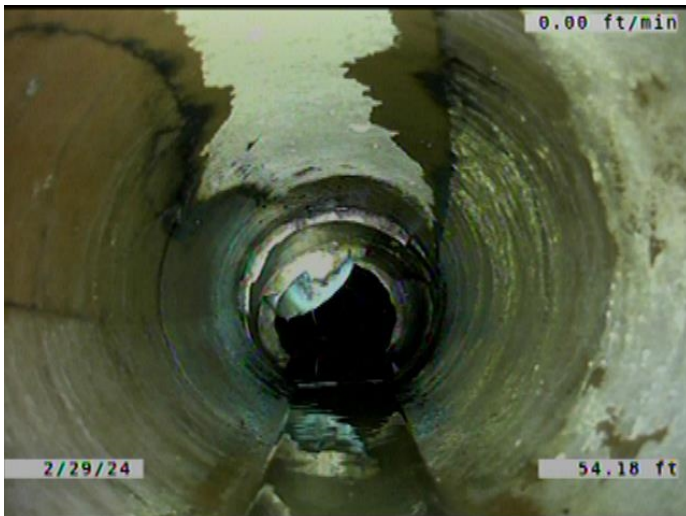
Code: **B**  
Description: **Broken**

Distance (ft): **54.2**  
Structural Grade: **4**  
O&M Grade: **0**  
Clock Start/From: **12**  
Clock To: **12**  
1st Value:  
2nd Value:  
Value Percent:  
Continuous Index: **S06**  
Within 8" of Joint: **YES**  
Remarks:

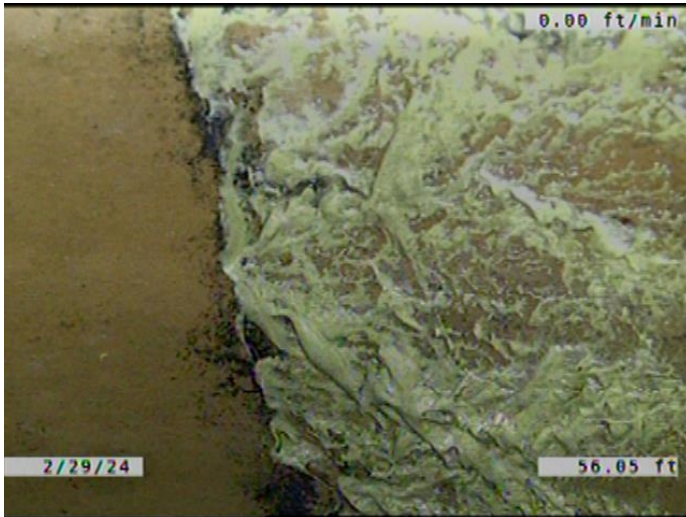
Code: **MGO**  
 Description: **Miscellaneous General Observation**

Distance (ft): **56.0**  
 Structural Grade: **0**  
 O&M Grade: **0**  
 Clock Start/From:  
 Clock To:  
 1st Value:  
 2nd Value:  
 Value Percent:  
 Continuous Index:  
 Within 8" of Joint: **NO**  
 Remarks: **SOIL ENTERING THE PIPE THROUGH THE BROKEN PIPE.**

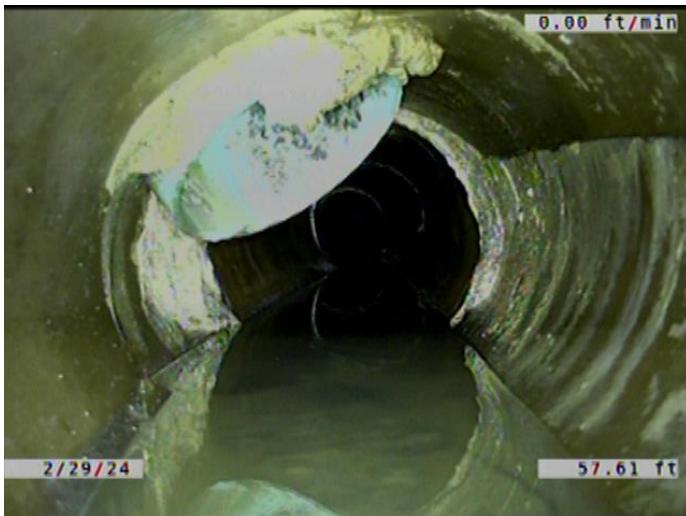
Code: **MWLS**  
 Description: **Miscellaneous Water Level Sag**

Distance (ft): **57.6**  
 Structural Grade: **2**  
 O&M Grade: **0**  
 Clock Start/From:  
 Clock To:  
 1st Value:  
 2nd Value:  
 Value Percent: **10.000**  
 Continuous Index:  
 Within 8" of Joint: **NO**  
 Remarks:

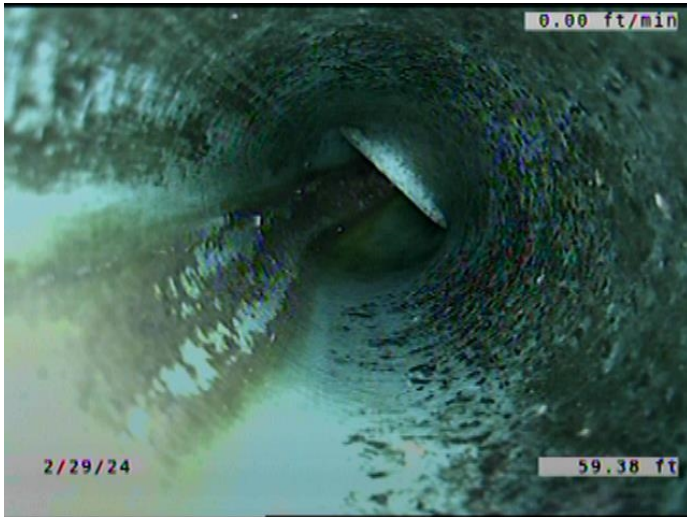
Code: **TBI**  
Description: **Tap Break-in Intruding**

Distance (ft): **59.4**  
Structural Grade: **0**  
O&M Grade: **2**  
Clock Start/From: **11**  
Clock To:  
1st Value: **6.000**  
2nd Value: **4.000**  
Value Percent:  
Continuous Index:  
Within 8" of Joint: **YES**  
Remarks: **CONSTANTLY DRIPPING WATER.**

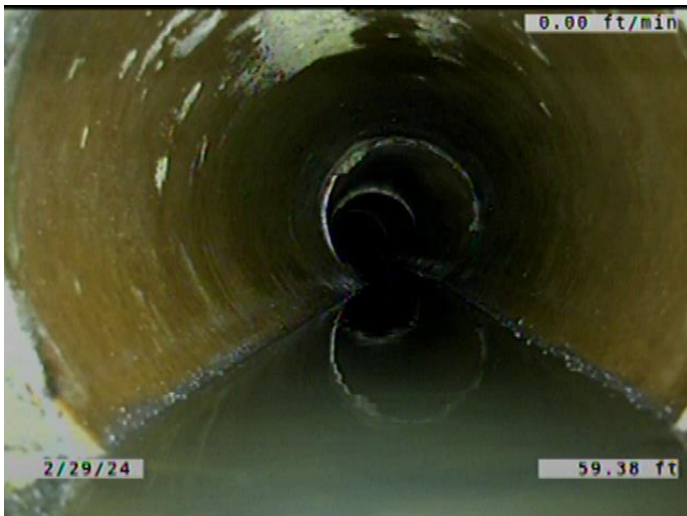
Code: **DAE**  
Description: **Deposits Attached Encrustation**

Distance (ft): **59.4**  
Structural Grade: **0**  
O&M Grade: **2**  
Clock Start/From: **7**  
Clock To: **5**  
1st Value:  
2nd Value:  
Value Percent: **5.000**  
Continuous Index: **F02**  
Within 8" of Joint: **YES**  
Remarks:

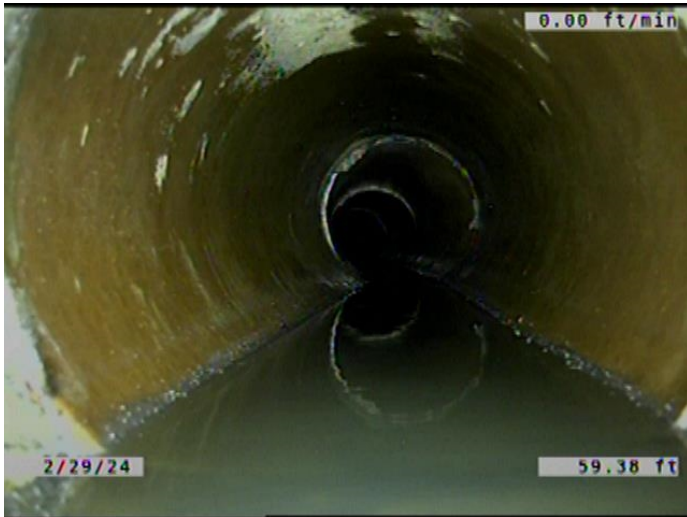
Code: **B**  
 Description: **Broken**

Distance (ft): **59.4**  
 Structural Grade: **4**  
 O&M Grade: **0**  
 Clock Start/From: **12**  
 Clock To: **12**  
 1st Value:  
 2nd Value:  
 Value Percent:  
 Continuous Index: **F06**  
 Within 8" of Joint: **YES**  
 Remarks:

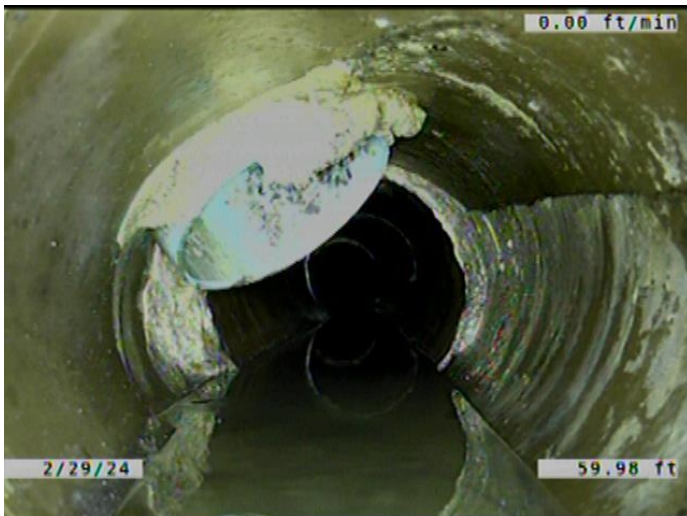
Code: **MSA**  
 Description: **Miscellaneous Survey Abandoned**

Distance (ft): **60.0**  
 Structural Grade: **0**  
 O&M Grade: **0**  
 Clock Start/From:  
 Clock To:  
 1st Value:  
 2nd Value:  
 Value Percent:  
 Continuous Index:  
 Within 8" of Joint: **NO**  
 Remarks: **CAMERA CANT MAKE IT PAST PROTRUDING TAP. MADE IT TO THE**
