## Profile/Photo Observation Report

Street:	<b>S PENNSYLVANIA ST</b>	Flow Control:	<b>Not Controlled</b>
City:	<b>Hobart, IN</b>	Year Renewed:	
Location:	<b>Yard</b>	Tape/Media #:	
Purpose:	<b>Routine Assessment</b>	Dia/Height:	<b>10"</b>
Use:	<b>Sanitary</b>	Material:	<b>VCP</b>
Drain Area:	<b>NA</b>	Lining:	
Category:	<b>NA</b>		
Comment:	<b>Flow direction is marked wrong.</b>

Location Details:		Direction of Survey:	<b>Downstream</b>
US MH:	<b>M-606-080</b>	DS MH:	<b>M-606-081</b>
		Total Length Surveyed (ft):	<b>153.5</b>

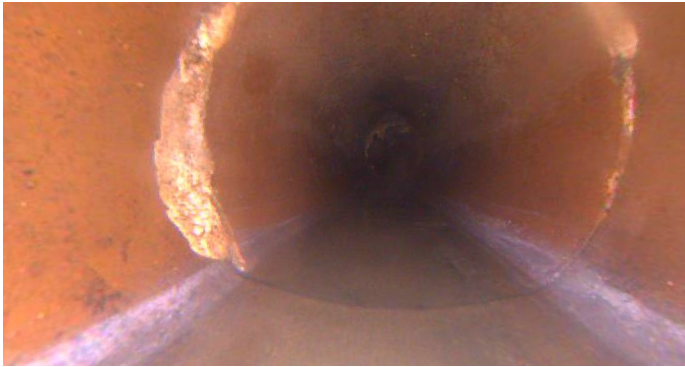
Code:	<b>MWL</b>
Description:	<b>Water Level</b>

Distance (ft):	<b>.0</b>
Structural Grade:	<b>0</b>
O&M Grade:	<b>0</b>
Clock Start/From:	
Clock To:	
1st Value:	
2nd Value:	
Value Percent:	<b>10.000</b>
Continuous Index:	
Within 8" of Joint:	<b>NO</b>
Remarks:

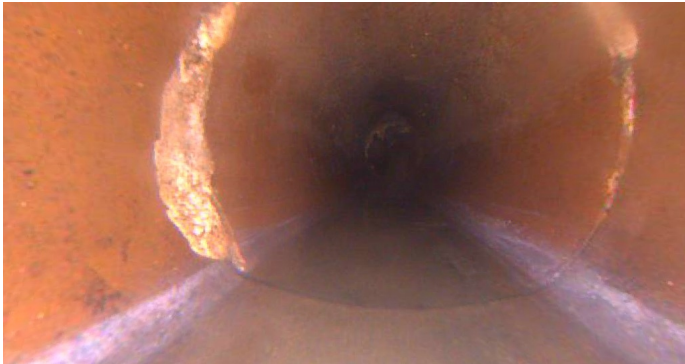
Code:	<b>DAZ</b>
Description:	<b>Deposits Attached Other</b>

Distance (ft):	<b>.0</b>
Structural Grade:	<b>0</b>
O&M Grade:	<b>2</b>
Clock Start/From:	<b>7</b>
Clock To:	<b>5</b>
1st Value:	
2nd Value:	
Value Percent:	<b>5.000</b>
Continuous Index:	<b>S01</b>
Within 8" of Joint:	<b>NO</b>
Remarks:

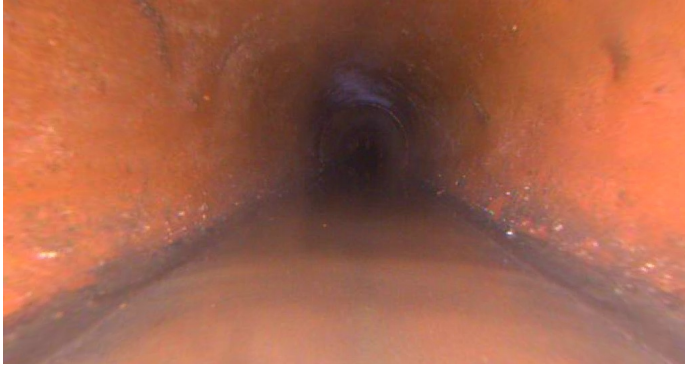
Code: **DAZ**  
Description: **Deposits Attached Other**

Distance (ft): **22.8**  
Structural Grade: **0**  
O&M Grade: **2**  
Clock Start/From: **7**  
Clock To: **5**  
1st Value:  
2nd Value:  
Value Percent: **5.000**  
Continuous Index: **F01**  
Within 8" of Joint: **NO**  
Remarks:

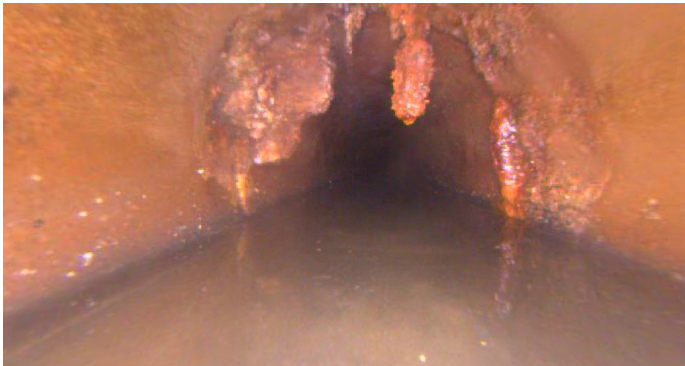
Code: **DAZ**  
Description: **Deposits Attached Other**

Distance (ft): **28.9**  
Structural Grade: **0**  
O&M Grade: **2**  
Clock Start/From: **7**  
Clock To: **5**  
1st Value:  
2nd Value:  
Value Percent: **5.000**  
Continuous Index:  
Within 8" of Joint: **YES**  
Remarks:

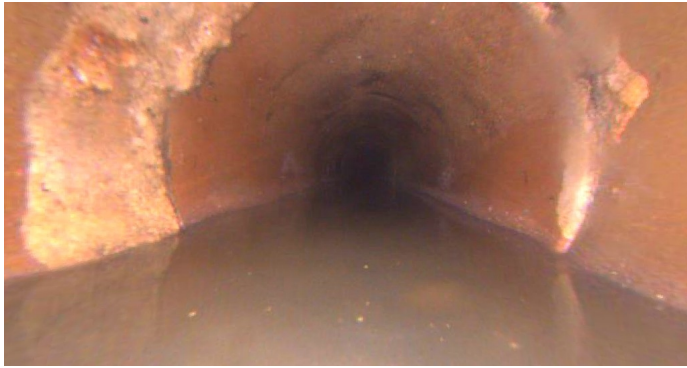
Code: **DAZ**  
Description: **Deposits Attached Other**

Distance (ft): **61.1**  
Structural Grade: **0**  
O&M Grade: **2**  
Clock Start/From: **7**  
Clock To: **5**  
1st Value:  
2nd Value:  
Value Percent: **5.000**  
Continuous Index:  
Within 8" of Joint: **YES**  
Remarks:

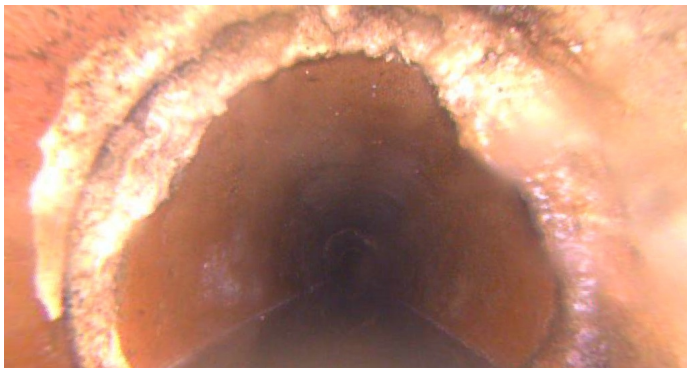
Code: **DAZ**  
Description: **Deposits Attached Other**

Distance (ft): **77.3**  
Structural Grade: **0**  
O&M Grade: **2**  
Clock Start/From: **7**  
Clock To: **5**  
1st Value:  
2nd Value:  
Value Percent: **10.000**  
Continuous Index: **S02**  
Within 8" of Joint: **YES**  
Remarks:

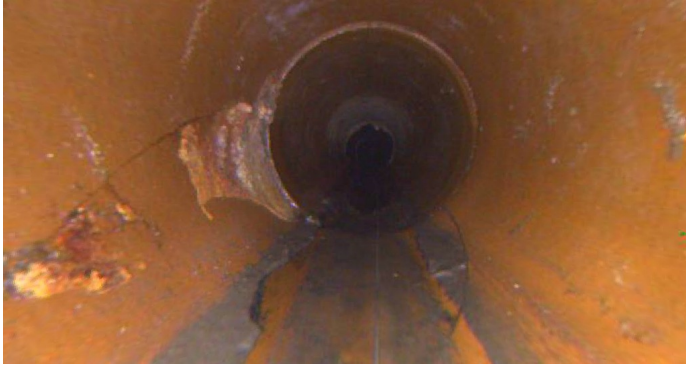
Code: **CS**  
Description: **Crack Spiral**

Distance (ft): **127.0**  
Structural Grade: **2**  
O&M Grade: **0**  
Clock Start/From: **7**  
Clock To: **3**  
1st Value:  
2nd Value:  
Value Percent:  
Continuous Index:  
Within 8" of Joint: **YES**  
Remarks:

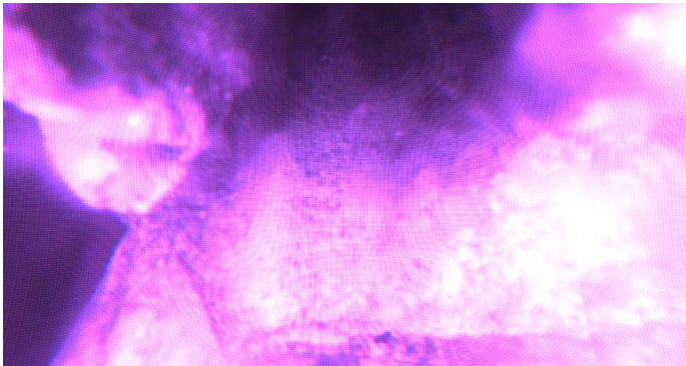
Code: **DAZ**  
Description: **Deposits Attached Other**

Distance (ft): **153.5**  
Structural Grade: **0**  
O&M Grade: **2**  
Clock Start/From: **7**  
Clock To: **5**  
1st Value:  
2nd Value:  
Value Percent: **10.000**  
Continuous Index: **F02**  
Within 8" of Joint: **YES**  
Remarks:

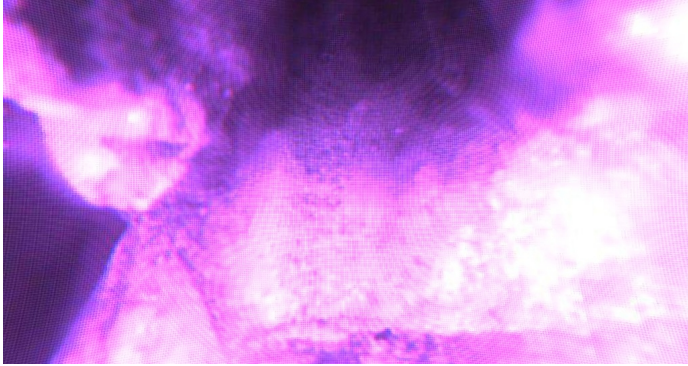
Code:	<b>MSA</b>
Description:	<b>Abandoned Survey</b>
Distance (ft):	<b>153.5</b>
Structural Grade:	<b>0</b>
O&M Grade:	<b>0</b>
Clock Start/From:	
Clock To:	
1st Value:	
2nd Value:	
Value Percent:	
Continuous Index:	
Within 8" of Joint:	<b>NO</b>
Remarks:	<b>DAZ</b>
