Profile/Photo Observation Report

Street:	FOXCROFT STREET	Flow Control:	Not Controlled
City:	Hobart, IN	Year Renewed:	
Location:	Yard	Tape/Media #:	
Purpose:	Routine Assessment	Dia/Height:	10"
Use:	Sanitary	Material:	VCP
Drain Area:	NA	Lining:	
Category:	NA		
Comment:	Flow direction is marked wrong.		
Location Details:		Direction of Survey:	Downstream
US MH:	M-606-080	DS MH:	M-606-081
		Total Length Surveyed (ft):	153.5

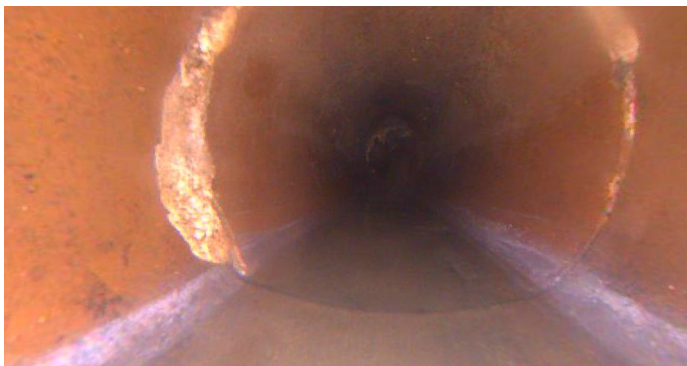
Code: **AMH**
Description: **Manhole**

Distance (ft): **.0**
Structural Grade: **0**
O&M Grade: **0**
Clock Start/From:
Clock To:
1st Value:
2nd Value:
Value Percent:
Continuous Index:
Within 8" of Joint: **NO**
Remarks: **M-606-080**

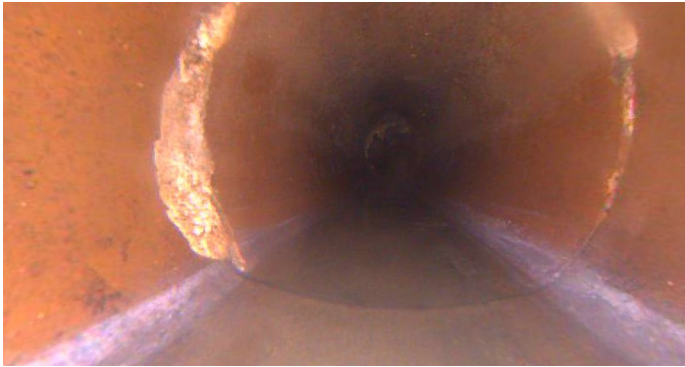
Code:	MWL
Description:	Water Level

Distance (ft):	.0
Structural Grade:	0
O&M Grade:	0
Clock Start/From:	
Clock To:	
1st Value:	
2nd Value:	
Value Percent:	10.000
Continuous Index:	
Within 8" of Joint:	NO
Remarks:

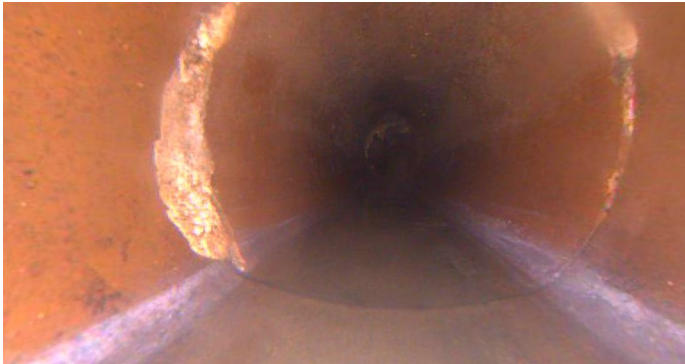
Code:	DAZ
Description:	Deposits Attached Other

Distance (ft):	.0
Structural Grade:	0
O&M Grade:	2
Clock Start/From:	7
Clock To:	5
1st Value:	
2nd Value:	
Value Percent:	5.000
Continuous Index:	S01
Within 8" of Joint:	NO
Remarks:

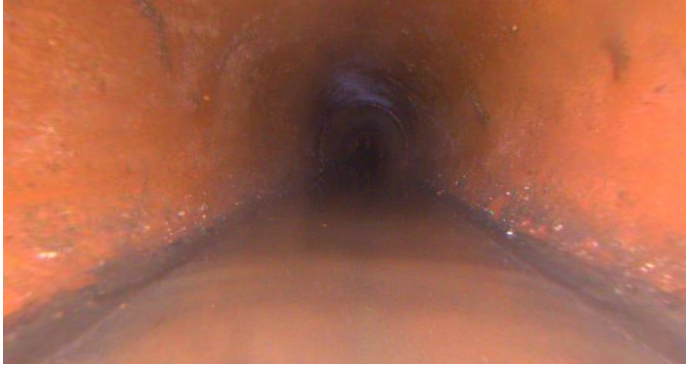
Code: **DAZ**
Description: **Deposits Attached Other**

Distance (ft): **22.8**
Structural Grade: **0**
O&M Grade: **2**
Clock Start/From: **7**
Clock To: **5**
1st Value:
2nd Value:
Value Percent: **5.000**
Continuous Index: **F01**
Within 8" of Joint: **NO**
Remarks:

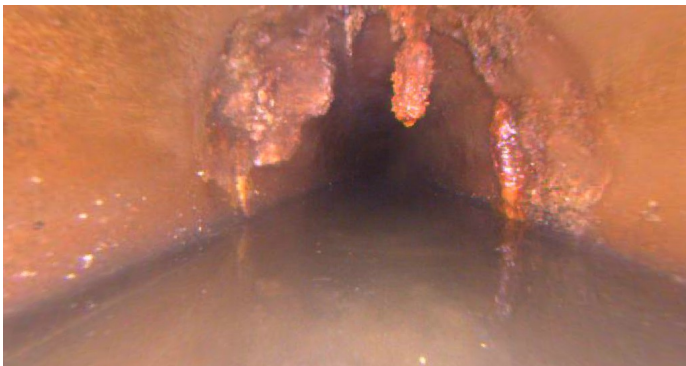
Code: **DAZ**
Description: **Deposits Attached Other**

Distance (ft): **28.9**
Structural Grade: **0**
O&M Grade: **2**
Clock Start/From: **7**
Clock To: **5**
1st Value:
2nd Value:
Value Percent: **5.000**
Continuous Index:
Within 8" of Joint: **YES**
Remarks:

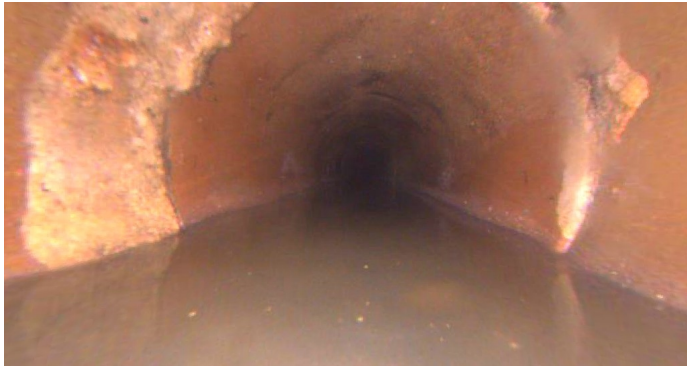
Code: **DAZ**
Description: **Deposits Attached Other**

Distance (ft): **61.1**
Structural Grade: **0**
O&M Grade: **2**
Clock Start/From: **7**
Clock To: **5**
1st Value:
2nd Value:
Value Percent: **5.000**
Continuous Index:
Within 8" of Joint: **YES**
Remarks:

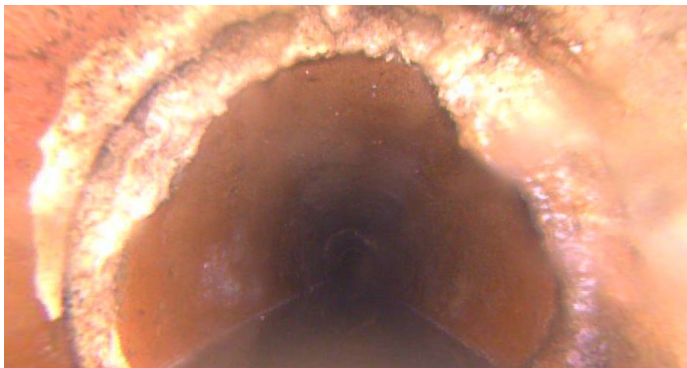
Code: **DAZ**
Description: **Deposits Attached Other**

Distance (ft): **77.3**
Structural Grade: **0**
O&M Grade: **2**
Clock Start/From: **7**
Clock To: **5**
1st Value:
2nd Value:
Value Percent: **10.000**
Continuous Index: **S02**
Within 8" of Joint: **YES**
Remarks:

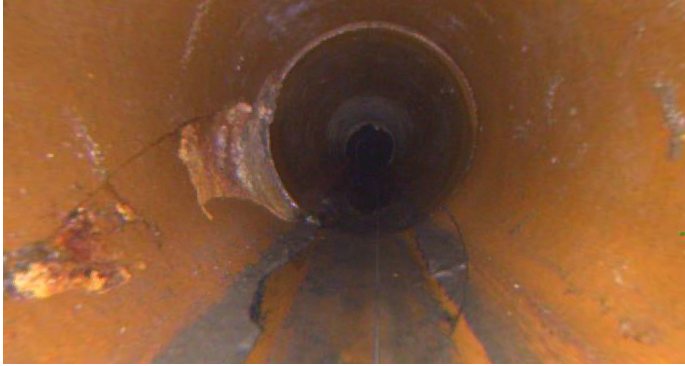
Code: **CS**
Description: **Crack Spiral**

Distance (ft): **127.0**
Structural Grade: **2**
O&M Grade: **0**
Clock Start/From: **7**
Clock To: **3**
1st Value:
2nd Value:
Value Percent:
Continuous Index:
Within 8" of Joint: **YES**
Remarks:

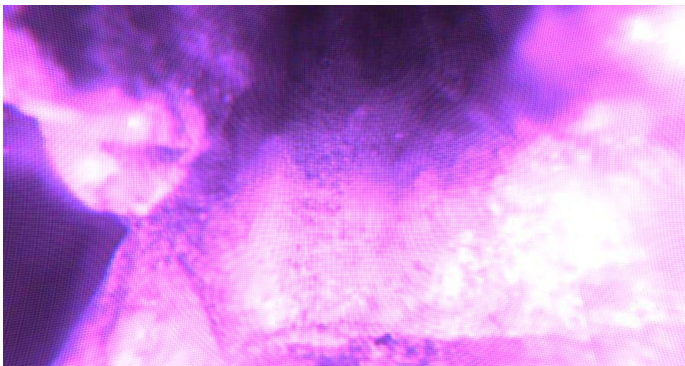
Code: **DAZ**
Description: **Deposits Attached Other**

Distance (ft): **153.5**
Structural Grade: **0**
O&M Grade: **2**
Clock Start/From: **7**
Clock To: **5**
1st Value:
2nd Value:
Value Percent: **10.000**
Continuous Index: **F02**
Within 8" of Joint: **YES**
Remarks:

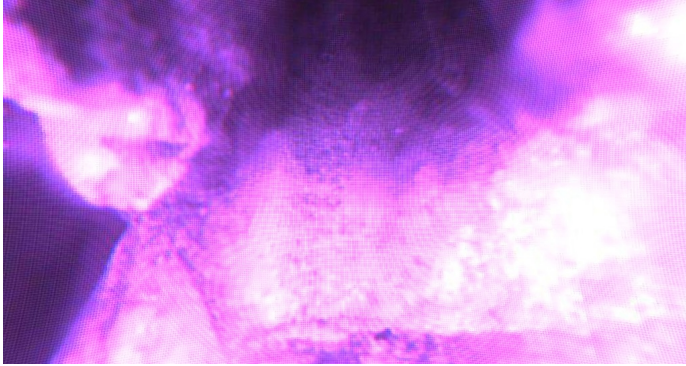
Code:	MSA
Description:	Abandoned Survey
Distance (ft):	153.5
Structural Grade:	0
O&M Grade:	0
Clock Start/From:	
Clock To:	
1st Value:	
2nd Value:	
Value Percent:	
Continuous Index:	
Within 8" of Joint:	NO
Remarks:	DAZ
