Profile/Photo Observation Report

Date:	02/29/2024	Weather:		Coding:	PACP 7.0
Pipe Length (ft):	85.1	Owner:	City of Hobart	Pre Clean:	Heavy Cleaning
P.O.#:		Surveyor:	S. Bucklin	PSR:	M-606-084-M-606-083
Customer:	City of Hobart	Clean Date:	11/29/2023	Shape:	C

Street:	NORTH LAKE SHORE	Flow Control:	Not Controlled
City:	Hobart, IN	Year Renewed:	
Location:	Local rural streets with light traffic, t	Tape/Media #:	
Purpose:	Sewer System Evaluation Survey (SS	Dia/Height:	10"
Use:	Sanitary Sewage Pipe	Material:	VCP
Drain Area:		Lining:	None
Category:	NA		
Comment:			
Location Details:		Direction of Survey:	Downstream
US MH:	M-606-084	DS MH:	M-606-083
		Total Length Surveyed (ft):	172.4

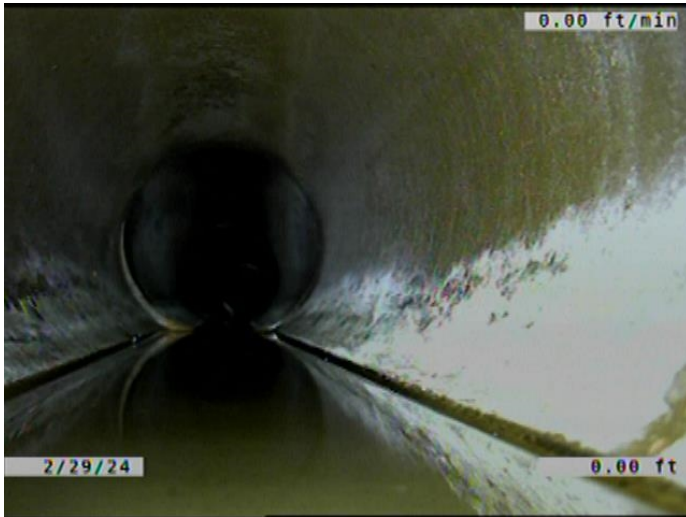
Code: **MWLS**
Description: **Miscellaneous Water Level Sag**

Distance (ft): **.0**
Structural Grade: **2**
O&M Grade: **0**
Clock Start/From:
Clock To:
1st Value:
2nd Value:
Value Percent: **10.000**
Continuous Index:
Within 8" of Joint: **NO**
Remarks:

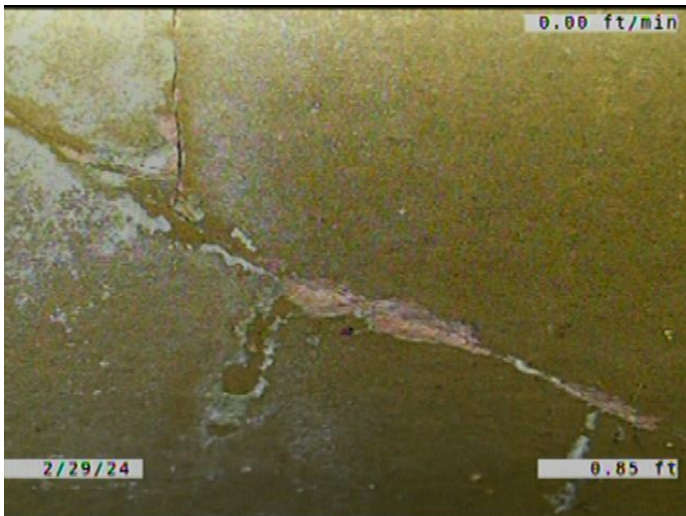
Code: **FM**
Description: **Fracture Multiple**

Distance (ft): **.8**
Structural Grade: **4**
O&M Grade: **0**
Clock Start/From: **8**
Clock To: **3**
1st Value:
2nd Value:
Value Percent:
Continuous Index:
Within 8" of Joint: **YES**
Remarks:

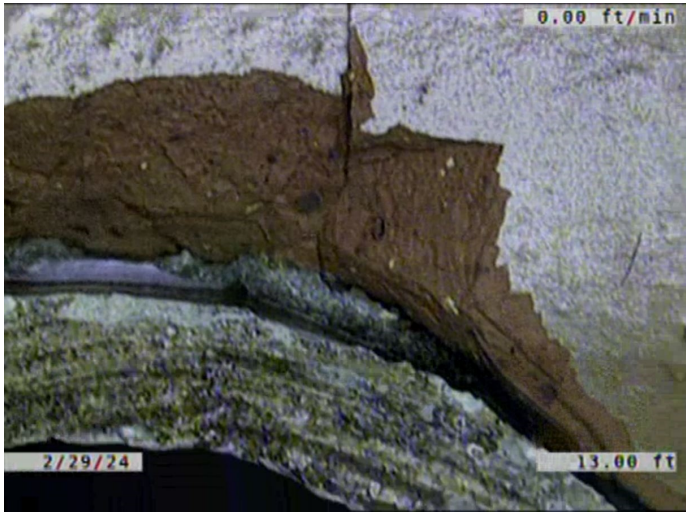
Code: **CL**
Description: **Crack Longitudinal**

Distance (ft): **13.0**
Structural Grade: **2**
O&M Grade: **0**
Clock Start/From: **1**
Clock To:
1st Value:
2nd Value:
Value Percent:
Continuous Index:
Within 8" of Joint: **NO**
Remarks:

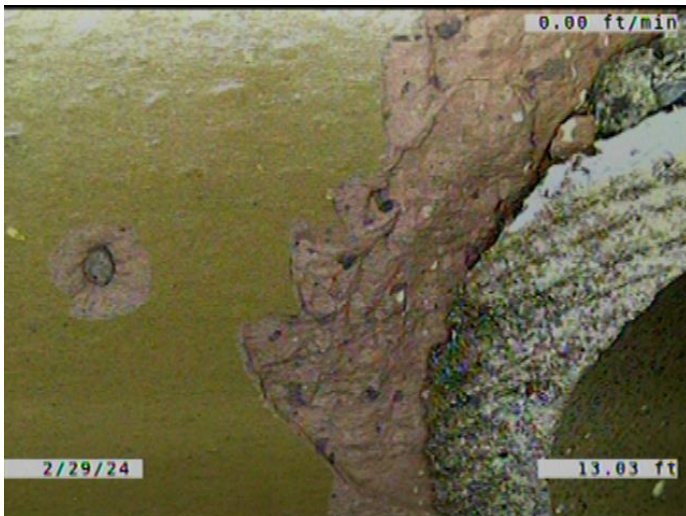
Code: **SSS**
Description: **Surface Damage Surface Spalling**

Distance (ft): **13.0**
Structural Grade: **2**
O&M Grade: **0**
Clock Start/From: **11**
Clock To: **2**
1st Value:
2nd Value:
Value Percent:
Continuous Index:
Within 8" of Joint: **YES**
Remarks:

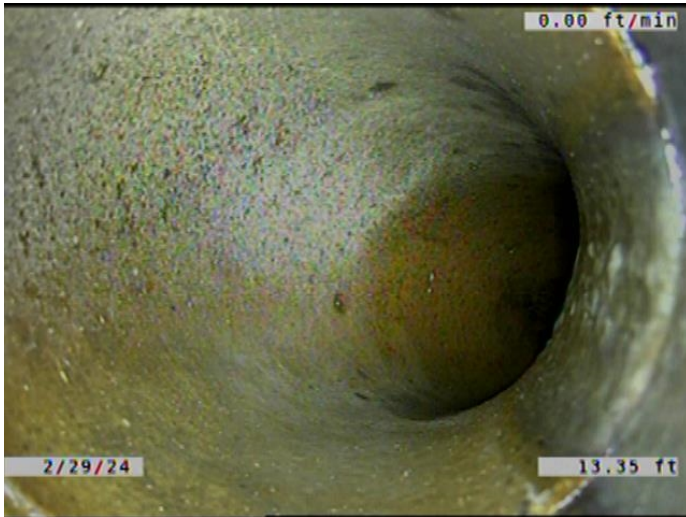
Code: **TBI**
Description: **Tap Break-in Intruding**

Distance (ft): **13.3**
Structural Grade: **0**
O&M Grade: **2**
Clock Start/From: **1**
Clock To:
1st Value: **6.000**
2nd Value: **1.000**
Value Percent:
Continuous Index:
Within 8" of Joint: **YES**
Remarks: **CONSTANTLY RUNNING WATER.**

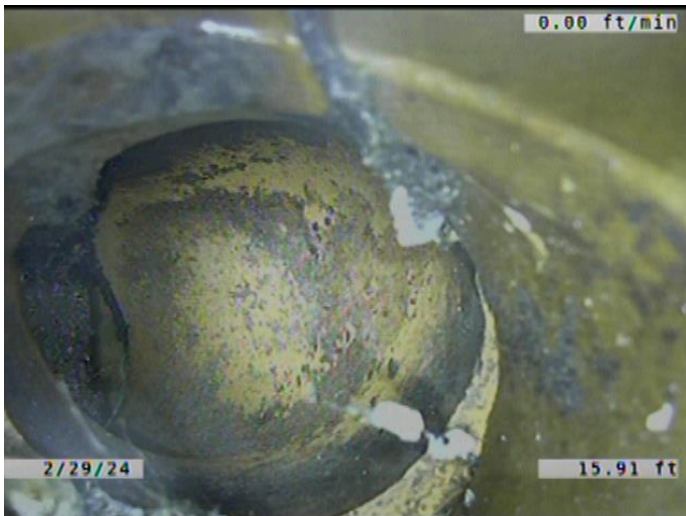
Code: **RFC**
Description: **Roots Fine Connection**

Distance (ft): **15.9**
Structural Grade: **0**
O&M Grade: **1**
Clock Start/From: **11**
Clock To:
1st Value:
2nd Value:
Value Percent:
Continuous Index:
Within 8" of Joint: **NO**
Remarks:

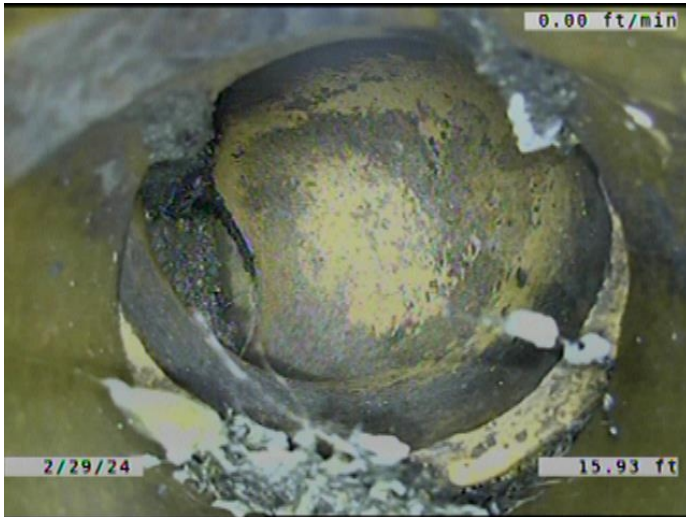
Code:	TFD
Description:	Tap Factory Defective
Distance (ft):	15.9
Structural Grade:	0
O&M Grade:	3
Clock Start/From:	11
Clock To:	
1st Value:	6.000
2nd Value:	
Value Percent:	
Continuous Index:	
Within 8" of Joint:	YES
Remarks:	SERVICE OFFSET. TAP CRACKED. ROOTS GROWING IN THE JOINTS INT

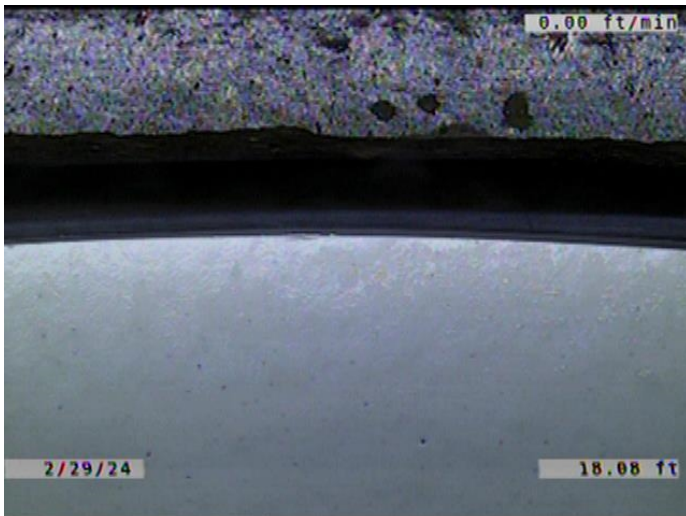
Code:	RPR
Description:	Point Repair Replacement
Distance (ft):	18.1
Structural Grade:	0
O&M Grade:	0
Clock Start/From:	
Clock To:	
1st Value:	
2nd Value:	
Value Percent:	
Continuous Index:	S01
Within 8" of Joint:	YES
Remarks:	REPLACED WITH PVC.

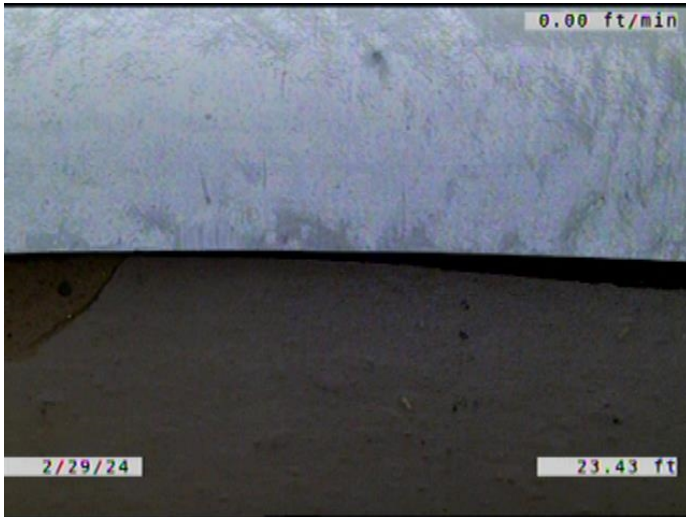
Code: **RPR**
Description: **Point Repair Replacement**

Distance (ft): **23.4**
Structural Grade: **0**
O&M Grade: **0**
Clock Start/From:
Clock To:
1st Value:
2nd Value:
Value Percent:
Continuous Index: **F01**
Within 8" of Joint: **YES**
Remarks: **REPLACED WITH PVC.**

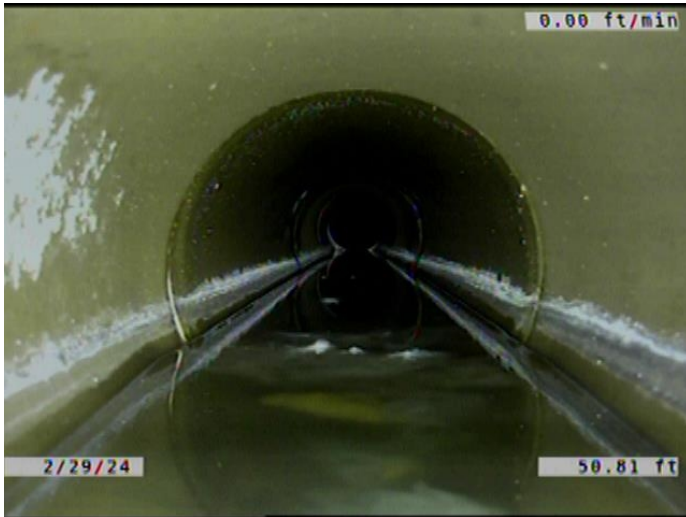
Code: **DSF**
Description: **Deposits Settled Fine**

Distance (ft): **50.8**
Structural Grade: **0**
O&M Grade: **2**
Clock Start/From: **5**
Clock To: **7**
1st Value:
2nd Value:
Value Percent: **5.000**
Continuous Index: **S05**
Within 8" of Joint: **YES**
Remarks:

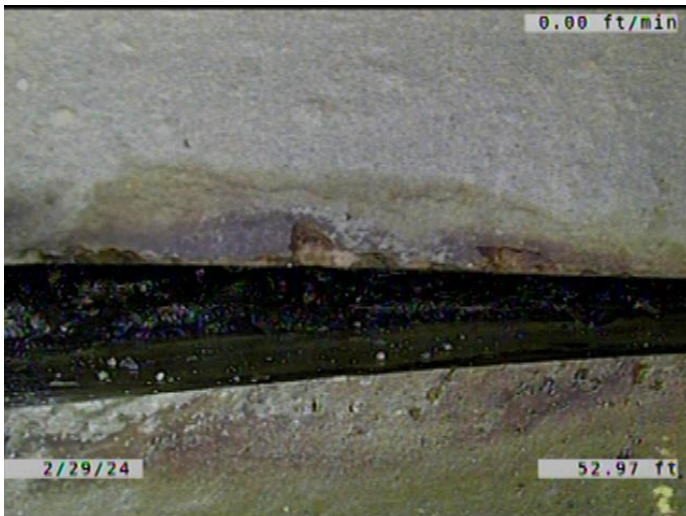
Code: **DAE**
Description: **Deposits Attached Encrustation**

Distance (ft): **53.0**
Structural Grade: **0**
O&M Grade: **2**
Clock Start/From: **8**
Clock To: **4**
1st Value:
2nd Value:
Value Percent: **5.000**
Continuous Index:
Within 8" of Joint: **YES**
Remarks:

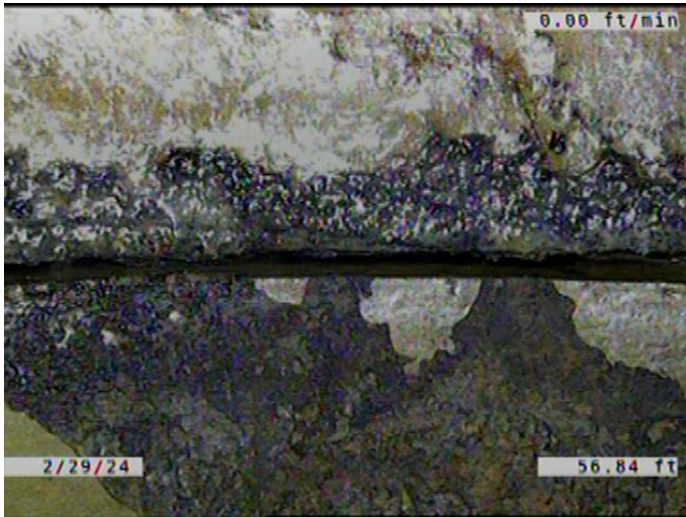
Code: **DAE**
Description: **Deposits Attached Encrustation**

Distance (ft): **56.8**
Structural Grade: **0**
O&M Grade: **2**
Clock Start/From: **8**
Clock To: **4**
1st Value:
2nd Value:
Value Percent: **5.000**
Continuous Index:
Within 8" of Joint: **YES**
Remarks:

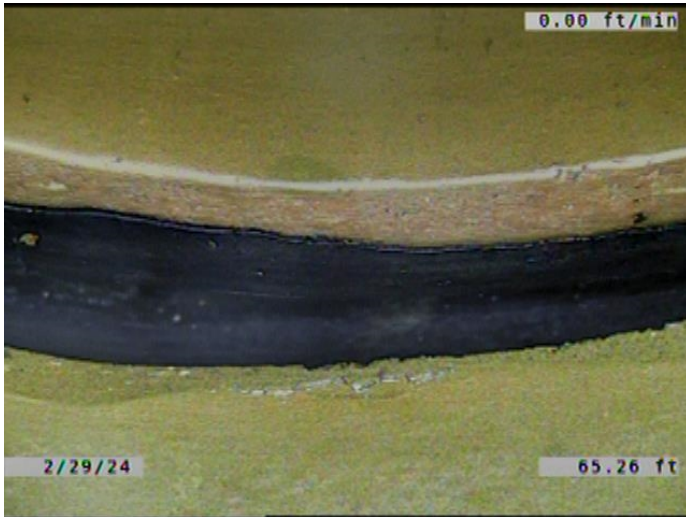
Code: **JOMD**
Description: **Joint Offset Medium Defective**

Distance (ft): **65.3**
Structural Grade: **3**
O&M Grade: **0**
Clock Start/From:
Clock To:
1st Value:
2nd Value:
Value Percent:
Continuous Index:
Within 8" of Joint: **NO**
Remarks:

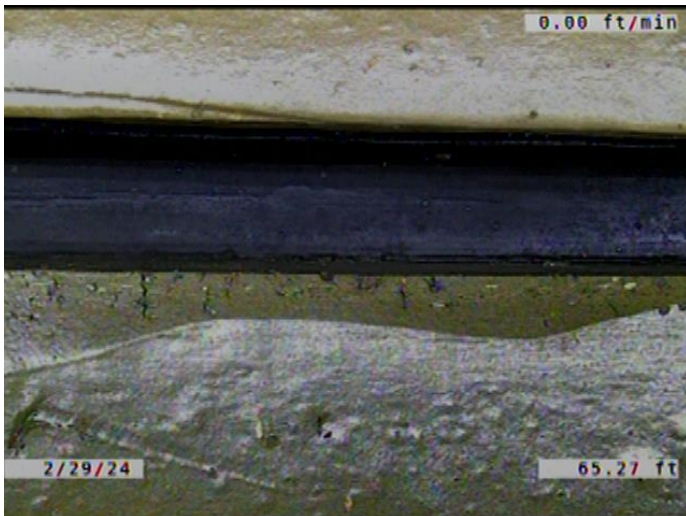
Code: **JAM**
Description: **Joint Angular Medium**

Distance (ft): **65.3**
Structural Grade: **3**
O&M Grade: **0**
Clock Start/From:
Clock To:
1st Value:
2nd Value:
Value Percent:
Continuous Index:
Within 8" of Joint: **NO**
Remarks:

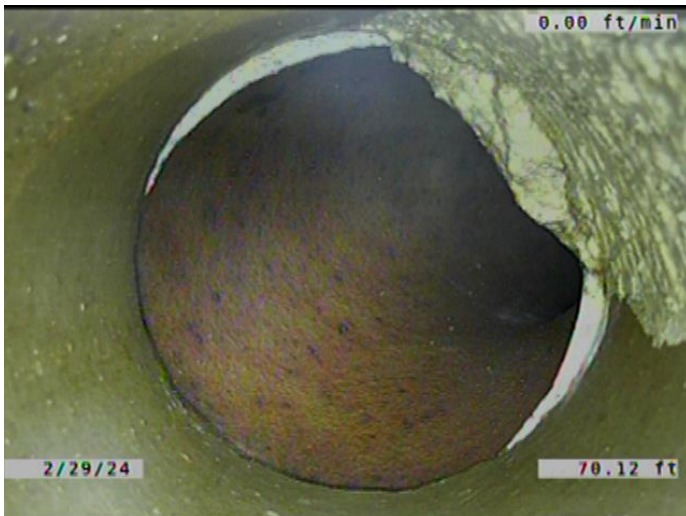
Code: **TFD**
Description: **Tap Factory Defective**

Distance (ft): **70.1**
Structural Grade: **0**
O&M Grade: **3**
Clock Start/From: **1**
Clock To:
1st Value: **6.000**
2nd Value:
Value Percent:
Continuous Index:
Within 8" of Joint: **YES**
Remarks: **ENCRUSTATION COMING FROM THE SERVICE INTO THE MAIN.**

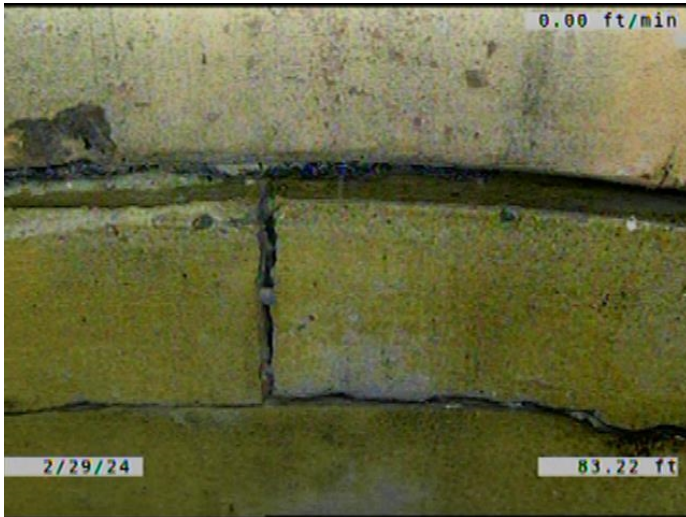
Code: **B**
Description: **Broken**

Distance (ft): **83.2**
Structural Grade: **4**
O&M Grade: **0**
Clock Start/From: **1**
Clock To: **11**
1st Value:
2nd Value:
Value Percent:
Continuous Index:
Within 8" of Joint: **YES**
Remarks:

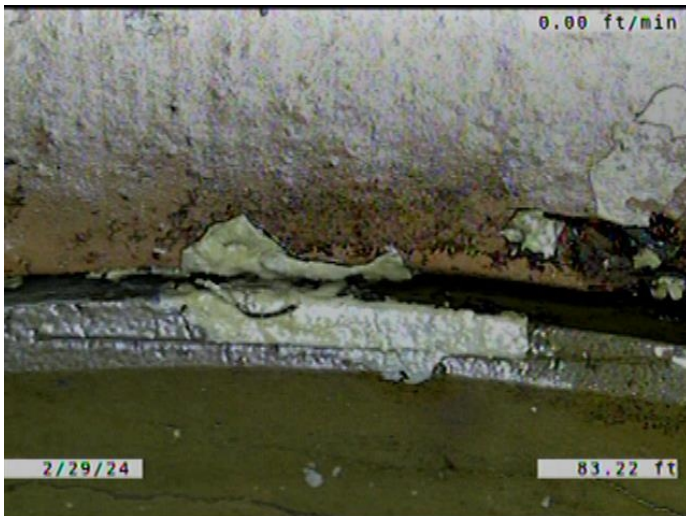
Code: **DAE**
Description: **Deposits Attached Encrustation**

Distance (ft): **83.2**
Structural Grade: **0**
O&M Grade: **2**
Clock Start/From: **1**
Clock To: **5**
1st Value:
2nd Value:
Value Percent: **5.000**
Continuous Index:
Within 8" of Joint: **YES**
Remarks:

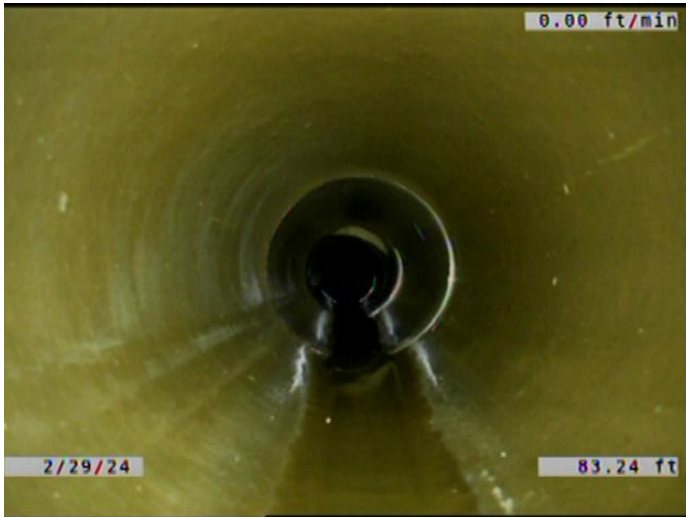
Code: **DSF**
Description: **Deposits Settled Fine**

Distance (ft): **83.2**
Structural Grade: **0**
O&M Grade: **2**
Clock Start/From: **5**
Clock To: **7**
1st Value:
2nd Value:
Value Percent: **5.000**
Continuous Index: **F05**
Within 8" of Joint: **YES**
Remarks:

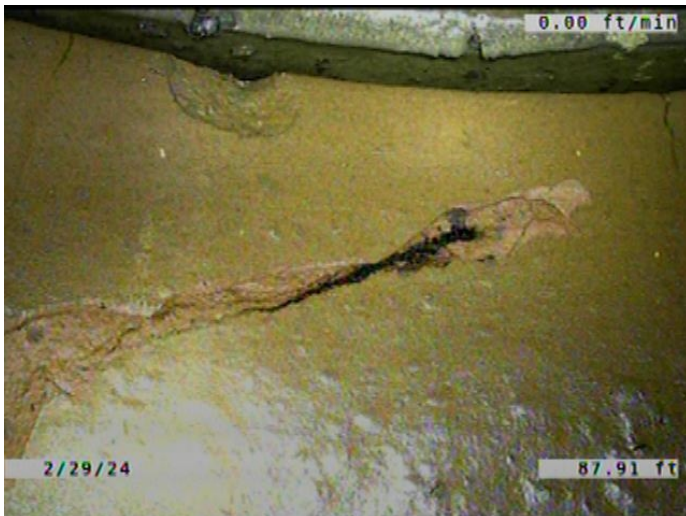
Code: **FM**
Description: **Fracture Multiple**

Distance (ft): **87.9**
Structural Grade: **4**
O&M Grade: **0**
Clock Start/From: **3**
Clock To: **4**
1st Value:
2nd Value:
Value Percent:
Continuous Index:
Within 8" of Joint: **YES**
Remarks:

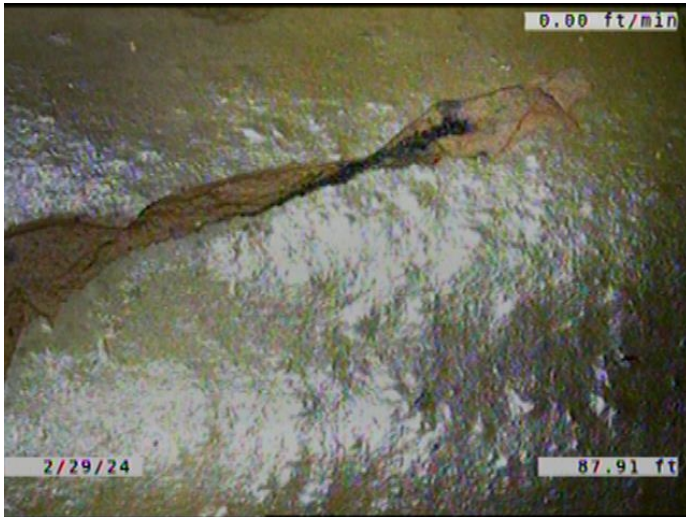
Code: **ISB**
Description: **Infiltration Stain Barrel**

Distance (ft): **87.9**
Structural Grade: **0**
O&M Grade: **1**
Clock Start/From: **3**
Clock To: **4**
1st Value:
2nd Value:
Value Percent:
Continuous Index:
Within 8" of Joint: **YES**
Remarks:

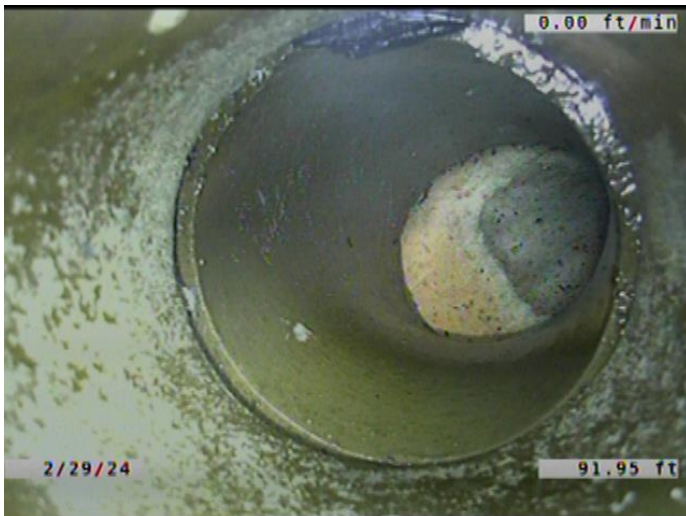
Code: **TFC**
Description: **Tap Factory Capped**

Distance (ft): **92.0**
Structural Grade: **0**
O&M Grade: **0**
Clock Start/From: **1**
Clock To:
1st Value: **6.000**
2nd Value:
Value Percent:
Continuous Index:
Within 8" of Joint: **YES**
Remarks: **TAP CRACKED.**

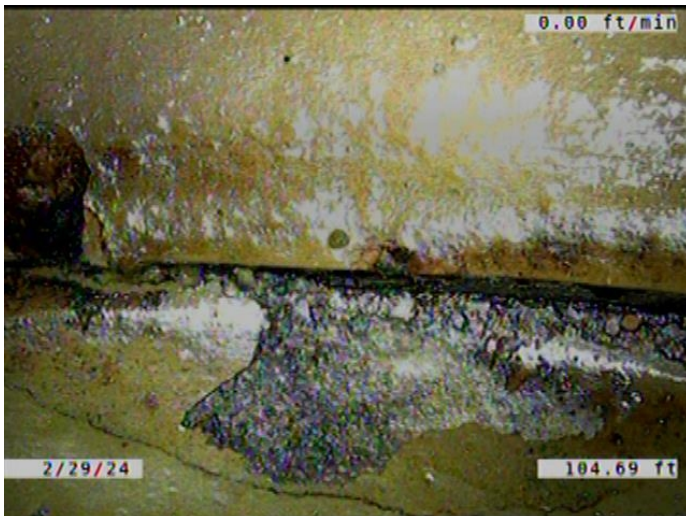
Code: **DAE**
Description: **Deposits Attached Encrustation**

Distance (ft): **104.7**
Structural Grade: **0**
O&M Grade: **2**
Clock Start/From: **1**
Clock To: **3**
1st Value:
2nd Value:
Value Percent: **5.000**
Continuous Index:
Within 8" of Joint: **YES**
Remarks:

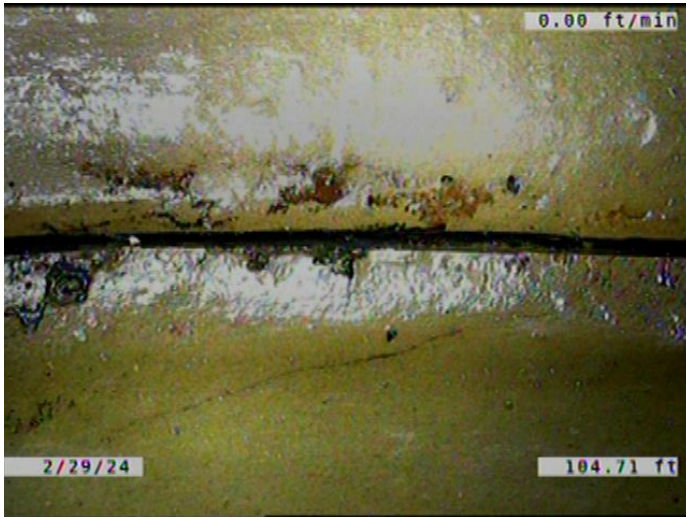
Code: **DAE**
Description: **Deposits Attached Encrustation**

Distance (ft): **104.7**
Structural Grade: **0**
O&M Grade: **2**
Clock Start/From: **8**
Clock To: **11**
1st Value:
2nd Value:
Value Percent: **5.000**
Continuous Index:
Within 8" of Joint: **YES**
Remarks:

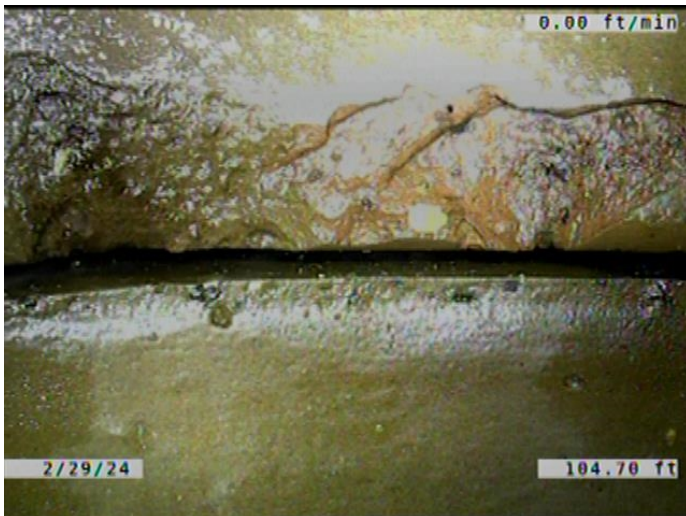
Code: **SZ**
Description: **Surface Damage Other**

Distance (ft): **104.7**
Structural Grade: **0**
O&M Grade: **0**
Clock Start/From: **8**
Clock To: **9**
1st Value:
2nd Value:
Value Percent:
Continuous Index:
Within 8" of Joint: **YES**
Remarks: **A PIECE CHIPPED AWAY FROM THE JOINT.**

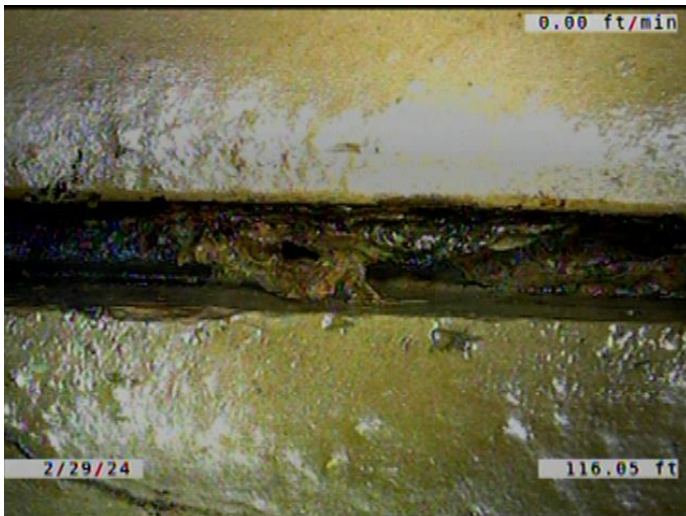
Code: **DAE**
Description: **Deposits Attached Encrustation**

Distance (ft): **116.0**
Structural Grade: **0**
O&M Grade: **2**
Clock Start/From: **7**
Clock To: **5**
1st Value:
2nd Value:
Value Percent: **5.000**
Continuous Index:
Within 8" of Joint: **YES**
Remarks:

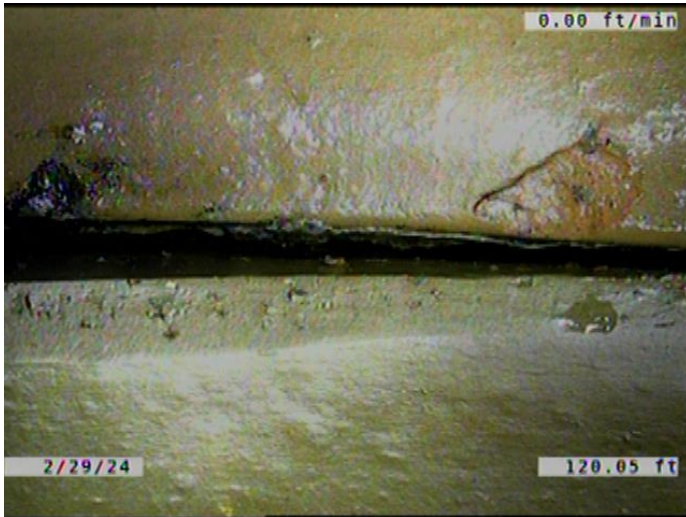
Code: **DAE**
Description: **Deposits Attached Encrustation**

Distance (ft): **120.0**
Structural Grade: **0**
O&M Grade: **2**
Clock Start/From: **8**
Clock To: **5**
1st Value:
2nd Value:
Value Percent: **5.000**
Continuous Index:
Within 8" of Joint: **YES**
Remarks:

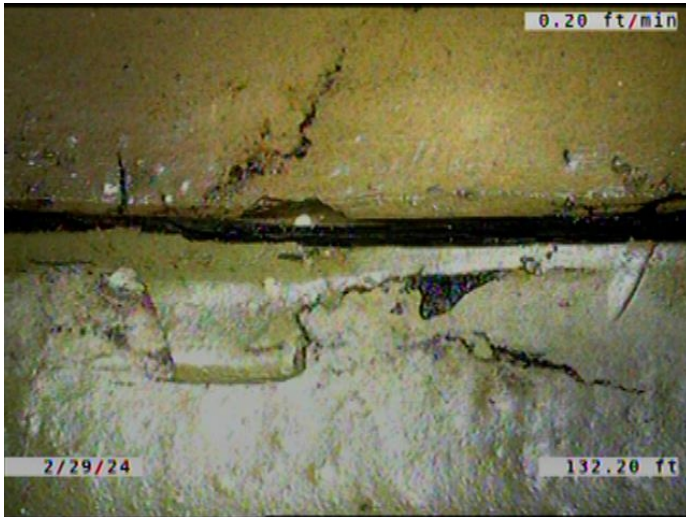
Code: **DAE**
Description: **Deposits Attached Encrustation**

Distance (ft): **132.6**
Structural Grade: **0**
O&M Grade: **2**
Clock Start/From: **7**
Clock To: **5**
1st Value:
2nd Value:
Value Percent: **5.000**
Continuous Index: **S07**
Within 8" of Joint: **YES**
Remarks:

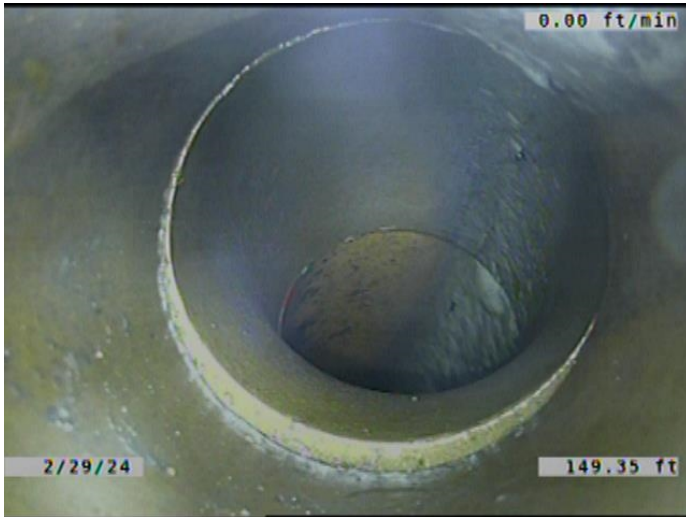
Code: **TF**
Description: **Tap Factory**

Distance (ft): **149.3**
Structural Grade: **0**
O&M Grade: **0**
Clock Start/From: **1**
Clock To:
1st Value: **6.000**
2nd Value:
Value Percent:
Continuous Index:
Within 8" of Joint: **YES**
Remarks: **SERVICE OFFSET.**

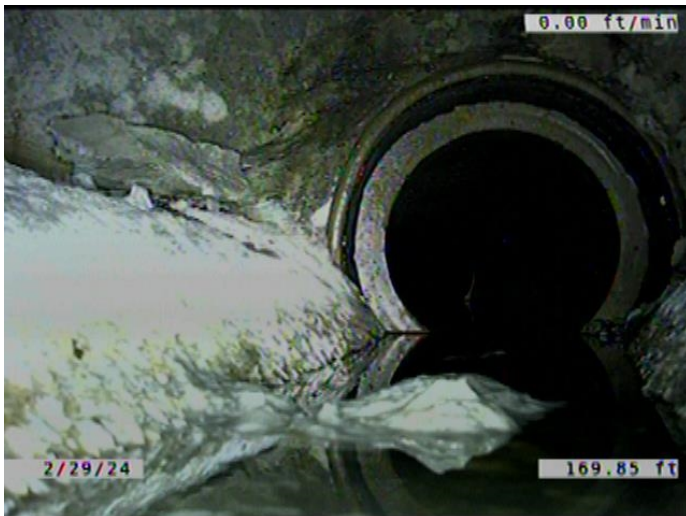
Code: **DAE**
Description: **Deposits Attached Encrustation**

Distance (ft): **169.8**
Structural Grade: **0**
O&M Grade: **2**
Clock Start/From: **7**
Clock To: **5**
1st Value:
2nd Value:
Value Percent: **5.000**
Continuous Index: **F07**
Within 8" of Joint: **YES**
Remarks:
