## Profile/Photo Observation Report

Date:	<b>04/08/2018</b>	Weather:		Coding:	<b>PACP 6.0</b>
Pipe Length (ft):	<b>85.1</b>	Owner:	<b>NA</b>	Pre Clean:	<b>No Pre-Cleaning</b>
P.O.#:		Surveyor:	<b>Jen Costello</b>	PSR:	<b>P-606-083-084</b>
Customer:		Clean Date:	<b>01/01/1900</b>	Shape:	<b>C</b>

Street:	<b>N LAKE SHORE DR</b>	Flow Control:	<b>Not Controlled</b>
City:	<b>Hobart, IN</b>	Year Renewed:	
Location:	<b>Yard</b>	Tape/Media #:	
Purpose:	<b>Routine Assessment</b>	Dia/Height:	<b>10"</b>
Use:	<b>Sanitary</b>	Material:	<b>VCP</b>
Drain Area:	<b>NA</b>	Lining:	
Category:	<b>NA</b>		
Comment:

Location Details:		Direction of Survey:	<b>Upstream</b>
US MH:	<b>M-606-084</b>	DS MH:	<b>M-606-083</b>
		Total Length Surveyed (ft):	<b>13.7</b>

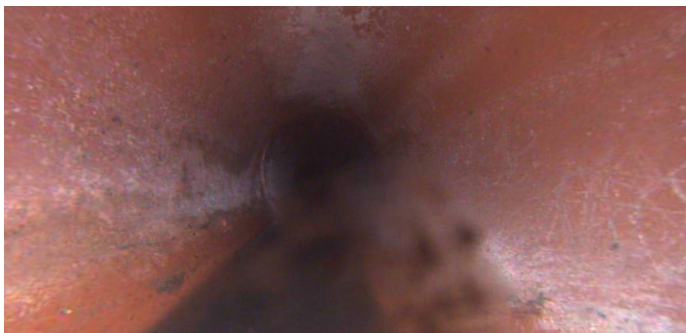
Code: **AMH**  
Description: **Manhole**

Distance (ft): **.0**  
Structural Grade: **0**  
O&M Grade: **0**  
Clock Start/From:  
Clock To:  
1st Value:  
2nd Value:  
Value Percent:  
Continuous Index:  
Within 8" of Joint: **NO**  
Remarks: **M-606-083**

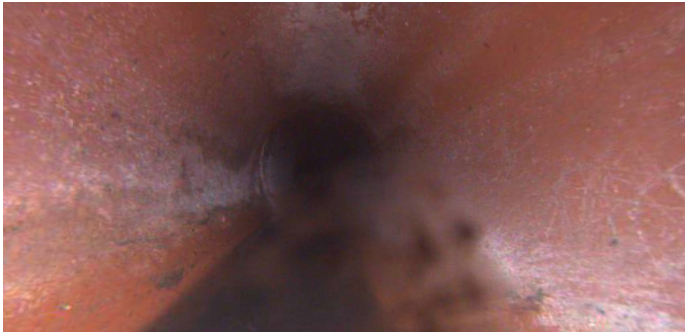
Code:	<b>MWL</b>
Description:	<b>Water Level</b>

Distance (ft):	<b>.0</b>
Structural Grade:	<b>0</b>
O&M Grade:	<b>0</b>
Clock Start/From:	
Clock To:	
1st Value:	
2nd Value:	
Value Percent:	<b>5.000</b>
Continuous Index:	
Within 8" of Joint:	<b>NO</b>
Remarks:

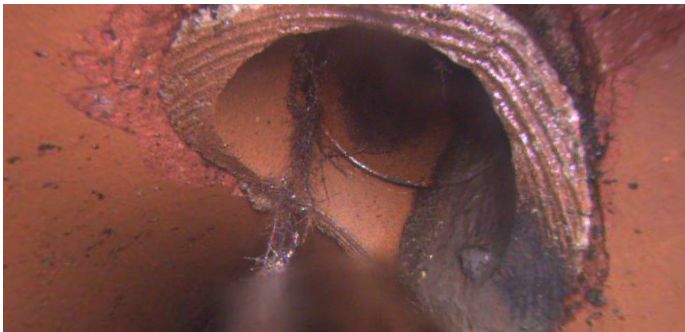
Code:	<b>TBI</b>
Description:	<b>Tap Break-in Intruding</b>

Distance (ft):	<b>11.5</b>
Structural Grade:	<b>0</b>
O&M Grade:	<b>2</b>
Clock Start/From:	<b>1</b>
Clock To:	
1st Value:	<b>4.000</b>
2nd Value:	<b>1.000</b>
Value Percent:	
Continuous Index:	
Within 8" of Joint:	
Remarks:	<b>rml</b>

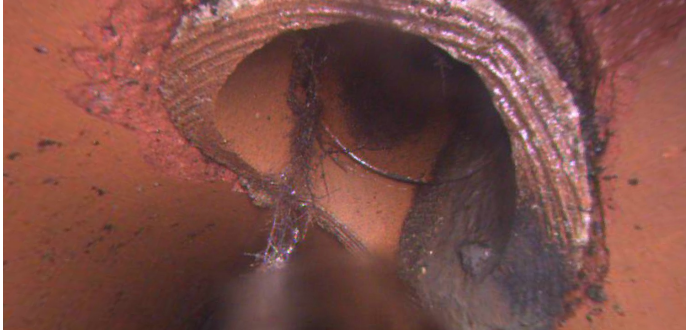
Code: **RFL**  
Description: **Roots Fine Lateral**

Distance (ft): **11.5**  
Structural Grade: **0**  
O&M Grade: **1**  
Clock Start/From: **12**  
Clock To:  
1st Value:  
2nd Value:  
Value Percent:  
Continuous Index:  
Within 8" of Joint: **NO**  
Remarks:

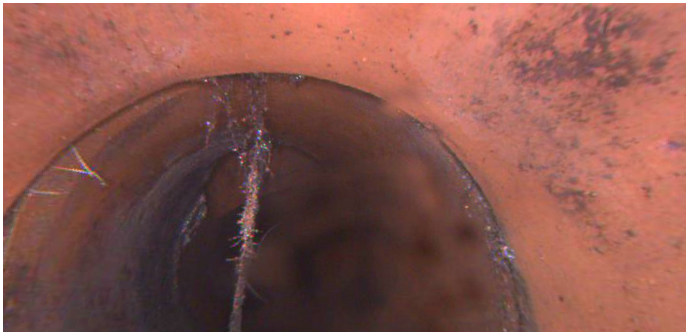
Code: **RFJ**  
Description: **Roots Fine Joint**

Distance (ft): **12.9**  
Structural Grade: **0**  
O&M Grade: **1**  
Clock Start/From: **8**  
Clock To: **4**  
1st Value:  
2nd Value:  
Value Percent:  
Continuous Index:  
Within 8" of Joint: **YES**  
Remarks:

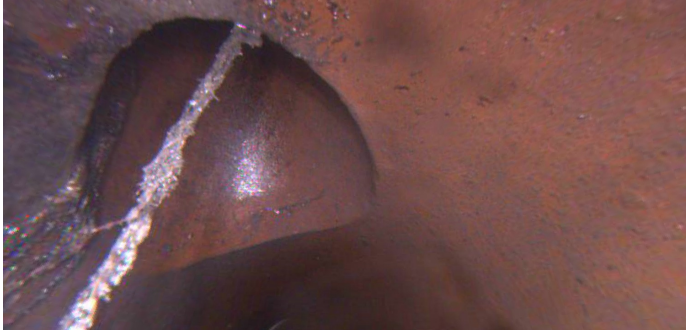
Code: **TFD**  
Description: **Tap Factory Defective**

Distance (ft): **13.7**  
Structural Grade: **0**  
O&M Grade: **2**  
Clock Start/From: **11**  
Clock To:  
1st Value: **4.000**  
2nd Value:  
Value Percent:  
Continuous Index:  
Within 8" of Joint:  
Remarks: **rfl**

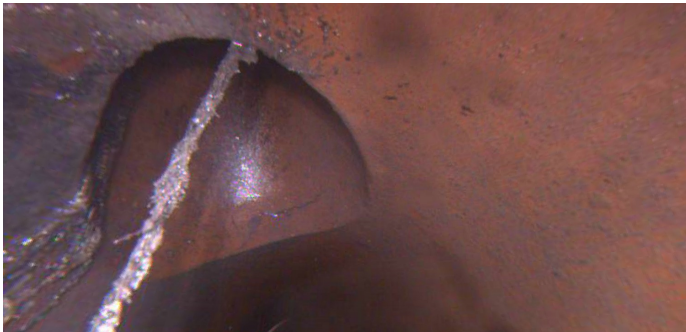
Code: **MSA**  
Description: **Abandoned Survey**

Distance (ft): **13.7**  
Structural Grade: **0**  
O&M Grade: **0**  
Clock Start/From:  
Clock To:  
1st Value:  
2nd Value:  
Value Percent:  
Continuous Index:  
Within 8" of Joint: **NO**  
Remarks: **unknown**
