Profile/Photo Observation Report

Date:	04/08/2018	Weather:		Coding:	PACP 6.0
Pipe Length (ft):	85.1	Owner:	NA	Pre Clean:	No Pre-Cleaning
P.O.#:		Surveyor:	Jen Costello	PSR:	P-606-083-084
Customer:		Clean Date:	01/01/1900	Shape:	C

Street:	FOXCROFT STREET	Flow Control:	Not Controlled
City:	Hobart, IN	Year Renewed:	
Location:	Yard	Tape/Media #:	
Purpose:	Routine Assessment	Dia/Height:	10"
Use:	Sanitary	Material:	VCP
Drain Area:	NA	Lining:	
Category:	NA		
Comment:

Location Details:		Direction of Survey:	Upstream
US MH:	M-606-084	DS MH:	M-606-083
		Total Length Surveyed (ft):	13.7

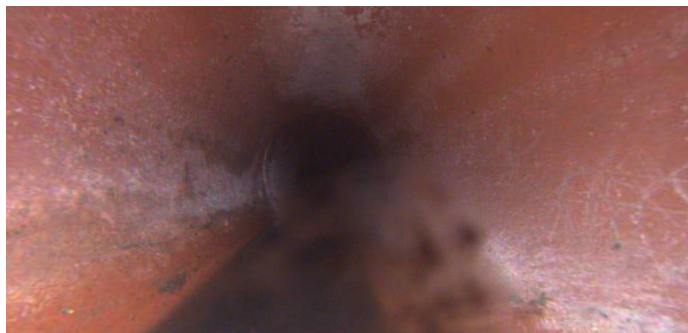
Code: **AMH**
Description: **Manhole**

Distance (ft): **.0**
Structural Grade: **0**
O&M Grade: **0**
Clock Start/From:
Clock To:
1st Value:
2nd Value:
Value Percent:
Continuous Index:
Within 8" of Joint: **NO**
Remarks: **M-606-083**

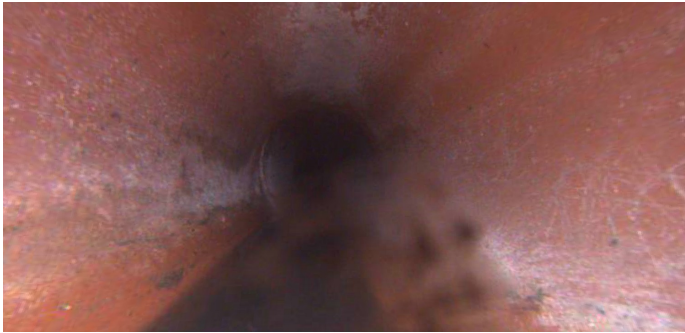
Code:	MWL
Description:	Water Level

Distance (ft):	.0
Structural Grade:	0
O&M Grade:	0
Clock Start/From:	
Clock To:	
1st Value:	
2nd Value:	
Value Percent:	5.000
Continuous Index:	
Within 8" of Joint:	NO
Remarks:

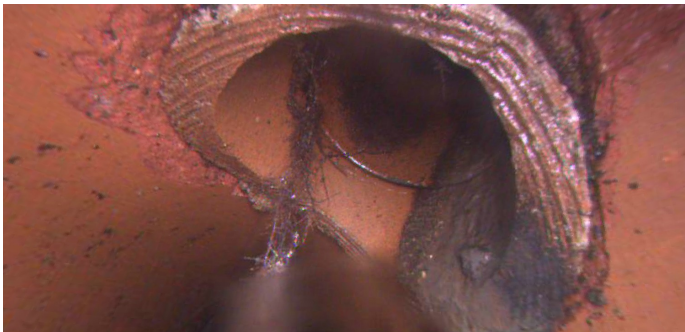
Code:	TBI
Description:	Tap Break-in Intruding

Distance (ft):	11.5
Structural Grade:	0
O&M Grade:	2
Clock Start/From:	1
Clock To:	
1st Value:	4.000
2nd Value:	1.000
Value Percent:	
Continuous Index:	
Within 8" of Joint:	
Remarks:	rml

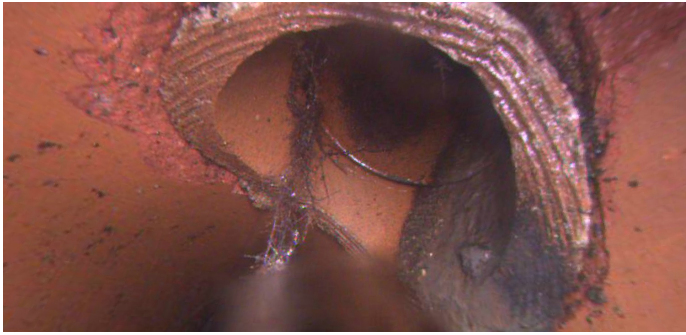
Code: **RFL**
Description: **Roots Fine Lateral**

Distance (ft): **11.5**
Structural Grade: **0**
O&M Grade: **1**
Clock Start/From: **12**
Clock To:
1st Value:
2nd Value:
Value Percent:
Continuous Index:
Within 8" of Joint: **NO**
Remarks:

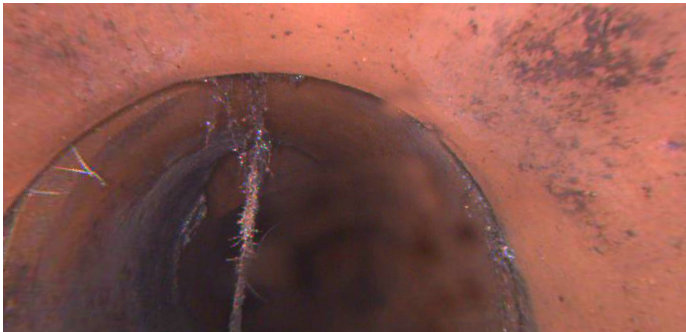
Code: **RFJ**
Description: **Roots Fine Joint**

Distance (ft): **12.9**
Structural Grade: **0**
O&M Grade: **1**
Clock Start/From: **8**
Clock To: **4**
1st Value:
2nd Value:
Value Percent:
Continuous Index:
Within 8" of Joint: **YES**
Remarks:

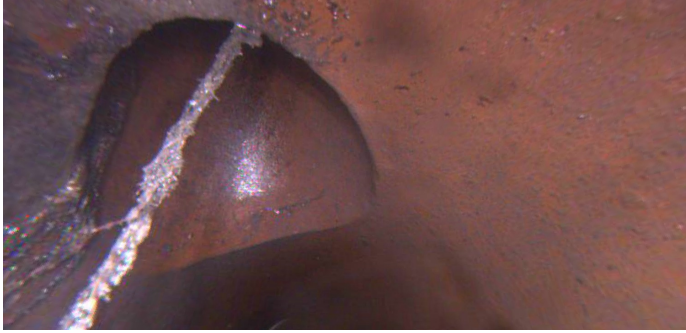
Code: **TFD**
Description: **Tap Factory Defective**

Distance (ft): **13.7**
Structural Grade: **0**
O&M Grade: **2**
Clock Start/From: **11**
Clock To:
1st Value: **4.000**
2nd Value:
Value Percent:
Continuous Index:
Within 8" of Joint:
Remarks: **rfl**

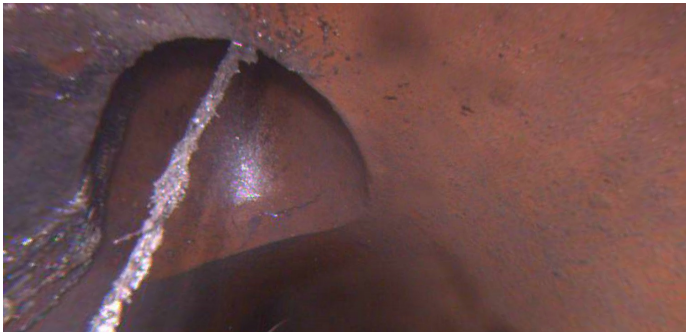
Code: **MSA**
Description: **Abandoned Survey**

Distance (ft): **13.7**
Structural Grade: **0**
O&M Grade: **0**
Clock Start/From:
Clock To:
1st Value:
2nd Value:
Value Percent:
Continuous Index:
Within 8" of Joint: **NO**
Remarks: **unknown**
