Profile/Photo Observation Report

Date:	02/04/2022	Weather:		Coding:	PACP 7.0
Pipe Length (ft):	254.1	Owner:	City of Hobart	Pre Clean:	Heavy Cleaning
P.O.#:	YES502259	Surveyor:	S. Bucklin	PSR:	P-606-086-085
Customer:	City of Hobart	Clean Date:	01/31/2022	Shape:	C

Street:	North Lake Shore Drive	Flow Control:	Not Controlled
City:	Hobart, IN	Year Renewed:	
Location:	Local rural streets with light traffic, t	Tape/Media #:	
Purpose:	Routine Assessment	Dia/Height:	12"
Use:	Sanitary Sewage Pipe	Material:	VCP
Drain Area:		Lining:	None
Category:	NA		
Comment:			
Location Details:		Direction of Survey:	Downstream
US MH:	M-606-085	DS MH:	M-606-086
		Total Length Surveyed (ft):	254.1

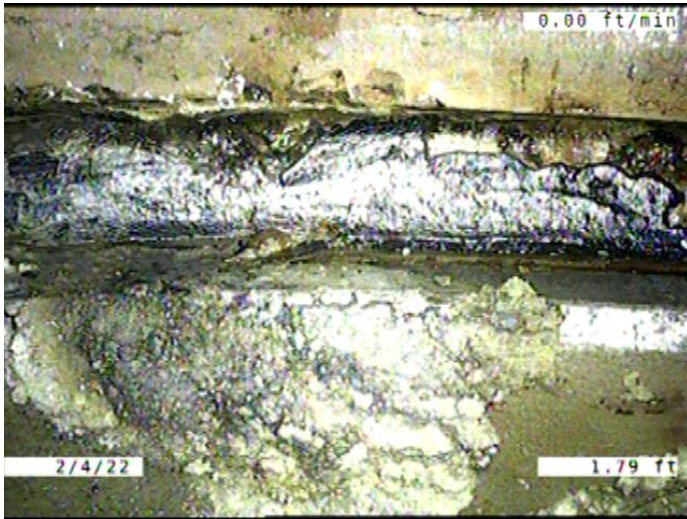
Code: **DAE**
 Description: **Deposits Attached Encrustation**

Distance (ft): **1.8**
 Structural Grade: **0**
 O&M Grade: **2**
 Clock Start/From: **7**
 Clock To: **5**
 1st Value:
 2nd Value:
 Value Percent: **5.000**
 Continuous Index: **S02**
 Within 8" of Joint: **YES**
 Remarks:

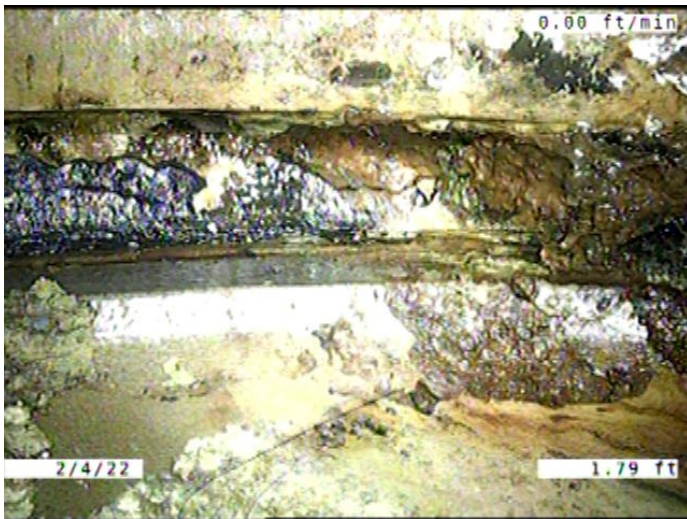
Code: **JSM**
 Description: **Joint Separated Medium**

Distance (ft): **1.8**
 Structural Grade: **3**
 O&M Grade: **0**
 Clock Start/From:
 Clock To:
 1st Value:
 2nd Value:
 Value Percent:
 Continuous Index:
 Within 8" of Joint: **NO**
 Remarks:

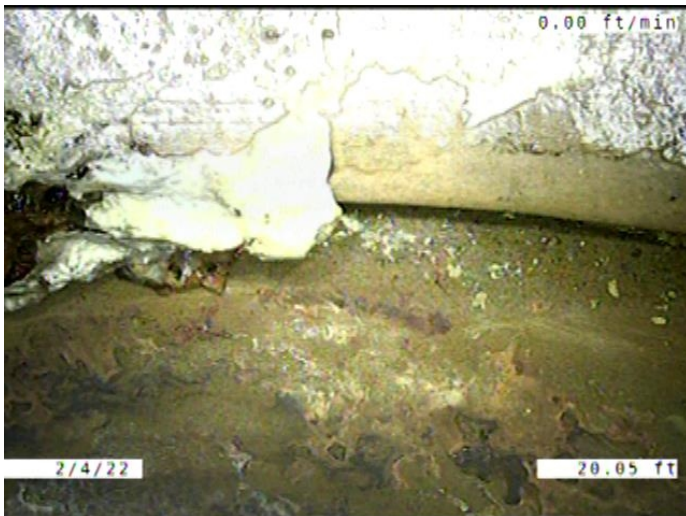
Code: **IWJ**
 Description: **Infiltration Weeper Joint**

Distance (ft): **20.1**
 Structural Grade: **0**
 O&M Grade: **2**
 Clock Start/From: **1**
 Clock To:
 1st Value:
 2nd Value:
 Value Percent:
 Continuous Index:
 Within 8" of Joint: **YES**
 Remarks:

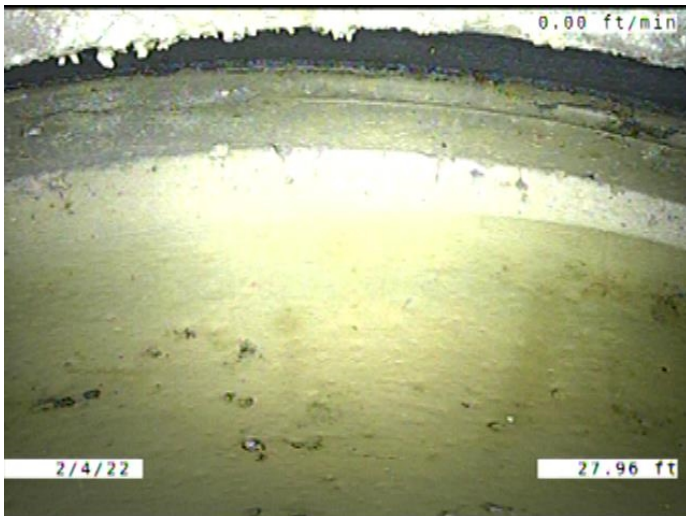
Code: **JOM**
 Description: **Joint Offset Medium**

Distance (ft): **28.0**
 Structural Grade: **3**
 O&M Grade: **0**
 Clock Start/From:
 Clock To:
 1st Value:
 2nd Value:
 Value Percent:
 Continuous Index:
 Within 8" of Joint: **NO**
 Remarks:

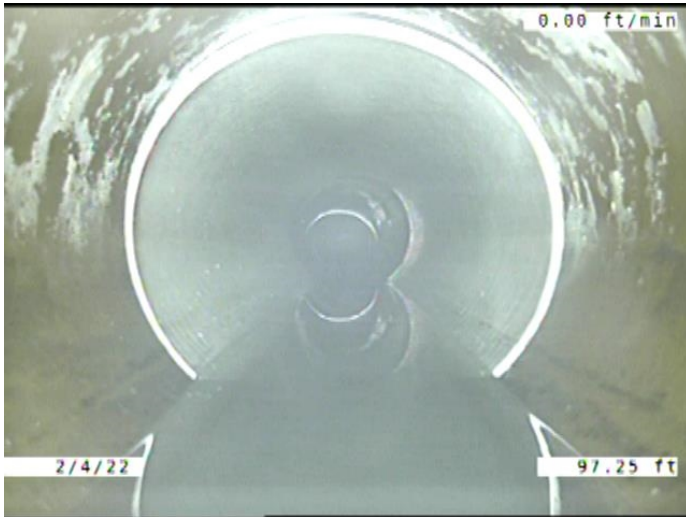
Code: **MWLS**
 Description: **Miscellaneous Water Level Sag**

Distance (ft): **97.2**
 Structural Grade: **2**
 O&M Grade: **0**
 Clock Start/From:
 Clock To:
 1st Value:
 2nd Value:
 Value Percent: **5.000**
 Continuous Index: **S03**
 Within 8" of Joint: **NO**
 Remarks:

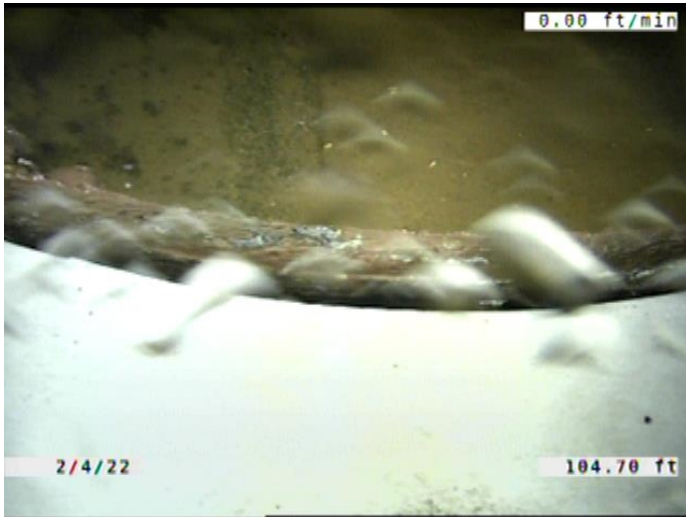
Code: **JOM**
 Description: **Joint Offset Medium**

Distance (ft): **104.7**
 Structural Grade: **3**
 O&M Grade: **0**
 Clock Start/From:
 Clock To:
 1st Value:
 2nd Value:
 Value Percent:
 Continuous Index:
 Within 8" of Joint: **NO**
 Remarks:

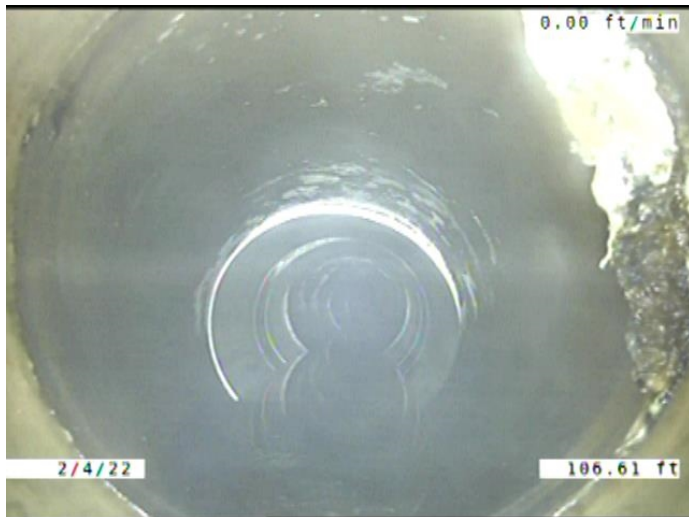
Code: **MWLS**
 Description: **Miscellaneous Water Level Sag**

Distance (ft): **106.6**
 Structural Grade: **2**
 O&M Grade: **0**
 Clock Start/From:
 Clock To:
 1st Value:
 2nd Value:
 Value Percent: **5.000**
 Continuous Index: **F03**
 Within 8" of Joint: **NO**
 Remarks:

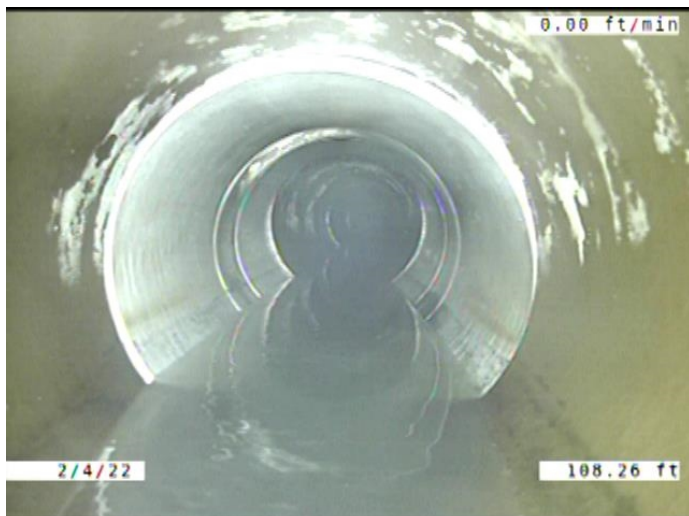
Code: **MWLS**
 Description: **Miscellaneous Water Level Sag**

Distance (ft): **108.3**
 Structural Grade: **2**
 O&M Grade: **0**
 Clock Start/From:
 Clock To:
 1st Value:
 2nd Value:
 Value Percent: **10.000**
 Continuous Index: **S04**
 Within 8" of Joint: **NO**
 Remarks:

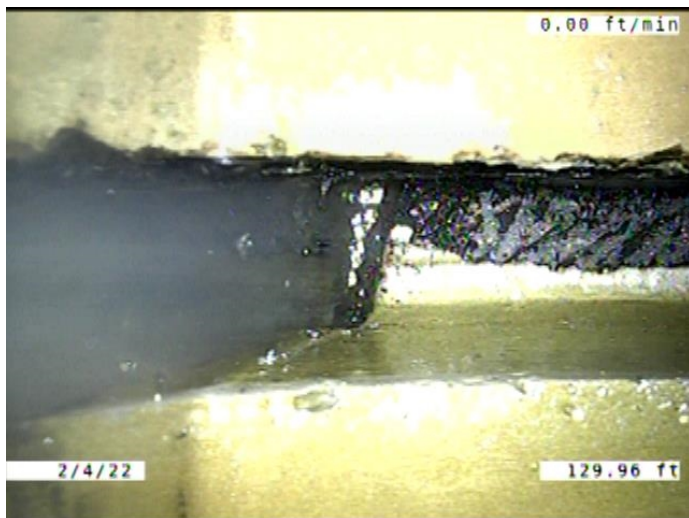
Code: **JAM**
Description: **Joint Angular Medium**

Distance (ft): **130.0**
Structural Grade: **3**
O&M Grade: **0**
Clock Start/From:
Clock To:
1st Value:
2nd Value:
Value Percent:
Continuous Index:
Within 8" of Joint: **NO**
Remarks:

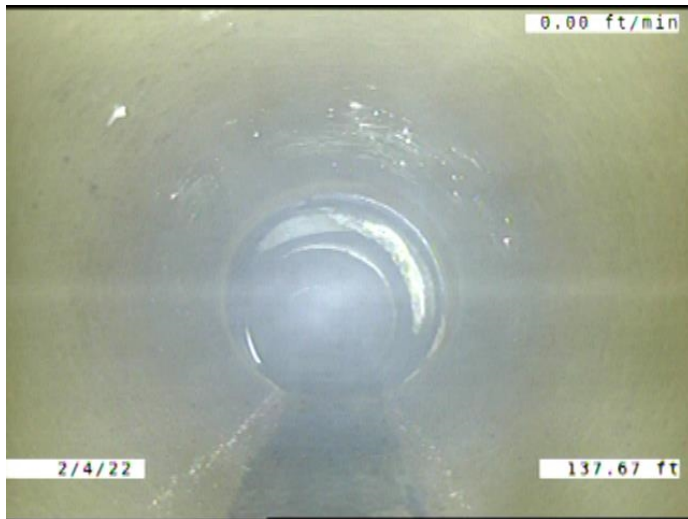
Code: **MWLS**
 Description: **Miscellaneous Water Level Sag**

Distance (ft): **137.7**
 Structural Grade: **2**
 O&M Grade: **0**
 Clock Start/From:
 Clock To:
 1st Value:
 2nd Value:
 Value Percent: **10.000**
 Continuous Index: **F04**
 Within 8" of Joint: **NO**
 Remarks:

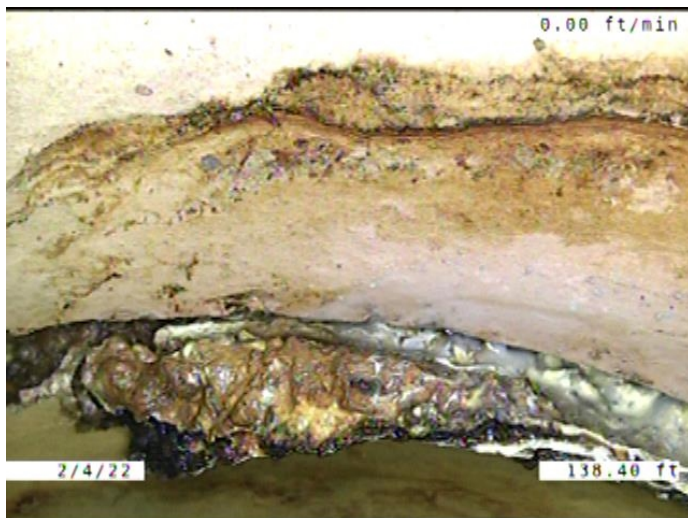
Code: **IRJ**
 Description: **Infiltration Runner Joint**

Distance (ft): **138.4**
 Structural Grade: **0**
 O&M Grade: **4**
 Clock Start/From: **1**
 Clock To:
 1st Value:
 2nd Value:
 Value Percent:
 Continuous Index:
 Within 8" of Joint: **YES**
 Remarks:

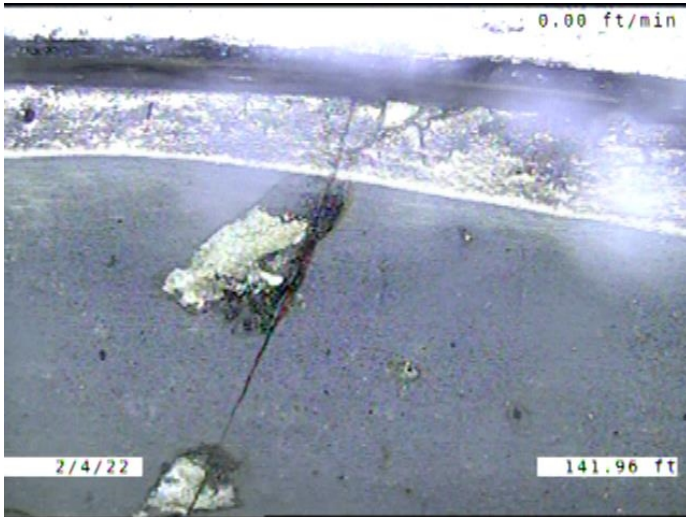
Code: **CS**
 Description: **Crack Spiral**

Distance (ft): **142.0**
 Structural Grade: **2**
 O&M Grade: **0**
 Clock Start/From: **11**
 Clock To: **12**
 1st Value:
 2nd Value:
 Value Percent:
 Continuous Index:
 Within 8" of Joint: **YES**
 Remarks:

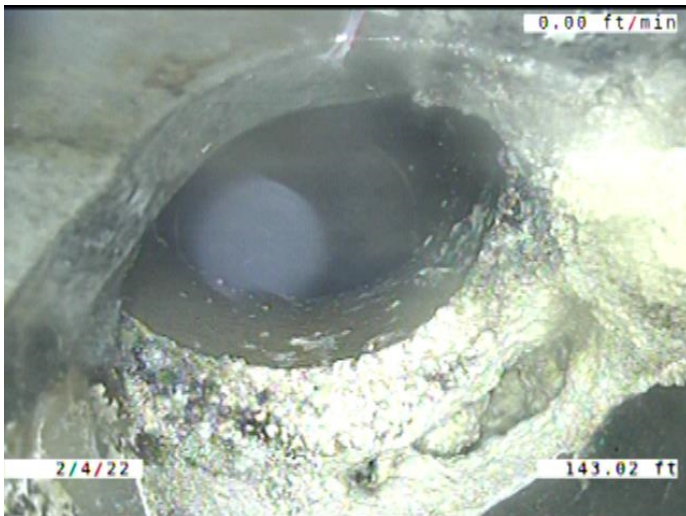
Code: **TFD**
 Description: **Tap Factory Defective**

Distance (ft): **143.0**
 Structural Grade: **0**
 O&M Grade: **3**
 Clock Start/From: **12**
 Clock To:
 1st Value: **6.000**
 2nd Value:
 Value Percent:
 Continuous Index:
 Within 8" of Joint: **YES**
 Remarks: **CRACKED. CONNECTION FROM MAIN TO SERVICE OFFSET. ENCRUST**

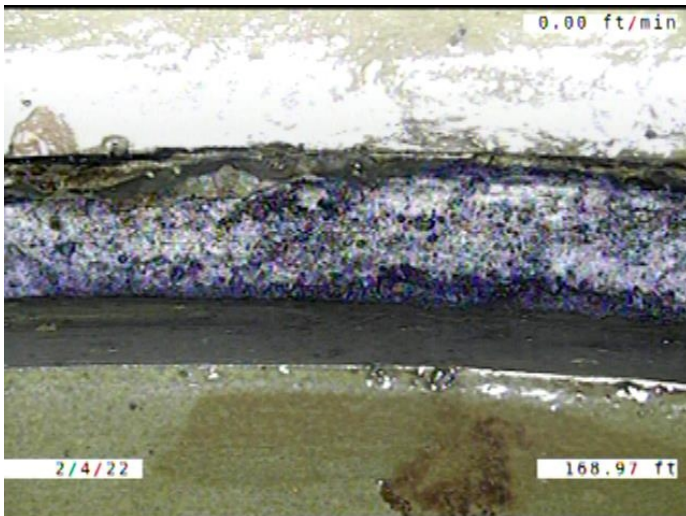
Code: **JAM**
Description: **Joint Angular Medium**

Distance (ft): **169.0**
Structural Grade: **3**
O&M Grade: **0**
Clock Start/From:
Clock To:
1st Value:
2nd Value:
Value Percent:
Continuous Index:
Within 8" of Joint: **NO**
Remarks:

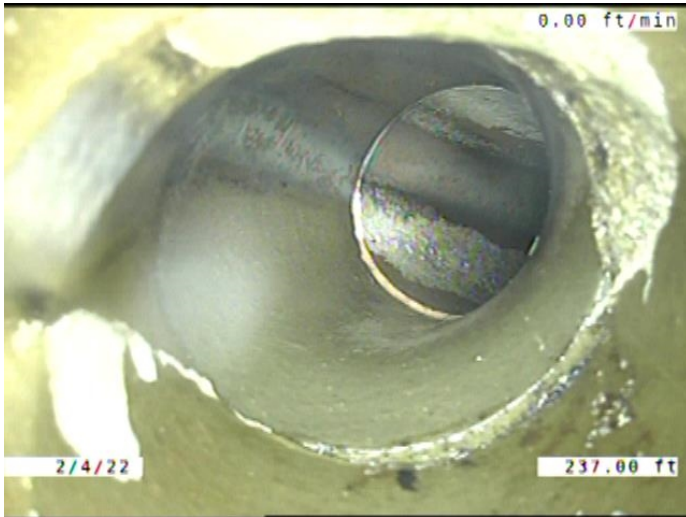
Code:	TF
Description:	Tap Factory
Distance (ft):	237.0
Structural Grade:	0
O&M Grade:	0
Clock Start/From:	11
Clock To:	
1st Value:	6.000
2nd Value:	
Value Percent:	
Continuous Index:	
Within 8" of Joint:	YES
Remarks:	ENCUSTATION COMING DOWN THE SERVICE INTO THE MAIN

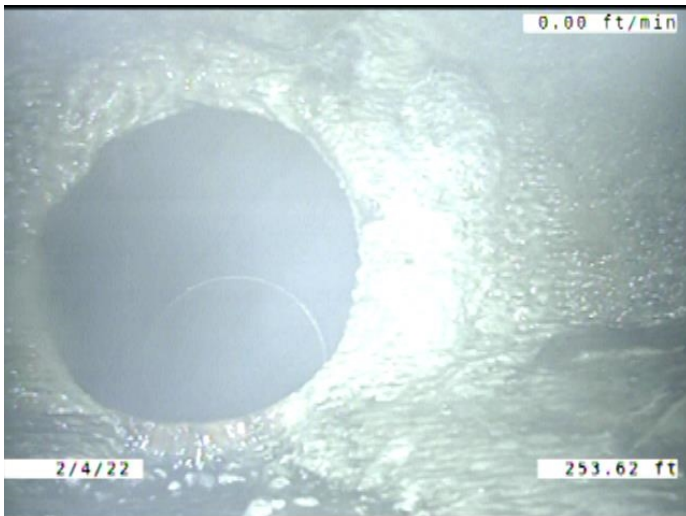
Code:	DAE
Description:	Deposits Attached Encrustation
Distance (ft):	253.6
Structural Grade:	0
O&M Grade:	2
Clock Start/From:	7
Clock To:	5
1st Value:	
2nd Value:	
Value Percent:	5.000
Continuous Index:	F02
Within 8" of Joint:	YES
Remarks:
