## Profile/Photo Observation Report

Date:	<b>02/05/2022</b>	Weather:		Coding:	<b>PACP 7.0</b>
Pipe Length (ft):	<b>84.6</b>	Owner:	<b>City of Hobart</b>	Pre Clean:	<b>Heavy Cleaning</b>
P.O.#:	<b>YES502259</b>	Surveyor:	<b>S. Bucklin</b>	PSR:	<b>P-606-084-085</b>
Customer:	<b>City of Hobart</b>	Clean Date:	<b>01/31/2022</b>	Shape:	<b>C</b>

Street:	<b>North Lake Shore Drive</b>	Flow Control:	<b>Not Controlled</b>
City:	<b>Hobart, IN</b>	Year Renewed:	
Location:	<b>Local rural streets with light traffic, t</b>	Tape/Media #:	
Purpose:	<b>Routine Assessment</b>	Dia/Height:	<b>10"</b>
Use:	<b>Sanitary Sewage Pipe</b>	Material:	<b>VCP</b>
Drain Area:		Lining:	<b>None</b>
Category:	<b>NA</b>		
Comment:			
Location Details:		Direction of Survey:	<b>Upstream</b>
US MH:	<b>M-606-085</b>	DS MH:	<b>M-606-084</b>
		Total Length Surveyed (ft):	<b>84.6</b>

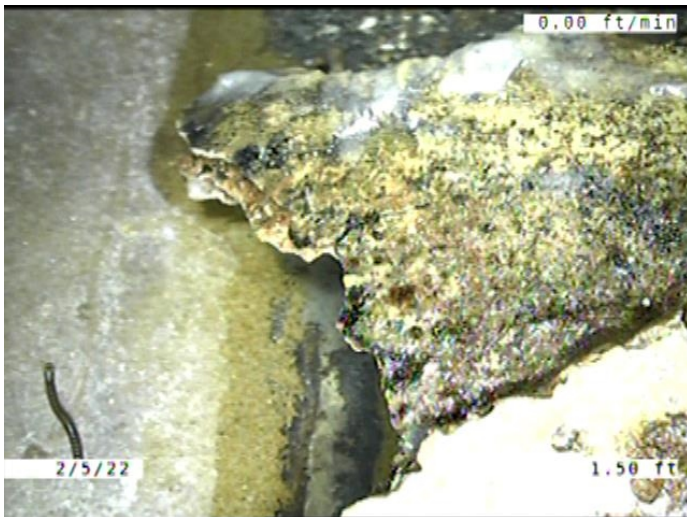
Code: **OBZ**  
Description: **Obstruction Other**

Distance (ft): **1.5**  
Structural Grade: **0**  
O&M Grade: **2**  
Clock Start/From: **5**  
Clock To: **7**  
1st Value:  
2nd Value:  
Value Percent: **5.000**  
Continuous Index: **S01**  
Within 8" of Joint: **YES**  
Remarks: **ENCrustION CUT OFF THE PIPE WALL**

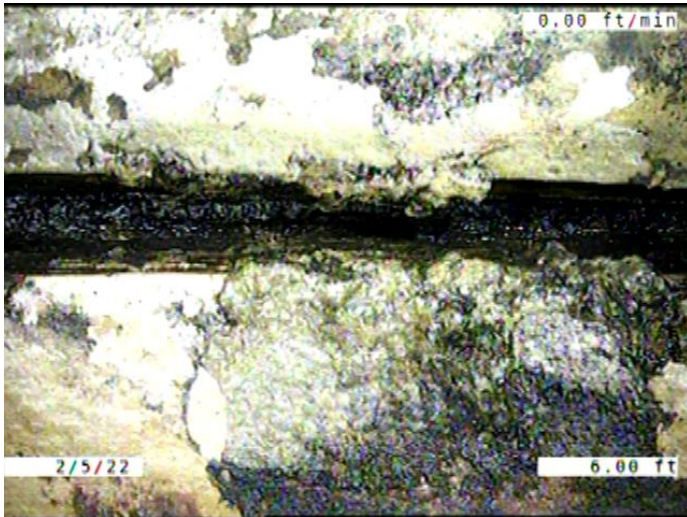
Code: **DAE**  
 Description: **Deposits Attached Encrustation**

Distance (ft): **6.0**  
 Structural Grade: **0**  
 O&M Grade: **2**  
 Clock Start/From: **7**  
 Clock To: **5**  
 1st Value:  
 2nd Value:  
 Value Percent: **5.000**  
 Continuous Index: **S02**  
 Within 8" of Joint: **YES**  
 Remarks:

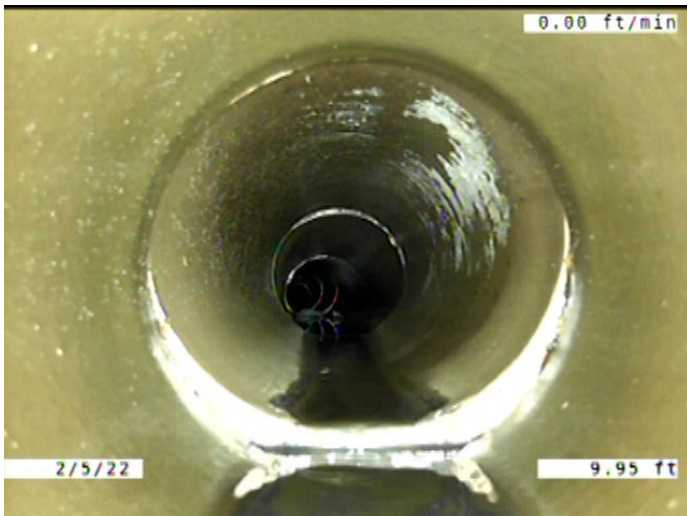
Code: **JOM**  
 Description: **Joint Offset Medium**

Distance (ft): **10.0**  
 Structural Grade: **3**  
 O&M Grade: **0**  
 Clock Start/From:  
 Clock To:  
 1st Value:  
 2nd Value:  
 Value Percent:  
 Continuous Index:  
 Within 8" of Joint: **NO**  
 Remarks:

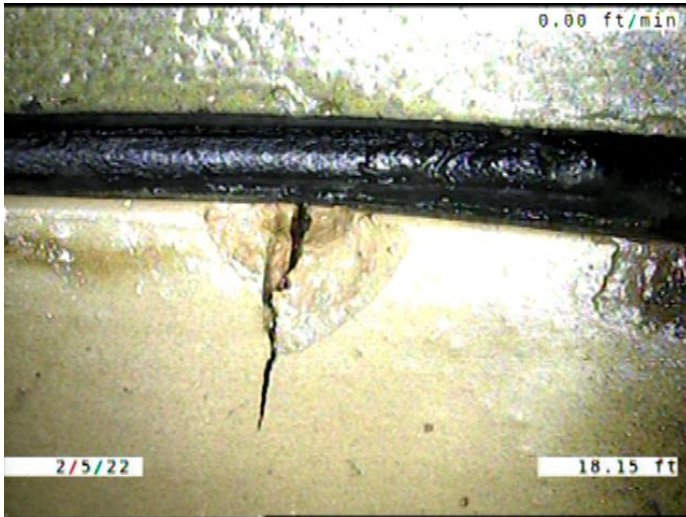
Code: **FL**  
 Description: **Fracture Longitudinal**

Distance (ft): **18.1**  
 Structural Grade: **3**  
 O&M Grade: **0**  
 Clock Start/From: **3**  
 Clock To:  
 1st Value:  
 2nd Value:  
 Value Percent:  
 Continuous Index:  
 Within 8" of Joint: **YES**  
 Remarks:

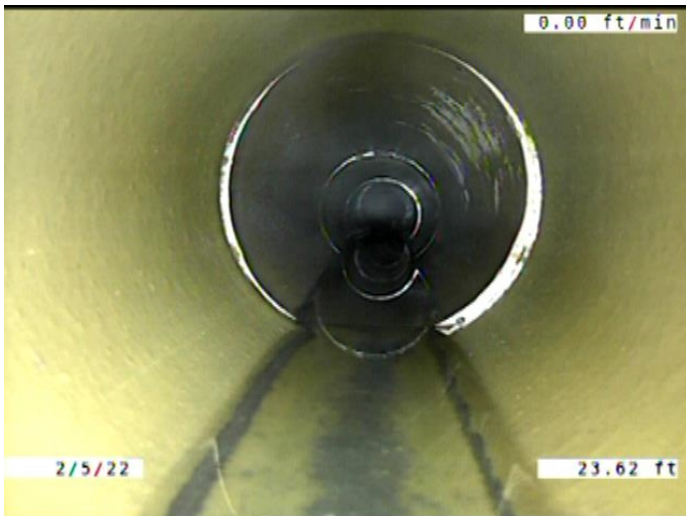
Code: **OBZ**  
 Description: **Obstruction Other**

Distance (ft): **23.6**  
 Structural Grade: **0**  
 O&M Grade: **2**  
 Clock Start/From: **5**  
 Clock To: **7**  
 1st Value:  
 2nd Value:  
 Value Percent: **5.000**  
 Continuous Index: **F01**  
 Within 8" of Joint: **YES**  
 Remarks: **ENCrustION CUT OFF THE PIPE WALL**

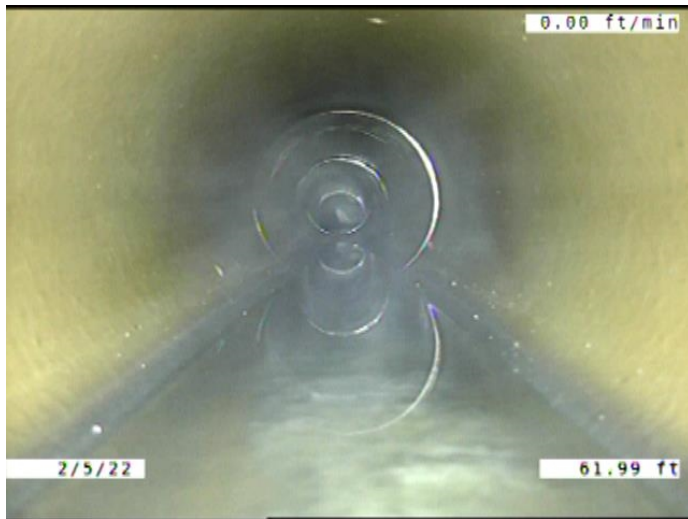
Code: **MWLS**  
 Description: **Miscellaneous Water Level Sag**

Distance (ft): **62.0**  
 Structural Grade: **2**  
 O&M Grade: **0**  
 Clock Start/From:  
 Clock To:  
 1st Value:  
 2nd Value:  
 Value Percent: **5.000**  
 Continuous Index: **S03**  
 Within 8" of Joint: **NO**  
 Remarks:

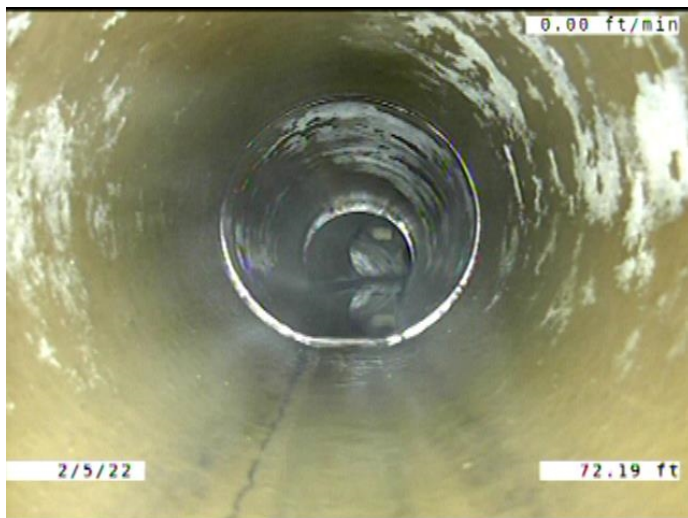
Code: **MWLS**  
 Description: **Miscellaneous Water Level Sag**

Distance (ft): **72.2**  
 Structural Grade: **2**  
 O&M Grade: **0**  
 Clock Start/From:  
 Clock To:  
 1st Value:  
 2nd Value:  
 Value Percent: **5.000**  
 Continuous Index: **F03**  
 Within 8" of Joint: **NO**  
 Remarks:

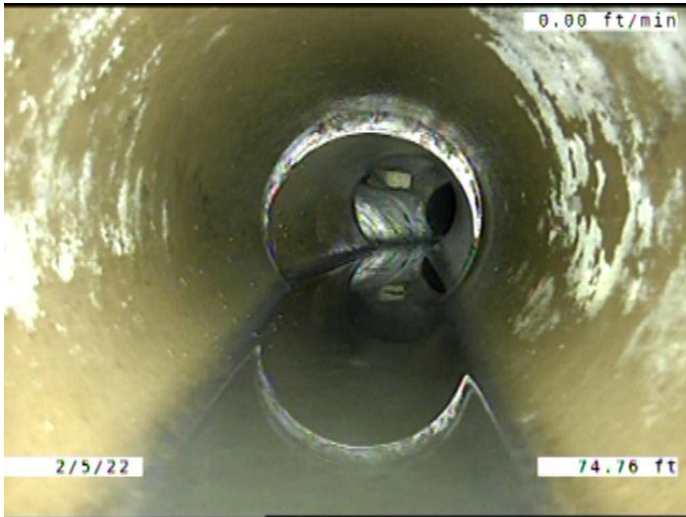
Code: **MWLS**  
 Description: **Miscellaneous Water Level Sag**

Distance (ft): **74.8**  
 Structural Grade: **2**  
 O&M Grade: **0**  
 Clock Start/From:  
 Clock To:  
 1st Value:  
 2nd Value:  
 Value Percent: **5.000**  
 Continuous Index: **S04**  
 Within 8" of Joint: **NO**  
 Remarks:

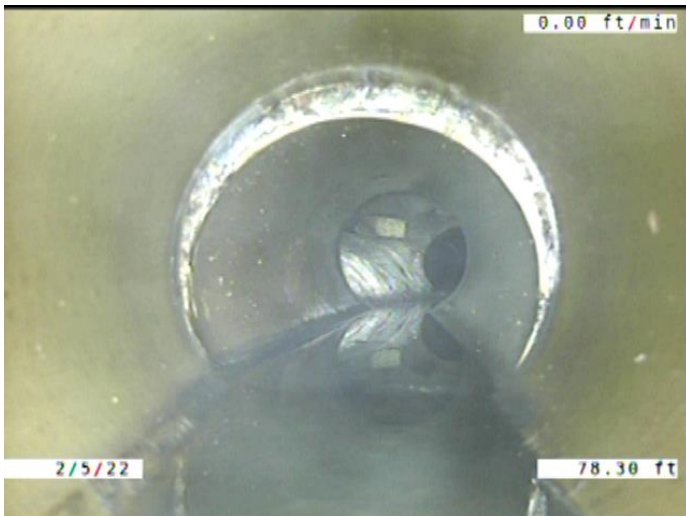
Code: **JOM**  
 Description: **Joint Offset Medium**

Distance (ft): **78.3**  
 Structural Grade: **3**  
 O&M Grade: **0**  
 Clock Start/From:  
 Clock To:  
 1st Value:  
 2nd Value:  
 Value Percent:  
 Continuous Index:  
 Within 8" of Joint: **NO**  
 Remarks:

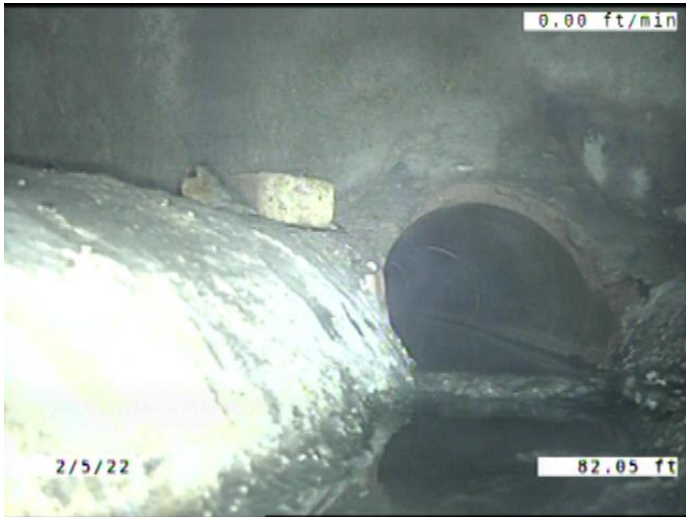
Code: **MWLS**  
Description: **Miscellaneous Water Level Sag**

Distance (ft): **82.0**  
Structural Grade: **2**  
O&M Grade: **0**  
Clock Start/From:  
Clock To:  
1st Value:  
2nd Value:  
Value Percent: **5.000**  
Continuous Index: **F04**  
Within 8" of Joint: **NO**  
Remarks:

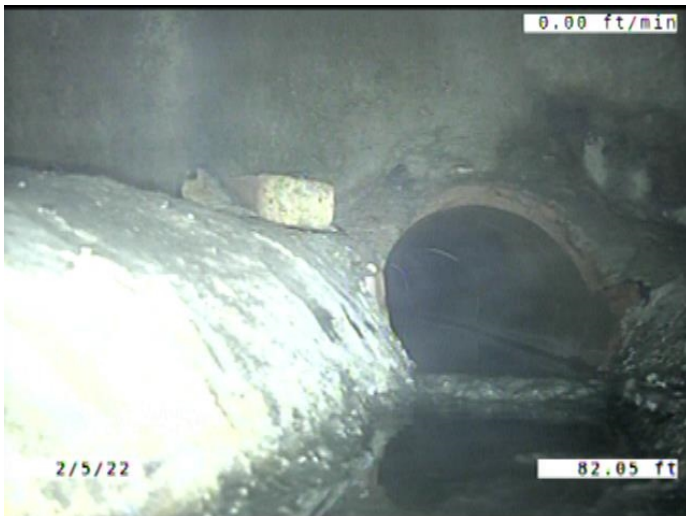
Code: **DAE**  
Description: **Deposits Attached Encrustation**

Distance (ft): **82.0**  
Structural Grade: **0**  
O&M Grade: **2**  
Clock Start/From: **7**  
Clock To: **5**  
1st Value:  
2nd Value:  
Value Percent: **5.000**  
Continuous Index: **F02**  
Within 8" of Joint: **YES**  
Remarks:
