Profile/Photo Observation Report

Date:	02/05/2022	Weather:		Coding:	PACP 7.0
Pipe Length (ft):	209.0	Owner:	City of Hobart	Pre Clean:	Heavy Cleaning
P.O.#:	YES502259	Surveyor:	S. Bucklin	PSR:	P-606-087-086
Customer:	City of Hobart	Clean Date:	01/31/2022	Shape:	C

Street:	North Lake Shore Drive	Flow Control:	Not Controlled
City:	Hobart, IN	Year Renewed:	
Location:	Local rural streets with light traffic, t	Tape/Media #:	
Purpose:	Routine Assessment	Dia/Height:	12"
Use:	Sanitary Sewage Pipe	Material:	VCP
Drain Area:		Lining:	None

US MH: **M-606-086** DS MH: **M-606-087** Total Length Surveyed (ft): **76.1**

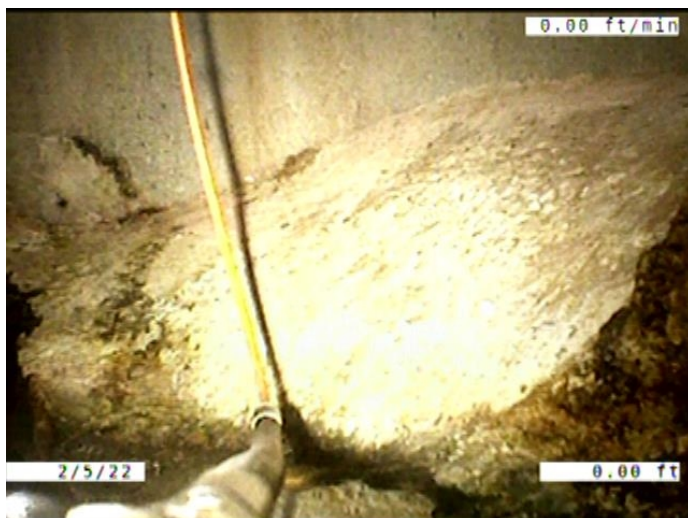
Code: **AMH**
 Description: **Manhole**

Distance (ft): **.0**
 Structural Grade: **0**
 O&M Grade: **0**
 Clock Start/From:
 Clock To:
 1st Value:
 2nd Value:
 Value Percent:
 Continuous Index:
 Within 8" of Joint: **NO**
 Remarks: **M-606-087**

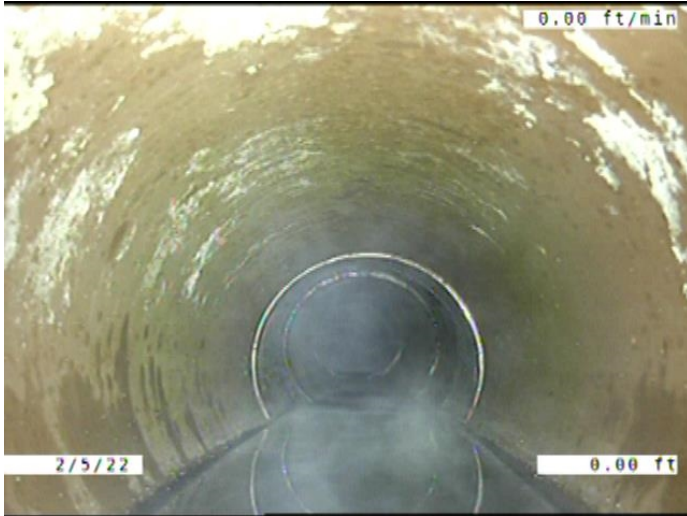
Code:	MWL
Description:	Miscellaneous Water Level
Distance (ft):	.0
Structural Grade:	0
O&M Grade:	0
Clock Start/From:	
Clock To:	
1st Value:	
2nd Value:	
Value Percent:	10.000
Continuous Index:	
Within 8" of Joint:	NO
Remarks:

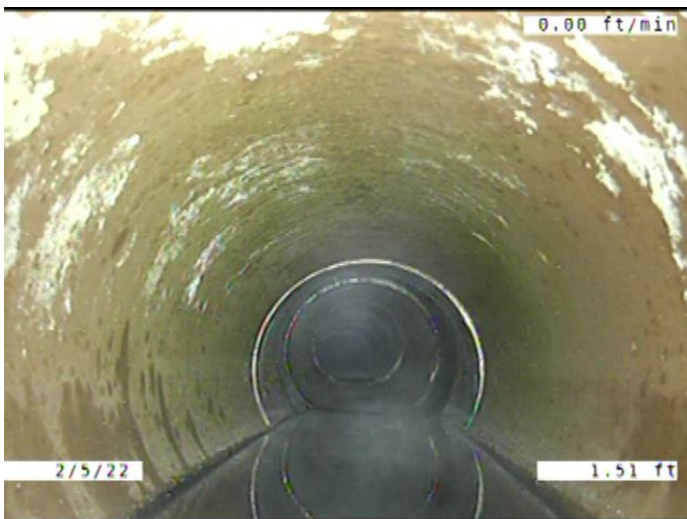
Code:	MGO
Description:	Miscellaneous General Observation
Distance (ft):	1.5
Structural Grade:	0
O&M Grade:	0
Clock Start/From:	
Clock To:	
1st Value:	
2nd Value:	
Value Percent:	
Continuous Index:	
Within 8" of Joint:	NO
Remarks:	TIGHT ACCESS IN THE MANHOLE. HAD TO START IN THE PIPE.

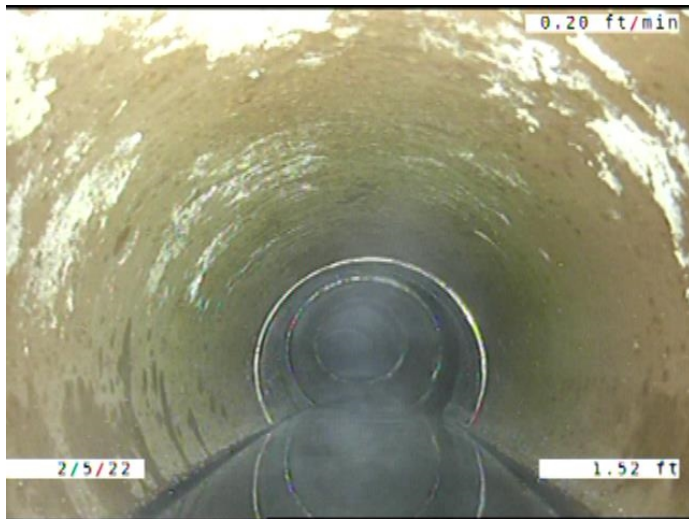
Code: **DAE**
 Description: **Deposits Attached Encrustation**

Distance (ft): **1.5**
 Structural Grade: **0**
 O&M Grade: **2**
 Clock Start/From: **7**
 Clock To: **5**
 1st Value:
 2nd Value:
 Value Percent: **5.000**
 Continuous Index: **S01**
 Within 8" of Joint: **YES**
 Remarks:

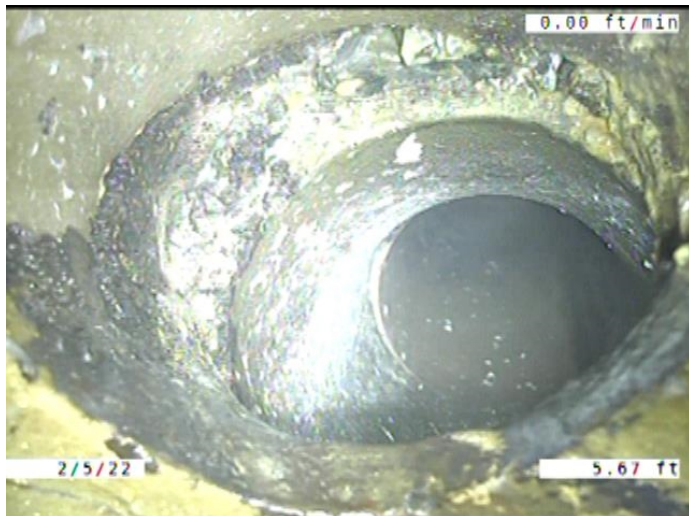
Code: **TF**
 Description: **Tap Factory**

Distance (ft): **5.7**
 Structural Grade: **0**
 O&M Grade: **0**
 Clock Start/From: **1**
 Clock To:
 1st Value: **4.000**
 2nd Value:
 Value Percent:
 Continuous Index:
 Within 8" of Joint: **YES**
 Remarks: **CONSTANTLY RUNNING WATER,
 LARGE OFFSET ON THE SERVICE SOIL**

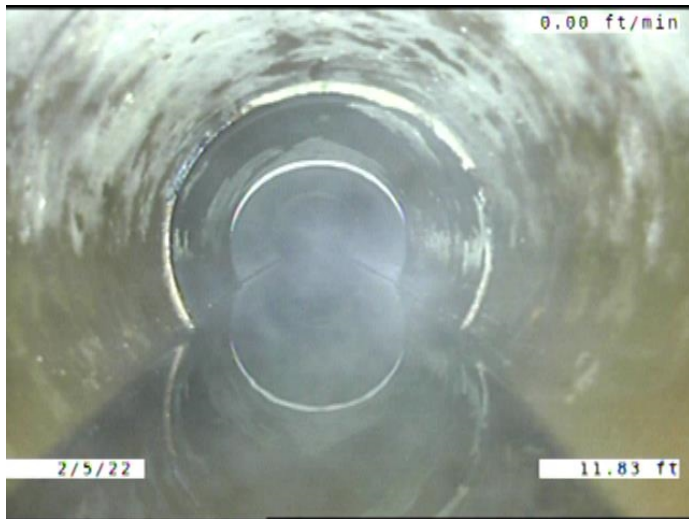
Code: **MWLS**
Description: **Miscellaneous Water Level Sag**

Distance (ft): **11.8**
Structural Grade: **2**
O&M Grade: **0**
Clock Start/From:
Clock To:
1st Value:
2nd Value:
Value Percent: **10.000**
Continuous Index: **S02**
Within 8" of Joint: **NO**
Remarks:

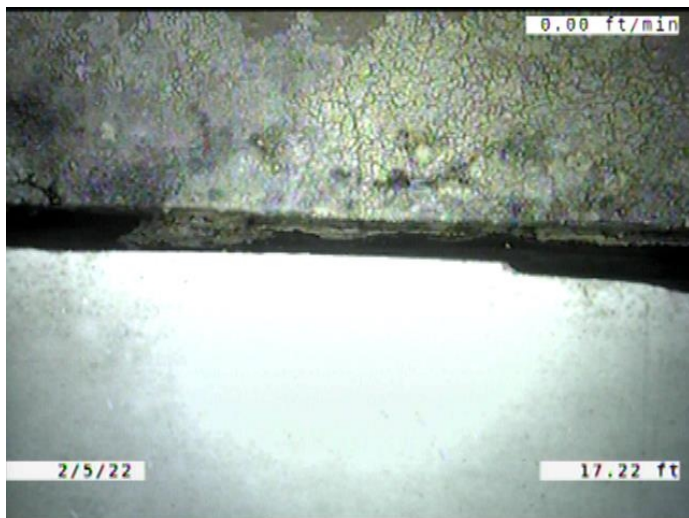
Code: **MMC**
Description: **Miscellaneous Material Change**

Distance (ft): **17.2**
Structural Grade: **0**
O&M Grade: **0**
Clock Start/From:
Clock To:
1st Value:
2nd Value:
Value Percent:
Continuous Index:
Within 8" of Joint: **NO**
Remarks: **VCP TO PVC**

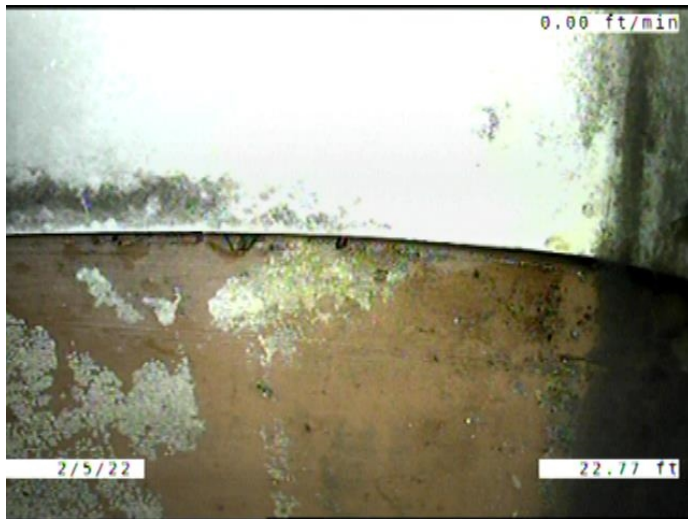
Code: **MMC**
 Description: **Miscellaneous Material Change**

Distance (ft): **22.8**
 Structural Grade: **0**
 O&M Grade: **0**
 Clock Start/From:
 Clock To:
 1st Value:
 2nd Value:
 Value Percent:
 Continuous Index:
 Within 8" of Joint: **NO**
 Remarks: **PVC TO VCP**

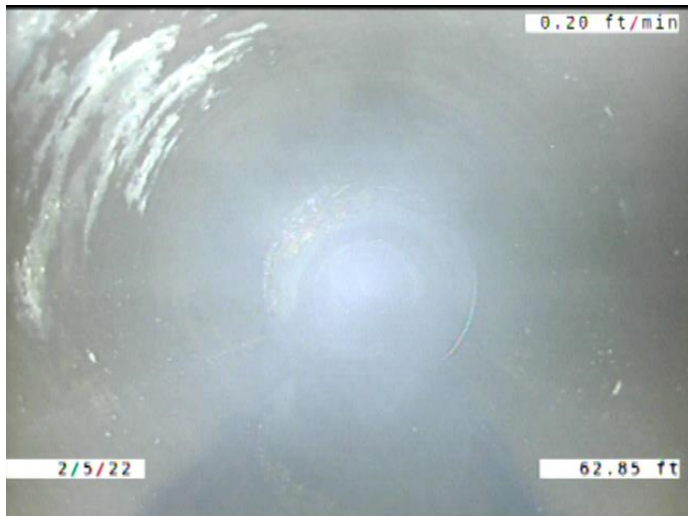
Code: **MWLS**
 Description: **Miscellaneous Water Level Sag**

Distance (ft): **62.8**
 Structural Grade: **2**
 O&M Grade: **0**
 Clock Start/From:
 Clock To:
 1st Value:
 2nd Value:
 Value Percent: **10.000**
 Continuous Index: **F02**
 Within 8" of Joint: **NO**
 Remarks:

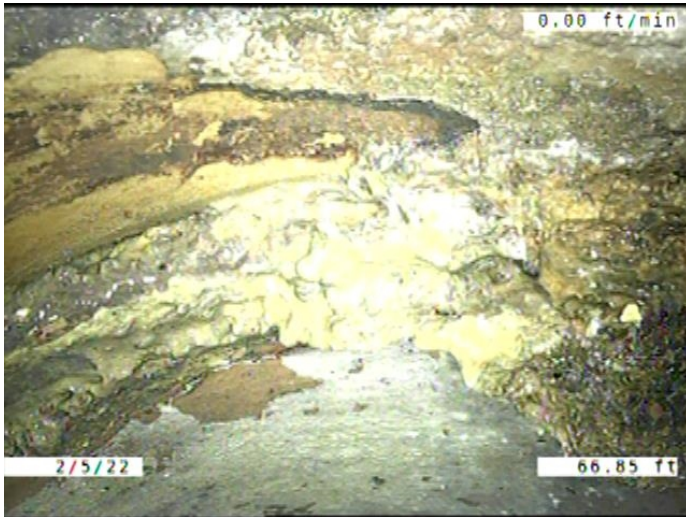
Code: **IRJ**
 Description: **Infiltration Runner Joint**

Distance (ft): **66.8**
 Structural Grade: **0**
 O&M Grade: **4**
 Clock Start/From: **10**
 Clock To: **12**
 1st Value:
 2nd Value:
 Value Percent:
 Continuous Index:
 Within 8" of Joint: **YES**
 Remarks:

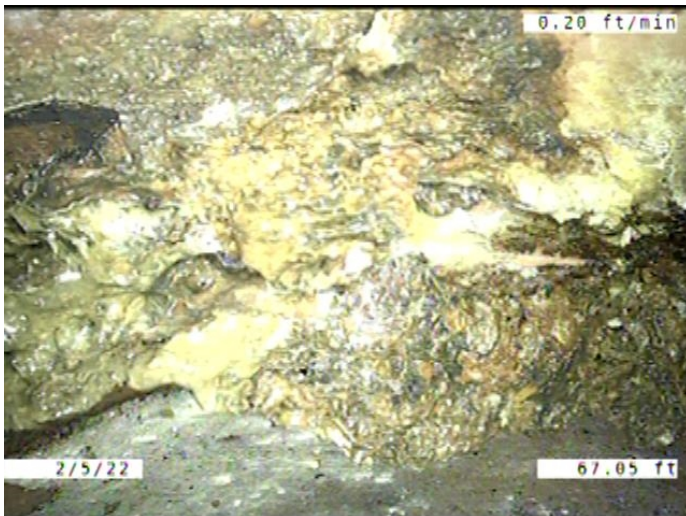
Code: **DAE**
 Description: **Deposits Attached Encrustation**

Distance (ft): **67.0**
 Structural Grade: **0**
 O&M Grade: **3**
 Clock Start/From: **7**
 Clock To: **5**
 1st Value:
 2nd Value:
 Value Percent: **15.000**
 Continuous Index:
 Within 8" of Joint: **YES**
 Remarks:

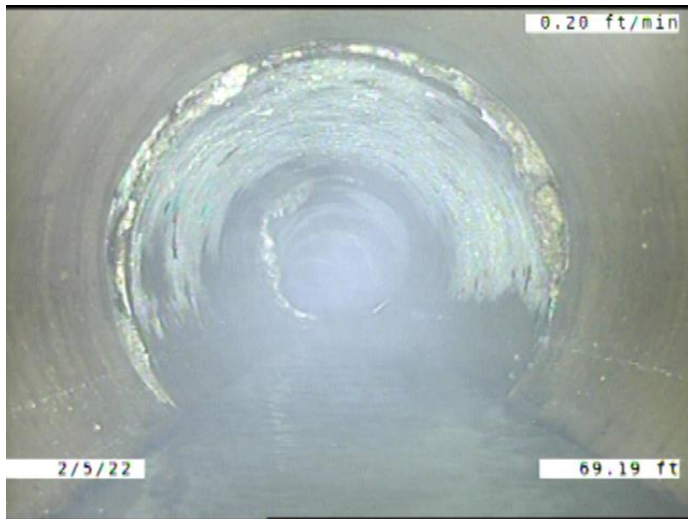
Code: **MWLS**
 Description: **Miscellaneous Water Level Sag**

Distance (ft): **69.2**
 Structural Grade: **2**
 O&M Grade: **0**
 Clock Start/From:
 Clock To:
 1st Value:
 2nd Value:
 Value Percent: **10.000**
 Continuous Index: **S03**
 Within 8" of Joint: **NO**
 Remarks:

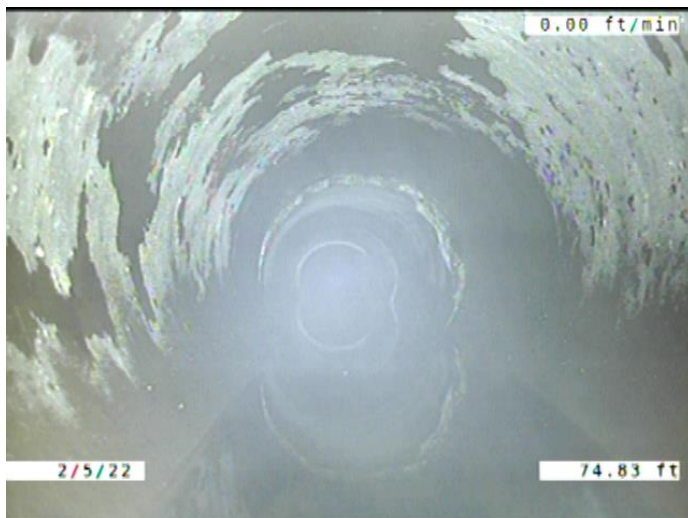
Code: **MWLS**
 Description: **Miscellaneous Water Level Sag**

Distance (ft): **74.8**
 Structural Grade: **2**
 O&M Grade: **0**
 Clock Start/From:
 Clock To:
 1st Value:
 2nd Value:
 Value Percent: **10.000**
 Continuous Index: **F03**
 Within 8" of Joint: **NO**
 Remarks:

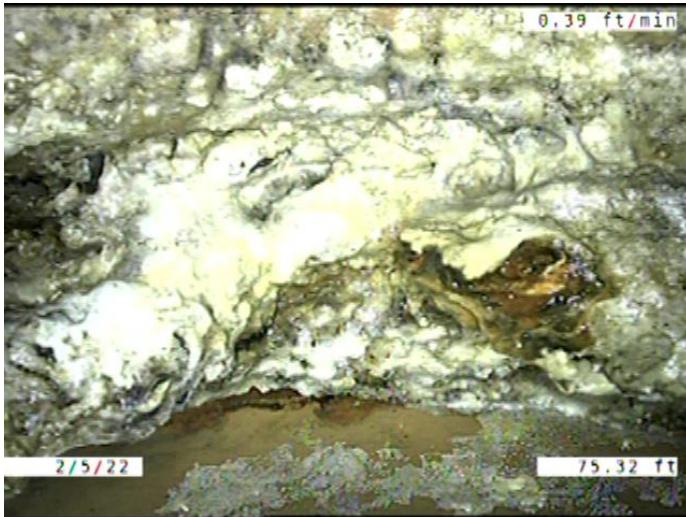
Code: **IDJ**
 Description: **Infiltration Dripper Joint**

Distance (ft): **75.3**
 Structural Grade: **0**
 O&M Grade: **3**
 Clock Start/From: **10**
 Clock To: **1**
 1st Value:
 2nd Value:
 Value Percent:
 Continuous Index:
 Within 8" of Joint: **YES**
 Remarks:

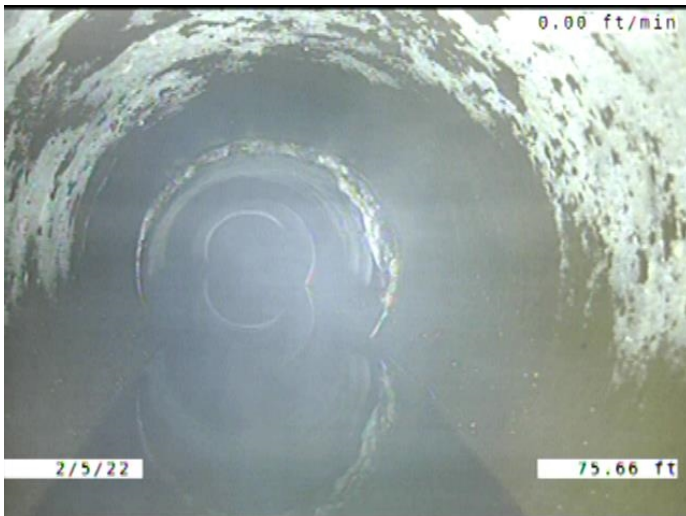
Code: **DAE**
 Description: **Deposits Attached Encrustation**

Distance (ft): **75.7**
 Structural Grade: **0**
 O&M Grade: **2**
 Clock Start/From: **7**
 Clock To: **5**
 1st Value:
 2nd Value:
 Value Percent: **5.000**
 Continuous Index: **F01**
 Within 8" of Joint: **YES**
 Remarks:

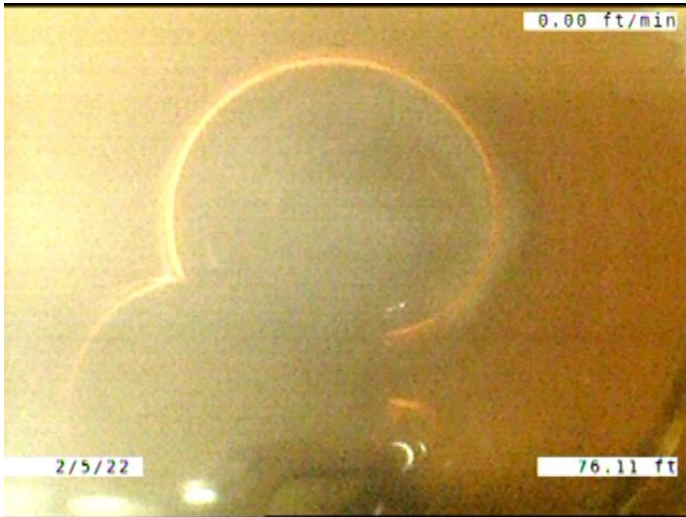
Code:	MSA
Description:	Miscellaneous Survey Abandoned
Distance (ft):	76.1
Structural Grade:	0
O&M Grade:	0
Clock Start/From:	
Clock To:	
1st Value:	
2nd Value:	
Value Percent:	
Continuous Index:	
Within 8" of Joint:	NO
Remarks:	CAMERA CANT MAKE IT PAST ENCRUSTATION.
