Profile/Photo Observation Report

Date:	02/08/2022	Weather:		Coding:	PACP 7.0
Pipe Length (ft):	209.0	Owner:	City of Hobart	Pre Clean:	Heavy Cleaning
P.O.#:	YES502259	Surveyor:	S. Bucklin	PSR:	P-606-087-086
Customer:	City of Hobart	Clean Date:	01/31/2022	Shape:	C

Street:	North Lake Shore Drive	Flow Control:	Not Controlled
City:	Hobart, IN	Year Renewed:	
Location:	Local rural streets with light traffic, t	Tape/Media #:	
Purpose:	Routine Assessment	Dia/Height:	12"
Use:	Sanitary Sewage Pipe	Material:	VCP
Drain Area:		Lining:	None
Category:	NA		
Comment:			
Location Details:		Direction of Survey:	Downstream
US MH:	M-606-086	DS MH:	M-606-087
		Total Length Surveyed (ft):	130.7

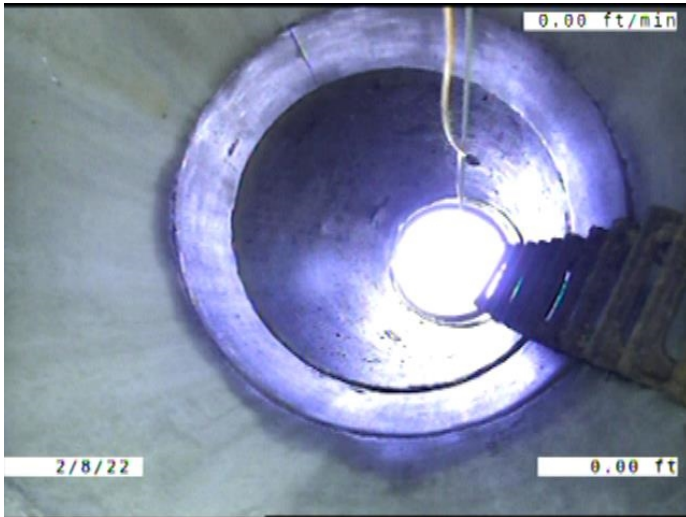
Code: **AMH**
Description: **Manhole**

Distance (ft): **.0**
Structural Grade: **0**
O&M Grade: **0**
Clock Start/From:
Clock To:
1st Value:
2nd Value:
Value Percent:
Continuous Index:
Within 8" of Joint: **NO**
Remarks: **M-606-086**

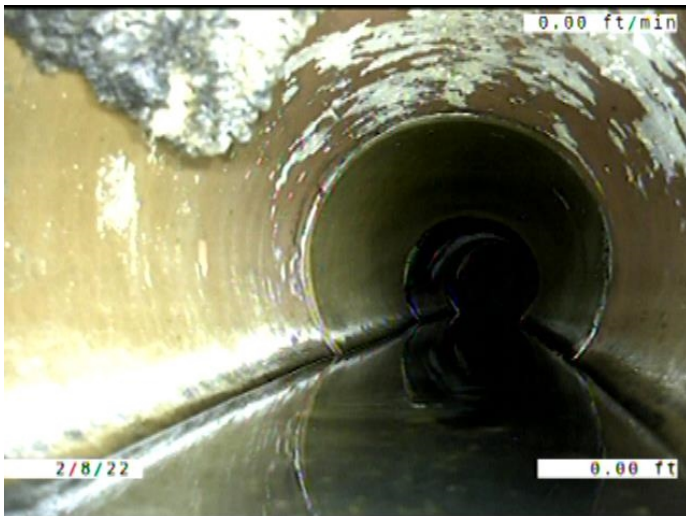
Code: **MWL**
Description: **Miscellaneous Water Level**

Distance (ft): **.0**
Structural Grade: **0**
O&M Grade: **0**
Clock Start/From:
Clock To:
1st Value:
2nd Value:
Value Percent: **5.000**
Continuous Index:
Within 8" of Joint: **NO**
Remarks:

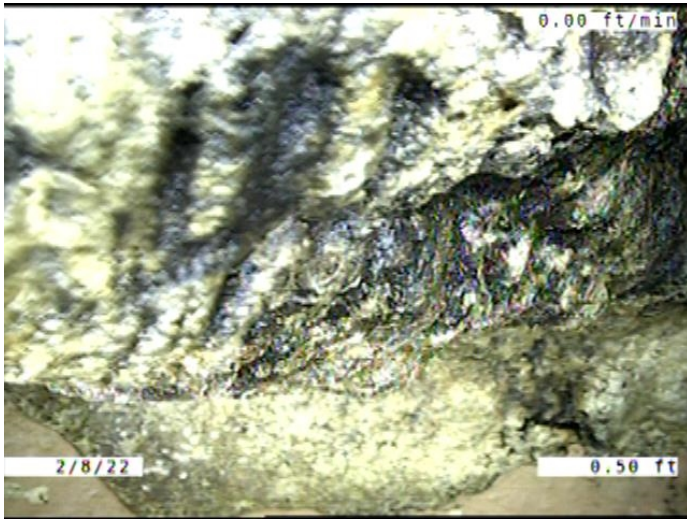
Code: **DAE**
 Description: **Deposits Attached Encrustation**

Distance (ft): **.5**
 Structural Grade: **0**
 O&M Grade: **3**
 Clock Start/From: **8**
 Clock To: **4**
 1st Value:
 2nd Value:
 Value Percent: **15.000**
 Continuous Index:
 Within 8" of Joint: **YES**
 Remarks:

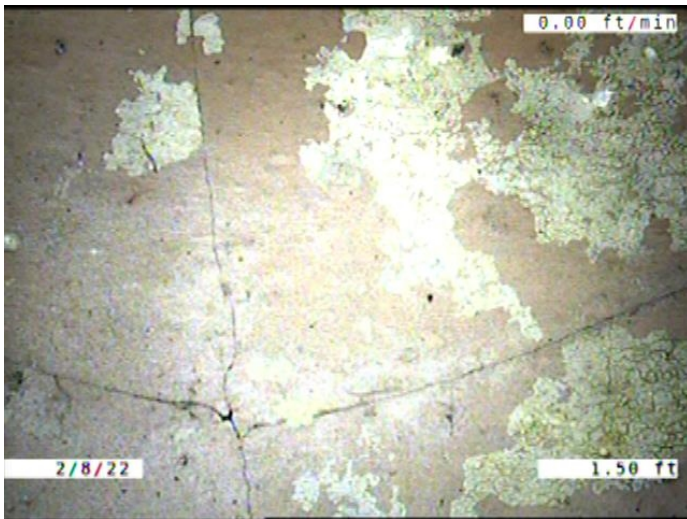
Code: **CM**
 Description: **Crack Multiple**

Distance (ft): **1.5**
 Structural Grade: **3**
 O&M Grade: **0**
 Clock Start/From: **8**
 Clock To: **1**
 1st Value:
 2nd Value:
 Value Percent:
 Continuous Index:
 Within 8" of Joint: **YES**
 Remarks:

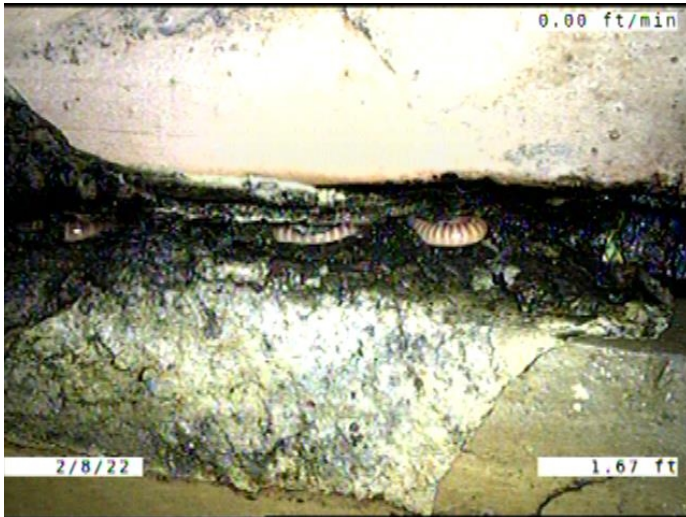
Code: **DAE**
 Description: **Deposits Attached Encrustation**

Distance (ft): **1.7**
 Structural Grade: **0**
 O&M Grade: **2**
 Clock Start/From: **8**
 Clock To: **4**
 1st Value:
 2nd Value:
 Value Percent: **5.000**
 Continuous Index: **S01**
 Within 8" of Joint: **YES**
 Remarks:

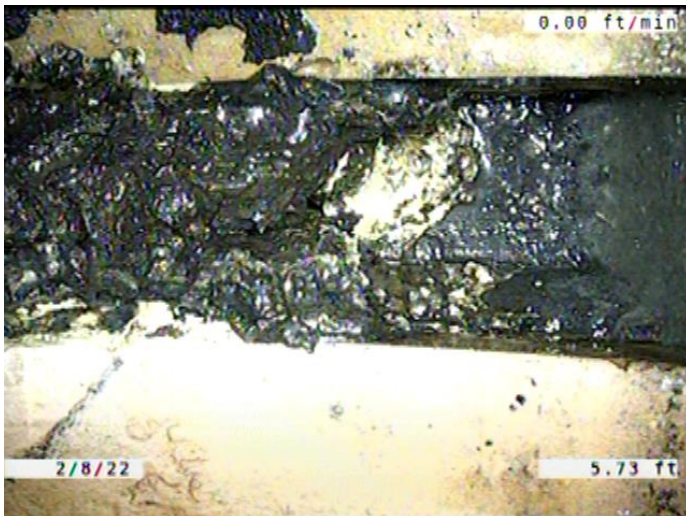
Code: **JAM**
 Description: **Joint Angular Medium**

Distance (ft): **5.7**
 Structural Grade: **3**
 O&M Grade: **0**
 Clock Start/From:
 Clock To:
 1st Value:
 2nd Value:
 Value Percent:
 Continuous Index:
 Within 8" of Joint: **NO**
 Remarks:

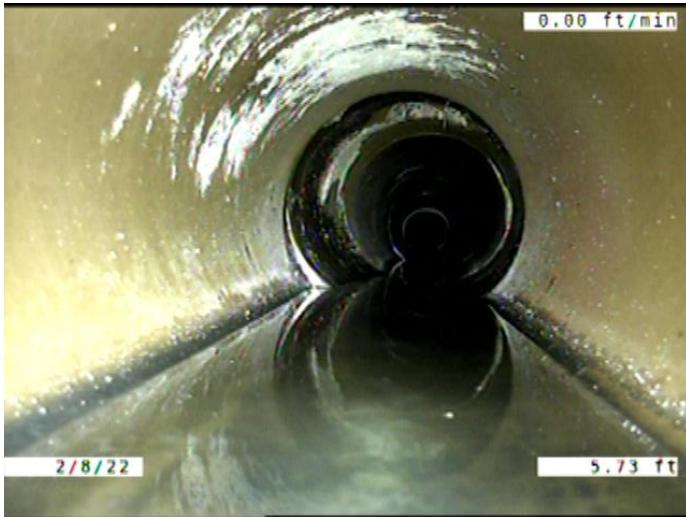
Code: **DSF**
 Description: **Deposits Settled Fine**

Distance (ft): **5.7**
 Structural Grade: **0**
 O&M Grade: **2**
 Clock Start/From: **5**
 Clock To: **7**
 1st Value:
 2nd Value:
 Value Percent: **5.000**
 Continuous Index: **S02**
 Within 8" of Joint: **YES**
 Remarks:

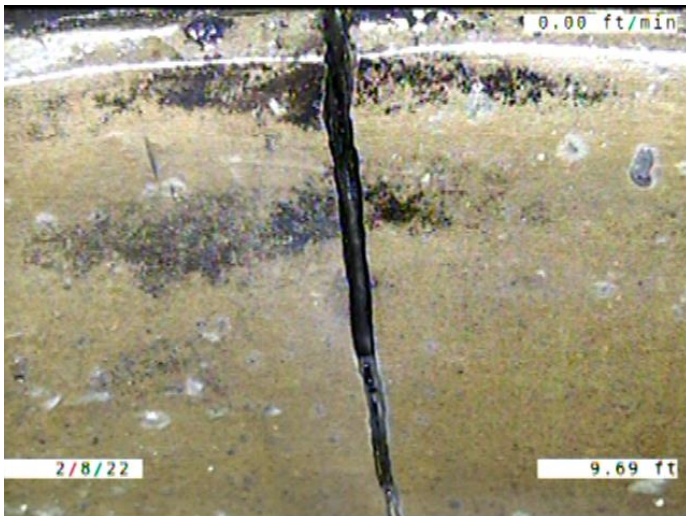
Code: **IRB**
 Description: **Infiltration Runner Barrel**

Distance (ft): **9.7**
 Structural Grade: **0**
 O&M Grade: **4**
 Clock Start/From: **12**
 Clock To:
 1st Value:
 2nd Value:
 Value Percent:
 Continuous Index:
 Within 8" of Joint: **YES**
 Remarks:

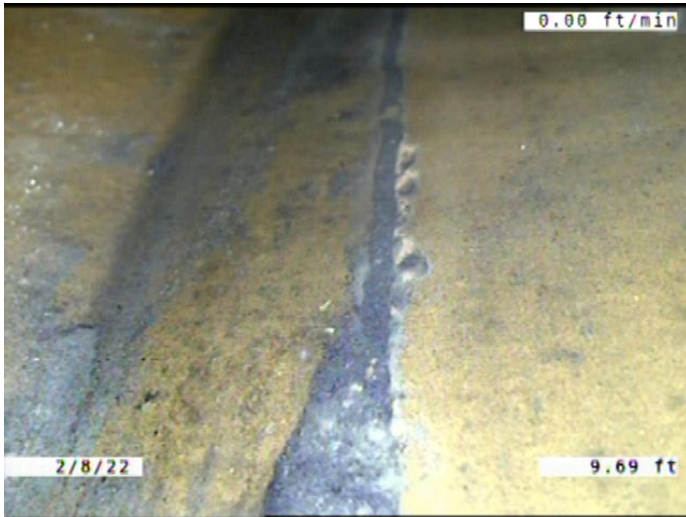
Code: **B**
Description: **Broken**

Distance (ft): **9.7**
Structural Grade: **4**
O&M Grade: **0**
Clock Start/From: **12**
Clock To: **12**
1st Value:
2nd Value:
Value Percent:
Continuous Index:
Within 8" of Joint: **YES**
Remarks:

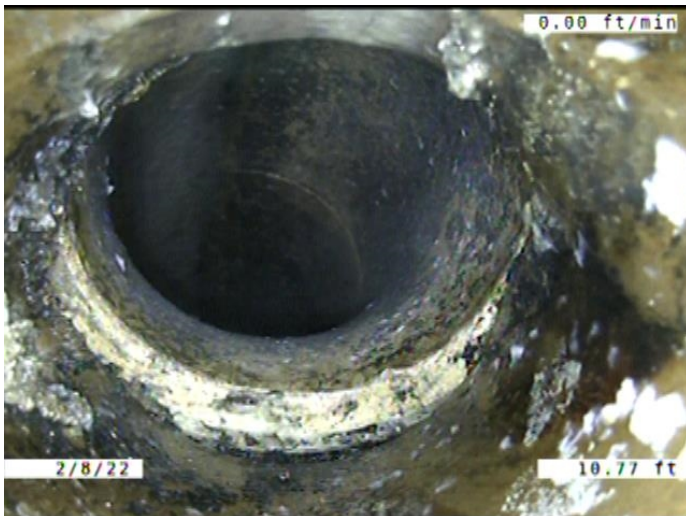
Code: **TFD**
Description: **Tap Factory Defective**

Distance (ft): **10.8**
Structural Grade: **0**
O&M Grade: **3**
Clock Start/From: **12**
Clock To:
1st Value: **6.000**
2nd Value:
Value Percent:
Continuous Index:
Within 8" of Joint: **YES**
Remarks: **BROKEN. LEAKING. SERVICE LINE OFFSET.**

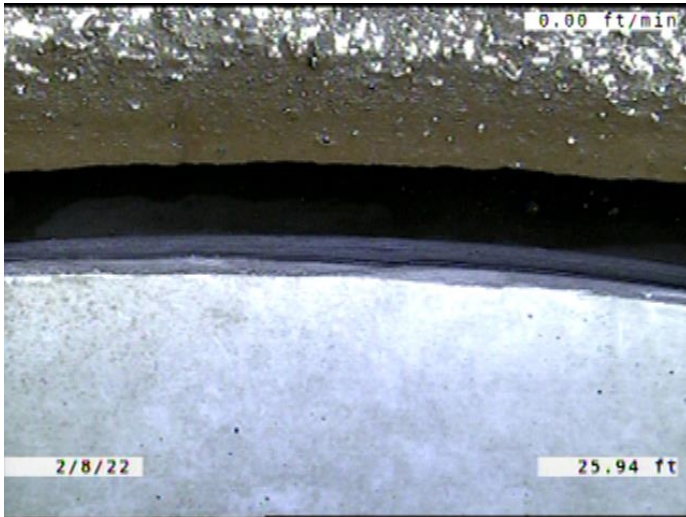
Code: **MMC**
 Description: **Miscellaneous Material Change**

Distance (ft): **25.9**
 Structural Grade: **0**
 O&M Grade: **0**
 Clock Start/From:
 Clock To:
 1st Value:
 2nd Value:
 Value Percent:
 Continuous Index:
 Within 8" of Joint: **NO**
 Remarks: **VCP TO PVC**

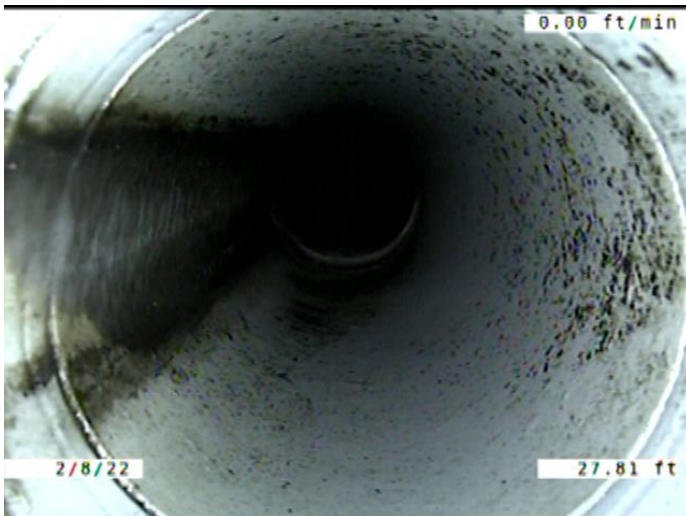
Code: **TF**
 Description: **Tap Factory**

Distance (ft): **27.8**
 Structural Grade: **0**
 O&M Grade: **0**
 Clock Start/From: **11**
 Clock To:
 1st Value: **6.000**
 2nd Value:
 Value Percent:
 Continuous Index:
 Within 8" of Joint: **YES**
 Remarks:

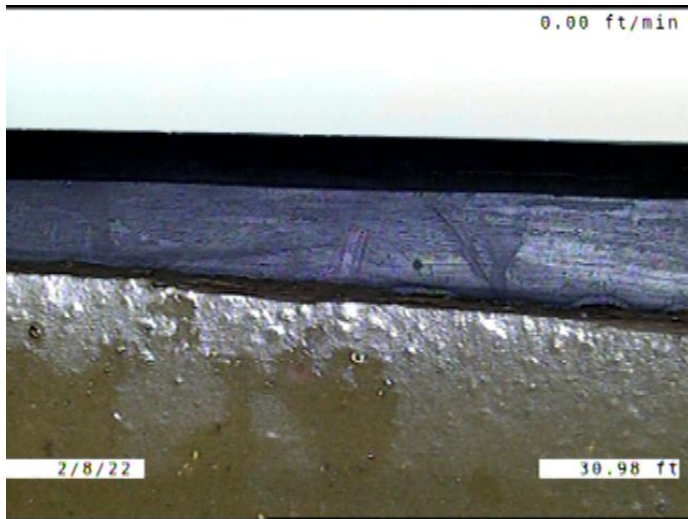
Code: **MMC**
Description: **Miscellaneous Material Change**

Distance (ft): **31.0**
Structural Grade: **0**
O&M Grade: **0**
Clock Start/From:
Clock To:
1st Value:
2nd Value:
Value Percent:
Continuous Index:
Within 8" of Joint: **NO**
Remarks: **PVC TO VCP**

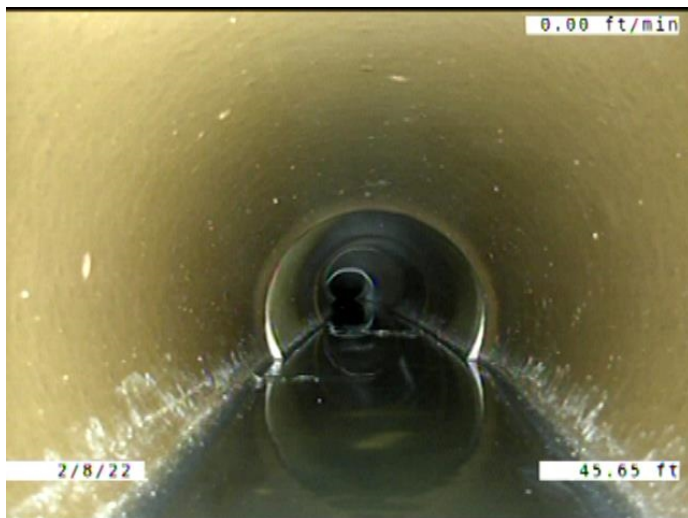
Code: **MWLS**
Description: **Miscellaneous Water Level Sag**

Distance (ft): **45.6**
Structural Grade: **2**
O&M Grade: **0**
Clock Start/From:
Clock To:
1st Value:
2nd Value:
Value Percent: **15.000**
Continuous Index: **S03**
Within 8" of Joint: **NO**
Remarks:

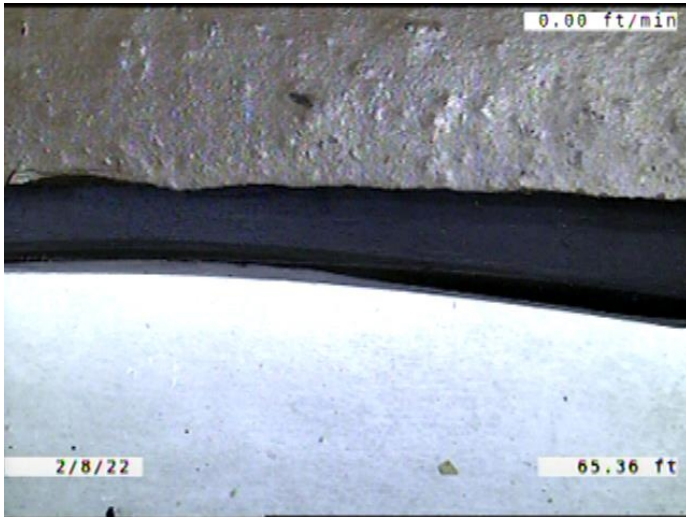
Code:	MMC
Description:	Miscellaneous Material Change
Distance (ft):	65.4
Structural Grade:	0
O&M Grade:	0
Clock Start/From:	
Clock To:	
1st Value:	
2nd Value:	
Value Percent:	
Continuous Index:	
Within 8" of Joint:	NO
Remarks:	VCP TO PVC

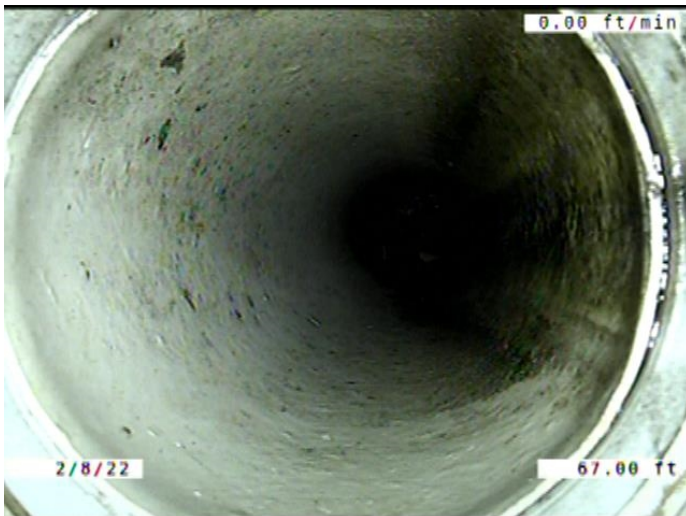
Code:	TF
Description:	Tap Factory
Distance (ft):	67.0
Structural Grade:	0
O&M Grade:	0
Clock Start/From:	1
Clock To:	
1st Value:	6.000
2nd Value:	
Value Percent:	
Continuous Index:	
Within 8" of Joint:	YES
Remarks:

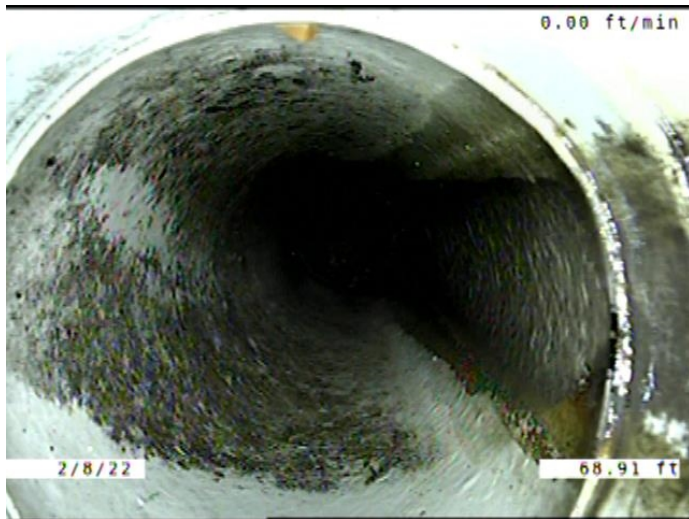
Code: **TF**
Description: **Tap Factory**

Distance (ft): **68.9**
Structural Grade: **0**
O&M Grade: **0**
Clock Start/From: **1**
Clock To:
1st Value: **6.000**
2nd Value:
Value Percent:
Continuous Index:
Within 8" of Joint: **YES**
Remarks:

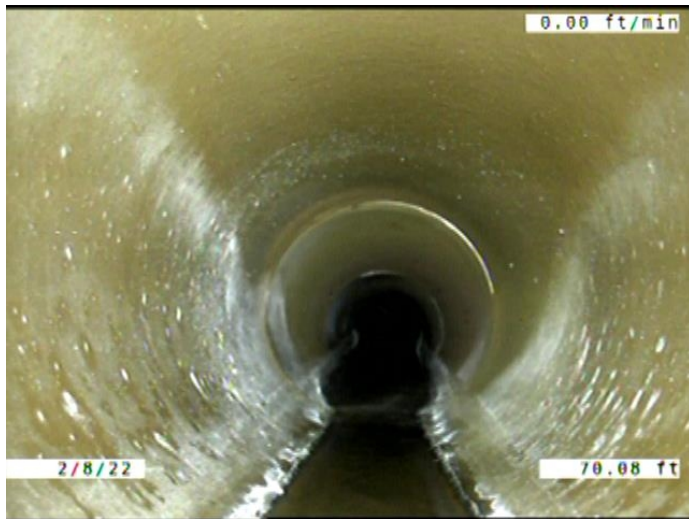
Code: **MWLS**
Description: **Miscellaneous Water Level Sag**

Distance (ft): **70.1**
Structural Grade: **2**
O&M Grade: **0**
Clock Start/From:
Clock To:
1st Value:
2nd Value:
Value Percent: **15.000**
Continuous Index: **F03**
Within 8" of Joint: **NO**
Remarks:

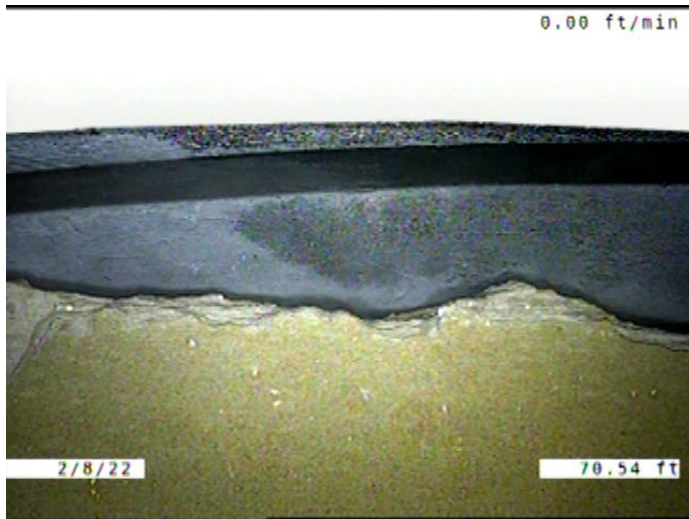
Code: **MMC**
Description: **Miscellaneous Material Change**

Distance (ft): **70.5**
Structural Grade: **0**
O&M Grade: **0**
Clock Start/From:
Clock To:
1st Value:
2nd Value:
Value Percent:
Continuous Index:
Within 8" of Joint: **NO**
Remarks: **PVC TO VCP**

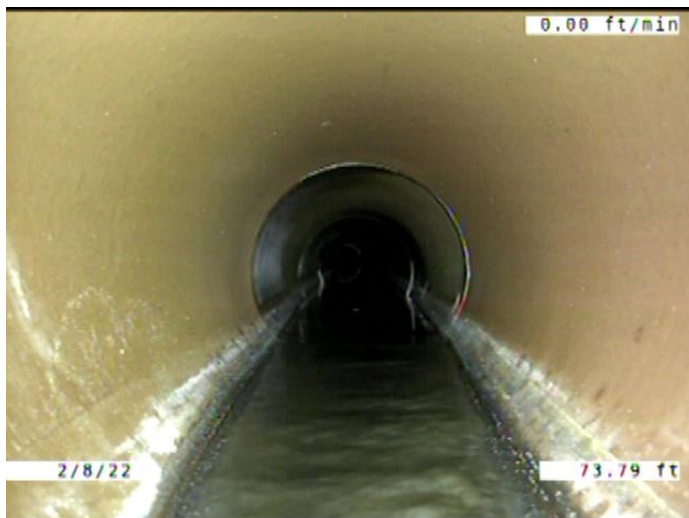
Code: **MWLS**
Description: **Miscellaneous Water Level Sag**

Distance (ft): **73.8**
Structural Grade: **2**
O&M Grade: **0**
Clock Start/From:
Clock To:
1st Value:
2nd Value:
Value Percent: **15.000**
Continuous Index: **S04**
Within 8" of Joint: **NO**
Remarks:

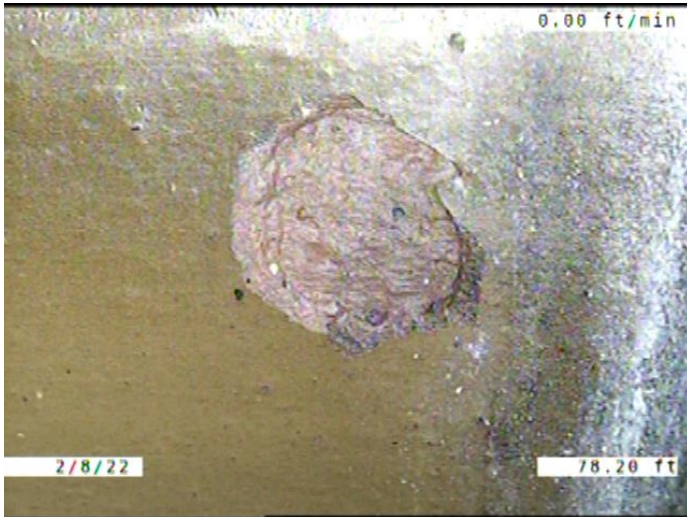
Code: **SSS**
Description: **Surface Damage Surface Spalling**

Distance (ft): **78.2**
Structural Grade: **2**
O&M Grade: **0**
Clock Start/From: **4**
Clock To:
1st Value:
2nd Value:
Value Percent:
Continuous Index:
Within 8" of Joint: **YES**
Remarks:

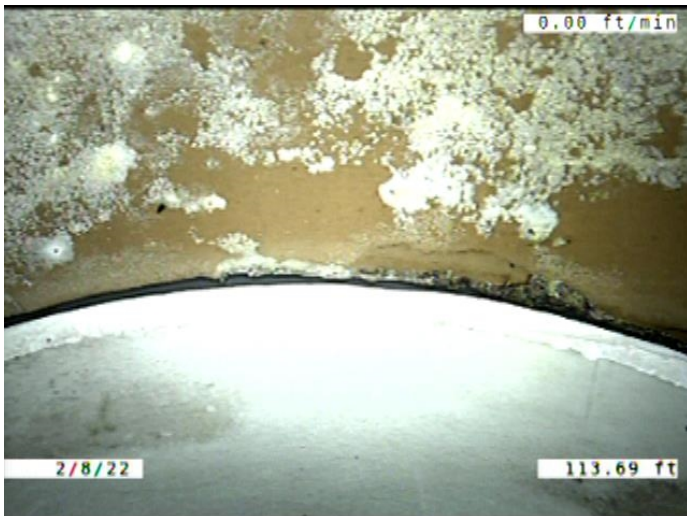
Code: **JOM**
Description: **Joint Offset Medium**

Distance (ft): **113.7**
Structural Grade: **3**
O&M Grade: **0**
Clock Start/From:
Clock To:
1st Value:
2nd Value:
Value Percent:
Continuous Index:
Within 8" of Joint: **NO**
Remarks:

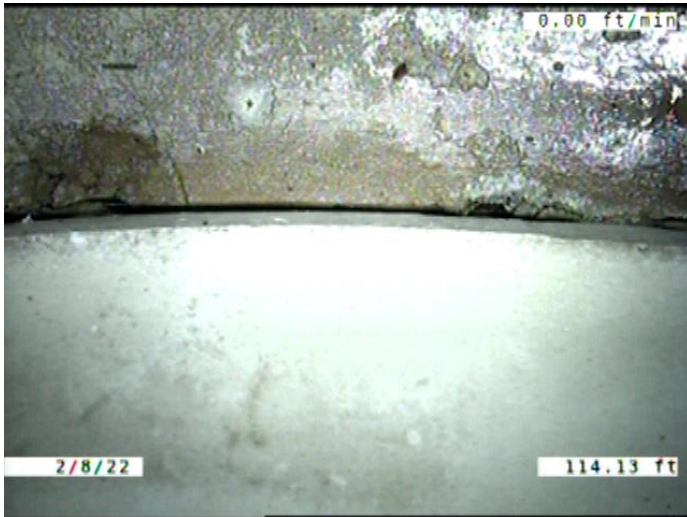
Code: **MMC**
Description: **Miscellaneous Material Change**

Distance (ft): **114.1**
Structural Grade: **0**
O&M Grade: **0**
Clock Start/From:
Clock To:
1st Value:
2nd Value:
Value Percent:
Continuous Index:
Within 8" of Joint: **NO**
Remarks: **VCP TO PVC**

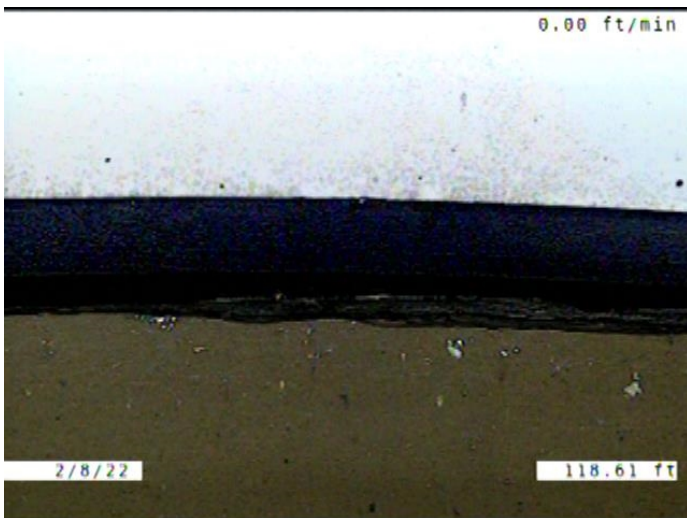
Code: **MMC**
Description: **Miscellaneous Material Change**

Distance (ft): **118.6**
Structural Grade: **0**
O&M Grade: **0**
Clock Start/From:
Clock To:
1st Value:
2nd Value:
Value Percent:
Continuous Index:
Within 8" of Joint: **NO**
Remarks: **PVC TO VCP**

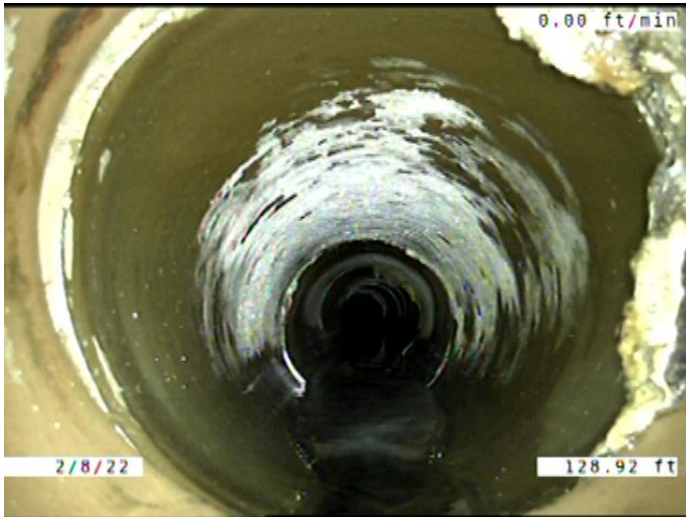
Code: **MWLS**
Description: **Miscellaneous Water Level Sag**

Distance (ft): **128.9**
Structural Grade: **2**
O&M Grade: **0**
Clock Start/From:
Clock To:
1st Value:
2nd Value:
Value Percent: **15.000**
Continuous Index: **F04**
Within 8" of Joint: **NO**
Remarks:

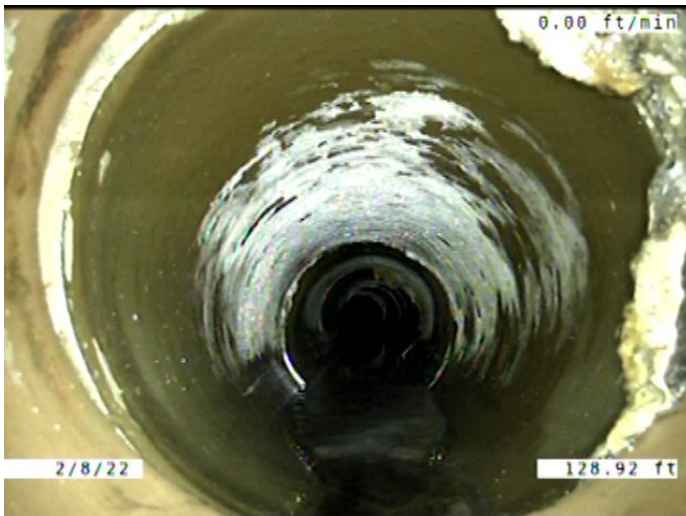
Code: **DSF**
Description: **Deposits Settled Fine**

Distance (ft): **128.9**
Structural Grade: **0**
O&M Grade: **2**
Clock Start/From: **5**
Clock To: **7**
1st Value:
2nd Value:
Value Percent: **5.000**
Continuous Index: **F02**
Within 8" of Joint: **YES**
Remarks:

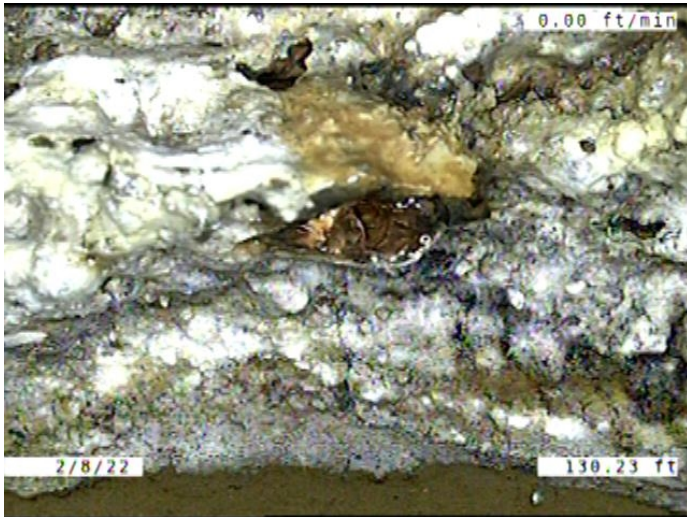
Code: **IWJ**
 Description: **Infiltration Weeper Joint**

Distance (ft): **130.2**
 Structural Grade: **0**
 O&M Grade: **2**
 Clock Start/From: **1**
 Clock To: **2**
 1st Value:
 2nd Value:
 Value Percent:
 Continuous Index:
 Within 8" of Joint: **YES**
 Remarks:

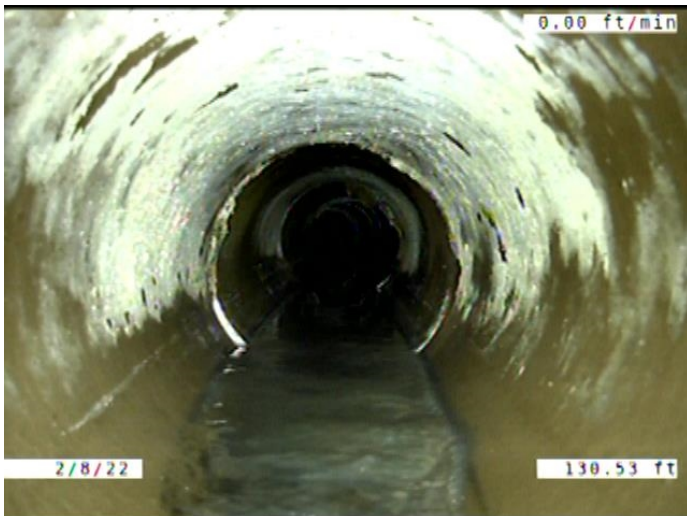
Code: **DAE**
 Description: **Deposits Attached Encrustation**

Distance (ft): **130.5**
 Structural Grade: **0**
 O&M Grade: **2**
 Clock Start/From: **8**
 Clock To: **4**
 1st Value:
 2nd Value:
 Value Percent: **5.000**
 Continuous Index: **F01**
 Within 8" of Joint: **YES**
 Remarks:

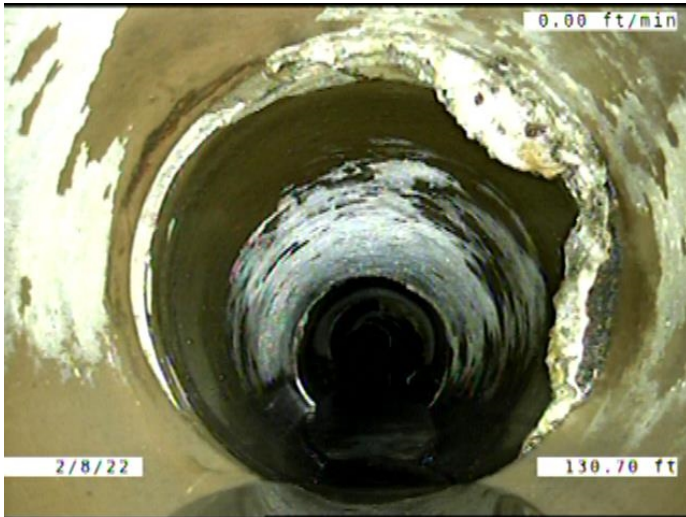
MSA

Miscellaneous Survey Abandoned

**CAMERA CANT MAKE IT PAST
ENCRUSTATION. MADE IT TO THE P**
