Profile/Photo Observation Report

Street:	N LAKE SHORE DR	Flow Control:	Not Controlled
City:	Hobart, IN	Year Renewed:	
Location:	Yard	Tape/Media #:	
Purpose:	Routine Assessment	Dia/Height:	12"
Use:	Sanitary	Material:	VCP
Drain Area:	NA	Lining:	
Category:	NA		
Comment:	Flow direction is wrong.

Location Details:		Direction of Survey:	Downstream
US MH:	M-606-087	DS MH:	M-606-088
		Total Length Surveyed (ft):	16.1

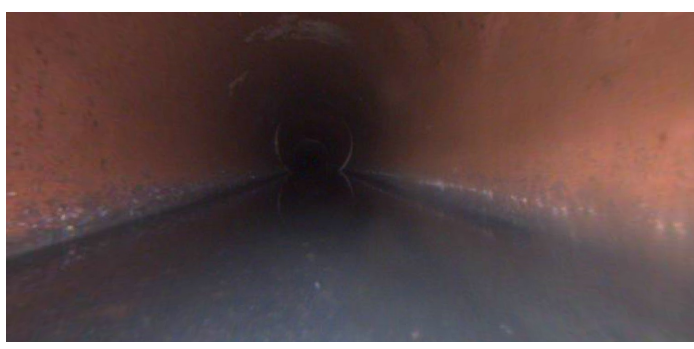
Code: **AMH**
Description: **Manhole**

Distance (ft): **.0**
Structural Grade: **0**
O&M Grade: **0**
Clock Start/From:
Clock To:
1st Value:
2nd Value:
Value Percent:
Continuous Index:
Within 8" of Joint: **NO**
Remarks: **M-606-087**

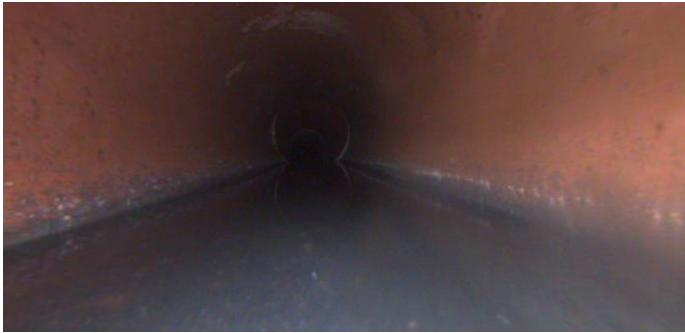
Code:	MWL
Description:	Water Level

Distance (ft):	.0
Structural Grade:	0
O&M Grade:	0
Clock Start/From:	
Clock To:	
1st Value:	
2nd Value:	
Value Percent:	20.000
Continuous Index:	
Within 8" of Joint:	NO
Remarks:

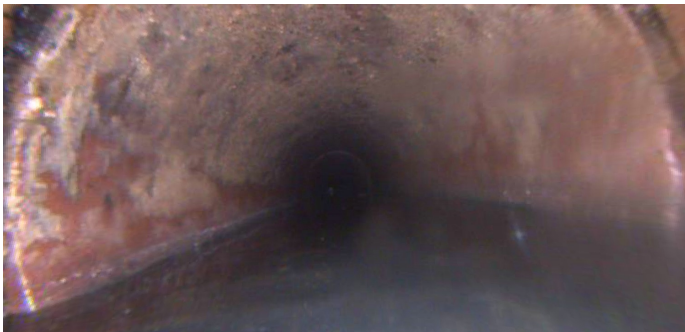
Code:	MSA
Description:	Abandoned Survey

Distance (ft):	16.1
Structural Grade:	0
O&M Grade:	0
Clock Start/From:	
Clock To:	
1st Value:	
2nd Value:	
Value Percent:	
Continuous Index:	
Within 8" of Joint:	NO
Remarks:	debris under water
