## Profile/Photo Observation Report

Street:	<b>FOXCROFT STREET</b>	Flow Control:	<b>Not Controlled</b>
City:	<b>Hobart, IN</b>	Year Renewed:	
Location:	<b>Yard</b>	Tape/Media #:	
Purpose:	<b>Routine Assessment</b>	Dia/Height:	<b>12"</b>
Use:	<b>Sanitary</b>	Material:	<b>VCP</b>
Drain Area:	<b>NA</b>	Lining:	
Category:	<b>NA</b>		
Comment:	<b>Flow direction is wrong.</b>

Location Details:		Direction of Survey:	<b>Downstream</b>
US MH:	<b>M-606-087</b>	DS MH:	<b>M-606-088</b>
		Total Length Surveyed (ft):	<b>16.1</b>

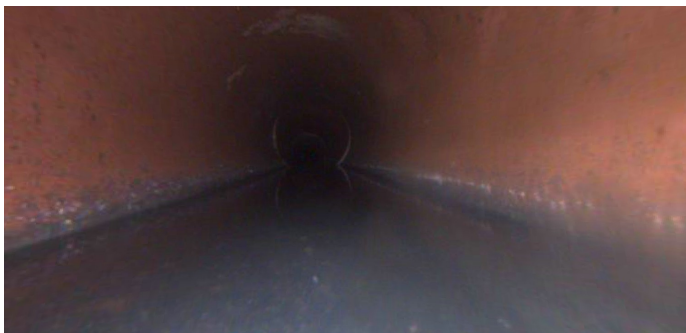
Code: **AMH**  
Description: **Manhole**

Distance (ft): **.0**  
Structural Grade: **0**  
O&M Grade: **0**  
Clock Start/From:  
Clock To:  
1st Value:  
2nd Value:  
Value Percent:  
Continuous Index:  
Within 8" of Joint: **NO**  
Remarks: **M-606-087**

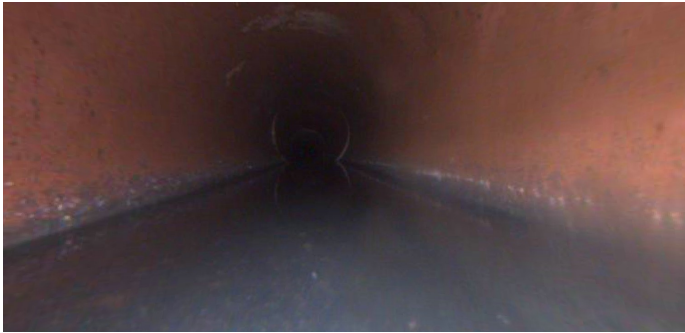
Code:	<b>MWL</b>
Description:	<b>Water Level</b>

Distance (ft):	<b>.0</b>
Structural Grade:	<b>0</b>
O&M Grade:	<b>0</b>
Clock Start/From:	
Clock To:	
1st Value:	
2nd Value:	
Value Percent:	<b>20.000</b>
Continuous Index:	
Within 8" of Joint:	<b>NO</b>
Remarks:

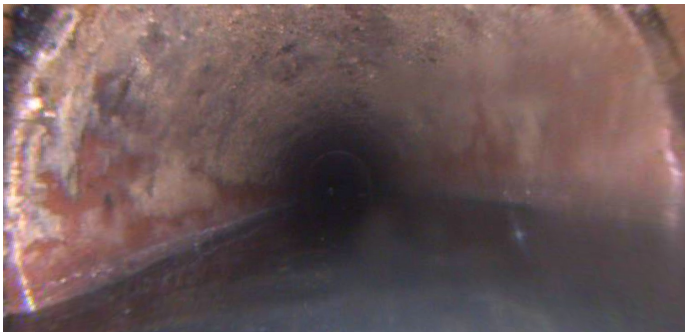
Code:	<b>MSA</b>
Description:	<b>Abandoned Survey</b>

Distance (ft):	<b>16.1</b>
Structural Grade:	<b>0</b>
O&M Grade:	<b>0</b>
Clock Start/From:	
Clock To:	
1st Value:	
2nd Value:	
Value Percent:	
Continuous Index:	
Within 8" of Joint:	<b>NO</b>
Remarks:	<b>debris under water</b>
