Profile/Photo Observation Report

Date:	04/09/2018	Weather:		Coding:	PACP 6.0
Pipe Length (ft):	205.1	Owner:	NA	Pre Clean:	No Pre-Cleaning
P.O.#:		Surveyor:	Byrd Fitzgerald	PSR:	P-606-088-087
Customer:		Clean Date:	01/01/1900	Shape:	C

Street:	N LAKE SHORE DR	Flow Control:	Not Controlled
City:	Hobart, IN	Year Renewed:	
Location:	Yard	Tape/Media #:	
Purpose:	Routine Assessment	Dia/Height:	12"
Use:	Sanitary	Material:	VCP
Drain Area:	NA	Lining:	
Category:	NA		
Comment:			
Location Details:		Direction of Survey:	Upstream
US MH:	M-606-087	DS MH:	M-606-088
		Total Length Surveyed (ft):	30.0

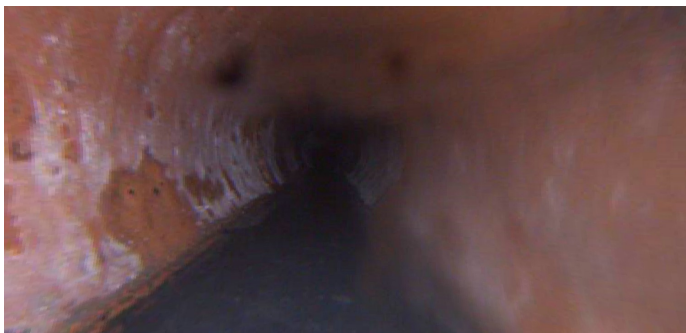
Code: **AMH**
Description: **Manhole**

Distance (ft): **.0**
Structural Grade: **0**
O&M Grade: **0**
Clock Start/From:
Clock To:
1st Value:
2nd Value:
Value Percent:
Continuous Index:
Within 8" of Joint: **NO**
Remarks: **M-606-088**

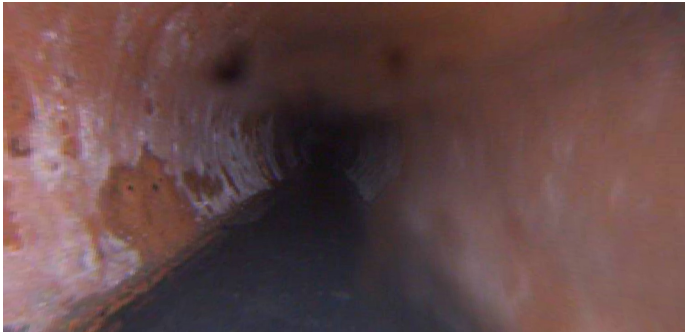
Code:	MWL
Description:	Water Level

Distance (ft):	.0
Structural Grade:	0
O&M Grade:	0
Clock Start/From:	
Clock To:	
1st Value:	
2nd Value:	
Value Percent:	5.000
Continuous Index:	
Within 8" of Joint:	NO
Remarks:

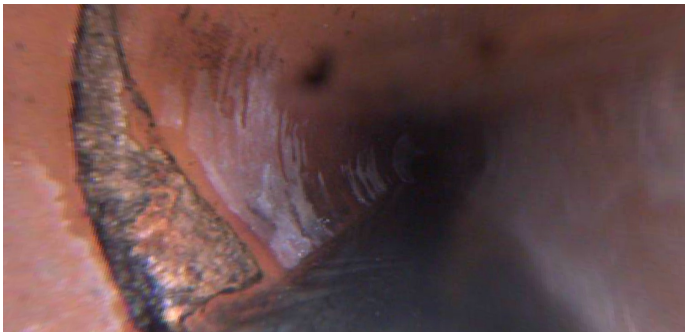
Code:	DAZ
Description:	Deposits Attached Other

Distance (ft):	2.5
Structural Grade:	0
O&M Grade:	2
Clock Start/From:	7
Clock To:	10
1st Value:	
2nd Value:	
Value Percent:	5.000
Continuous Index:	
Within 8" of Joint:	YES
Remarks:

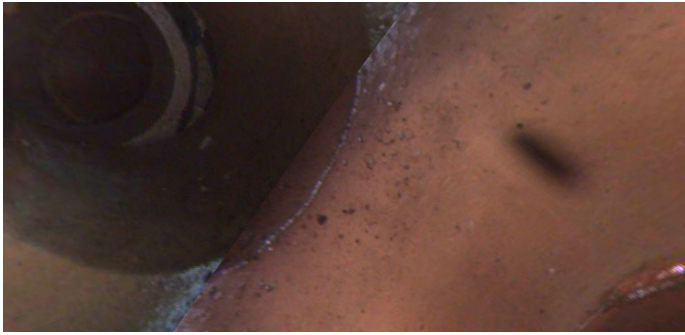
Code: **TF**
Description: **Tap Factory**

Distance (ft): **11.5**
Structural Grade: **0**
O&M Grade: **0**
Clock Start/From: **11**
Clock To:
1st Value: **4.000**
2nd Value:
Value Percent:
Continuous Index:
Within 8" of Joint: **YES**
Remarks:

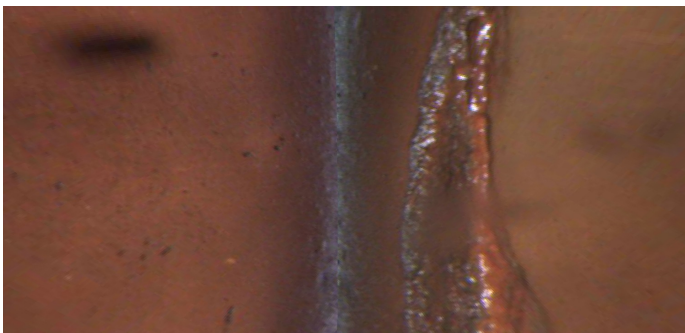
Code: **DAE**
Description: **Deposits Attached Encrustation**

Distance (ft): **12.8**
Structural Grade: **0**
O&M Grade: **2**
Clock Start/From: **1**
Clock To: **5**
1st Value:
2nd Value:
Value Percent: **5.000**
Continuous Index: **S01**
Within 8" of Joint: **YES**
Remarks: **wandering**

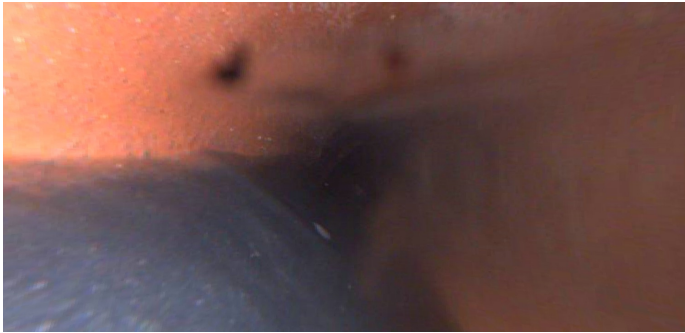
Code: **MSA**
Description: **Abandoned Survey**

Distance (ft): **30.0**
Structural Grade: **0**
O&M Grade: **0**
Clock Start/From:
Clock To:
1st Value:
2nd Value:
Value Percent:
Continuous Index:
Within 8" of Joint: **NO**
Remarks: **camera flipped**

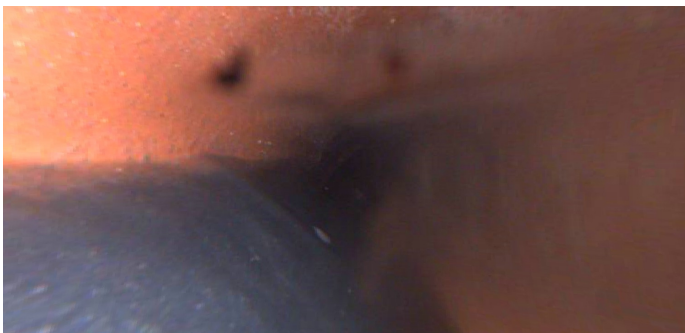
Code: **DAE**
Description: **Deposits Attached Encrustation**

Distance (ft): **30.0**
Structural Grade: **0**
O&M Grade: **2**
Clock Start/From: **1**
Clock To: **5**
1st Value:
2nd Value:
Value Percent: **5.000**
Continuous Index: **F01**
Within 8" of Joint: **YES**
Remarks: **wandering**
