Profile/Photo Observation Report

Street:	FOXCROFT STREET	Flow Control:	Not Controlled
City:	Hobart, IN	Year Renewed:	
Location:	Yard	Tape/Media #:	
Purpose:	Routine Assessment	Dia/Height:	12"
Use:	Sanitary	Material:	VCP
Drain Area:	NA	Lining:	
Category:	NA		
Comment:

Location Details:		Direction of Survey:	Upstream
US MH:	M-606-087	DS MH:	M-606-088
		Total Length Surveyed (ft):	30.0

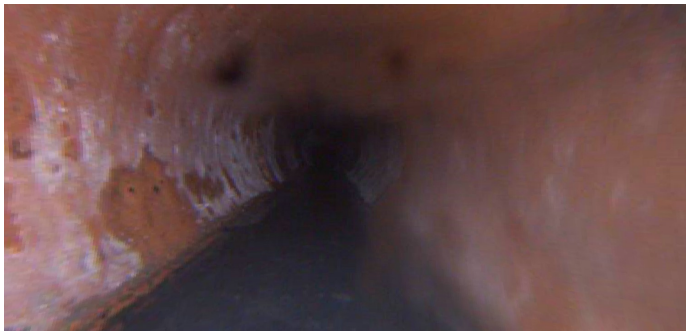
Code: **AMH**
Description: **Manhole**

Distance (ft): **.0**
Structural Grade: **0**
O&M Grade: **0**
Clock Start/From:
Clock To:
1st Value:
2nd Value:
Value Percent:
Continuous Index:
Within 8" of Joint: **NO**
Remarks: **M-606-088**

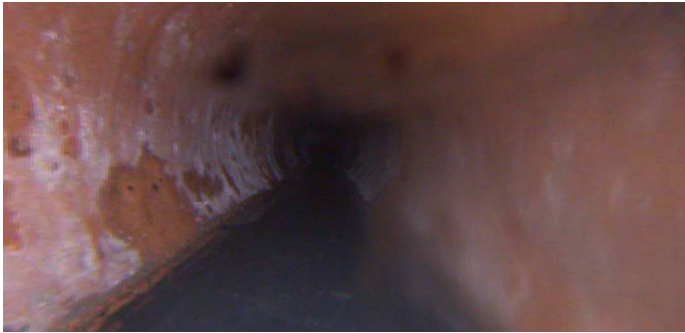
Code:	MWL
Description:	Water Level

Distance (ft):	.0
Structural Grade:	0
O&M Grade:	0
Clock Start/From:	
Clock To:	
1st Value:	
2nd Value:	
Value Percent:	5.000
Continuous Index:	
Within 8" of Joint:	NO
Remarks:

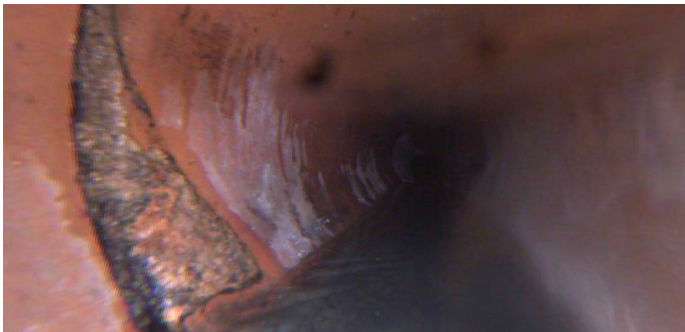
Code:	DAZ
Description:	Deposits Attached Other

Distance (ft):	2.5
Structural Grade:	0
O&M Grade:	2
Clock Start/From:	7
Clock To:	10
1st Value:	
2nd Value:	
Value Percent:	5.000
Continuous Index:	
Within 8" of Joint:	YES
Remarks:

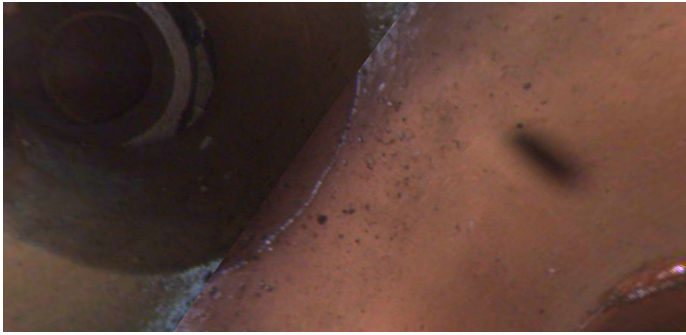
Code: **TF**
Description: **Tap Factory**

Distance (ft): **11.5**
Structural Grade: **0**
O&M Grade: **0**
Clock Start/From: **11**
Clock To:
1st Value: **4.000**
2nd Value:
Value Percent:
Continuous Index:
Within 8" of Joint: **YES**
Remarks:

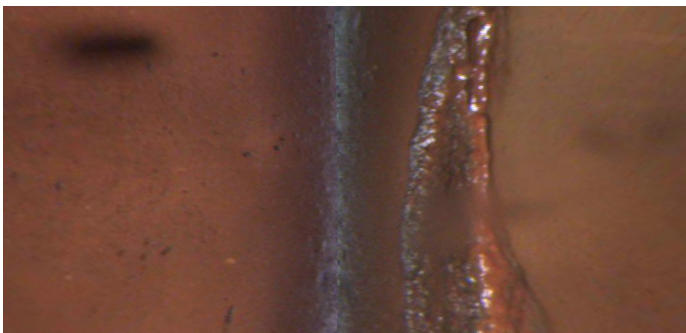
Code: **DAE**
Description: **Deposits Attached Encrustation**

Distance (ft): **12.8**
Structural Grade: **0**
O&M Grade: **2**
Clock Start/From: **1**
Clock To: **5**
1st Value:
2nd Value:
Value Percent: **5.000**
Continuous Index: **S01**
Within 8" of Joint: **YES**
Remarks: **wandering**

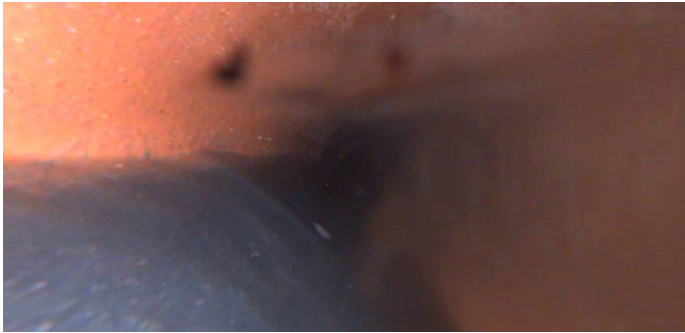
Code: **MSA**
Description: **Abandoned Survey**

Distance (ft): **30.0**
Structural Grade: **0**
O&M Grade: **0**
Clock Start/From:
Clock To:
1st Value:
2nd Value:
Value Percent:
Continuous Index:
Within 8" of Joint: **NO**
Remarks: **camera flipped**

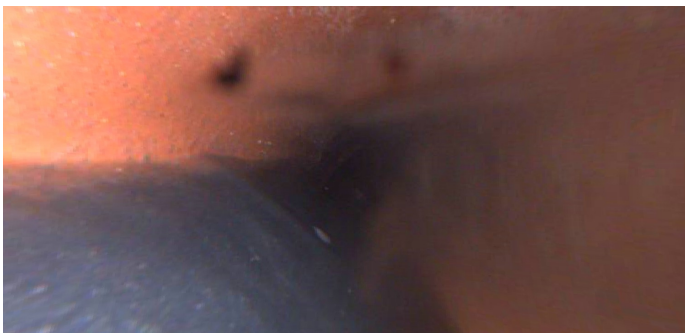
Code: **DAE**
Description: **Deposits Attached Encrustation**

Distance (ft): **30.0**
Structural Grade: **0**
O&M Grade: **2**
Clock Start/From: **1**
Clock To: **5**
1st Value:
2nd Value:
Value Percent: **5.000**
Continuous Index: **F01**
Within 8" of Joint: **YES**
Remarks: **wandering**
