## Profile/Photo Observation Report

Date:	<b>01/30/2022</b>	Weather:		Coding:	<b>PACP 7.0</b>
Pipe Length (ft):	<b>77.8</b>	Owner:	<b>City of Hobart</b>	Pre Clean:	<b>Heavy Cleaning</b>
P.O.#:	<b>YES502259</b>	Surveyor:	<b>S. Bucklin</b>	PSR:	<b>P-606-089-088</b>
Customer:	<b>City of Hobart</b>	Clean Date:	<b>01/30/2022</b>	Shape:	<b>C</b>

Street:	<b>North Lake Shore Drive</b>	Flow Control:	<b>Not Controlled</b>
City:	<b>Hobart, IN</b>	Year Renewed:	
Location:	<b>Easement/Right of Way</b>	Tape/Media #:	
Purpose:	<b>Routine Assessment</b>	Dia/Height:	<b>12"</b>
Use:	<b>Sanitary Sewage Pipe</b>	Material:	<b>VCP</b>
Drain Area:		Lining:	<b>None</b>
Category:	<b>NA</b>		
Comment:

Location Details:		Direction of Survey:	<b>Downstream</b>
US MH:	<b>M-606-088</b>	DS MH:	<b>M-606-089</b>
		Total Length Surveyed (ft):	<b>77.8</b>

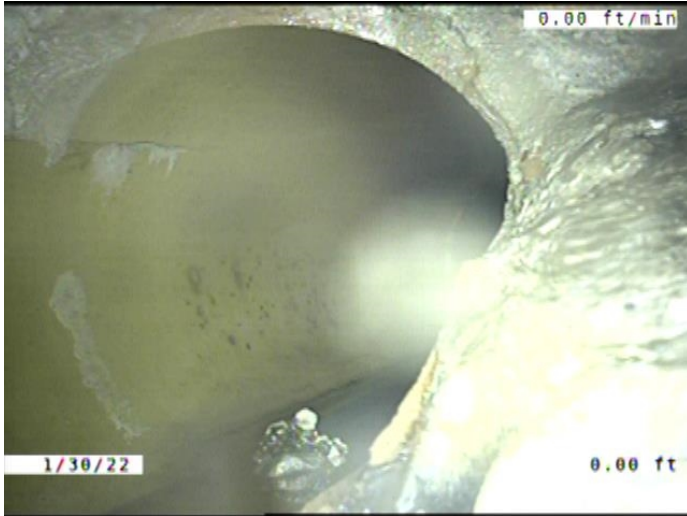
Code: **MWL**  
Description: **Miscellaneous Water Level**

Distance (ft): **.0**  
Structural Grade: **0**  
O&M Grade: **0**  
Clock Start/From:  
Clock To:  
1st Value:  
2nd Value:  
Value Percent: **5.000**  
Continuous Index:  
Within 8" of Joint: **NO**  
Remarks:

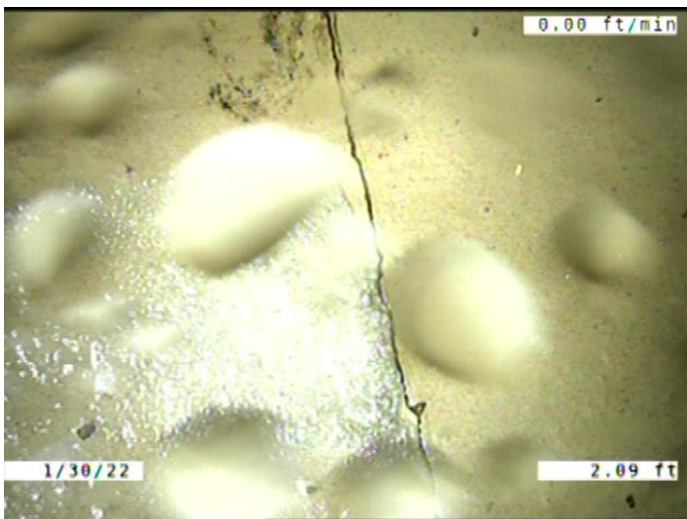
Code: **CS**  
Description: **Crack Spiral**

Distance (ft): **2.1**  
Structural Grade: **2**  
O&M Grade: **0**  
Clock Start/From: **11**  
Clock To: **1**  
1st Value:  
2nd Value:  
Value Percent:  
Continuous Index:  
Within 8" of Joint: **YES**  
Remarks:

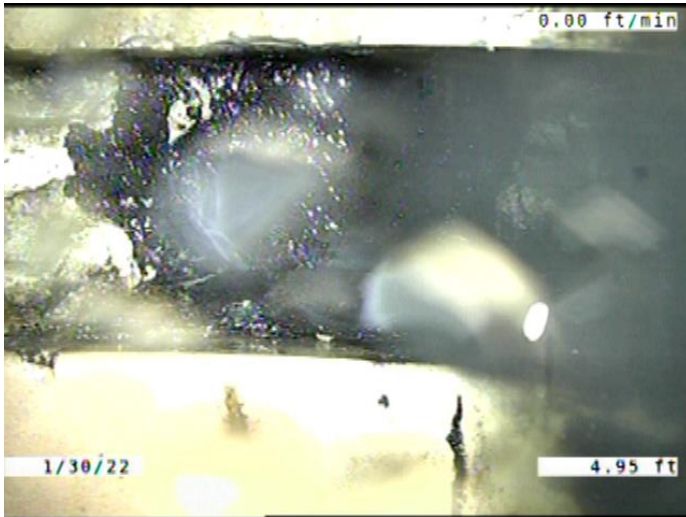
Code: **JAM**  
Description: **Joint Angular Medium**

Distance (ft): **4.9**  
Structural Grade: **3**  
O&M Grade: **0**  
Clock Start/From:  
Clock To:  
1st Value:  
2nd Value:  
Value Percent:  
Continuous Index:  
Within 8" of Joint: **NO**  
Remarks:

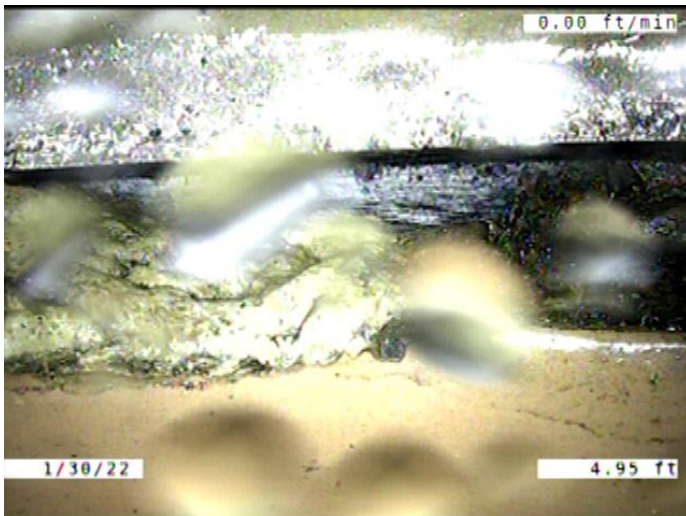
Code: **JSM**  
Description: **Joint Separated Medium**

Distance (ft): **4.9**  
Structural Grade: **3**  
O&M Grade: **0**  
Clock Start/From:  
Clock To:  
1st Value:  
2nd Value:  
Value Percent:  
Continuous Index:  
Within 8" of Joint: **NO**  
Remarks:

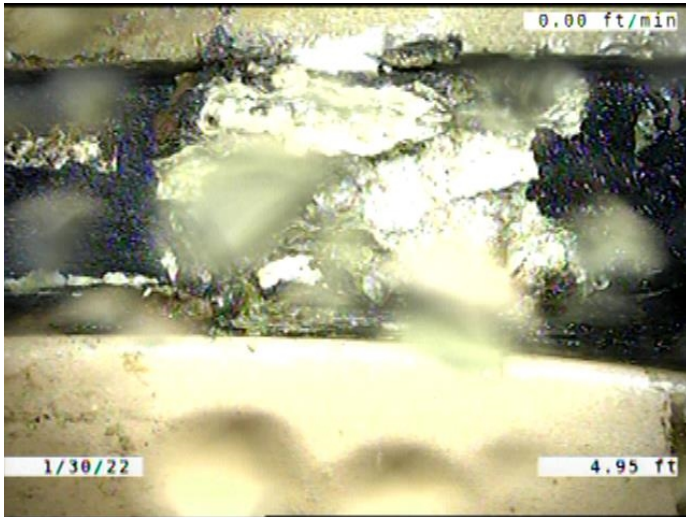
Code: **DAE**  
Description: **Deposits Attached Encrustation**

Distance (ft): **5.0**  
Structural Grade: **0**  
O&M Grade: **2**  
Clock Start/From: **8**  
Clock To: **4**  
1st Value:  
2nd Value:  
Value Percent: **5.000**  
Continuous Index: **S01**  
Within 8" of Joint: **YES**  
Remarks:

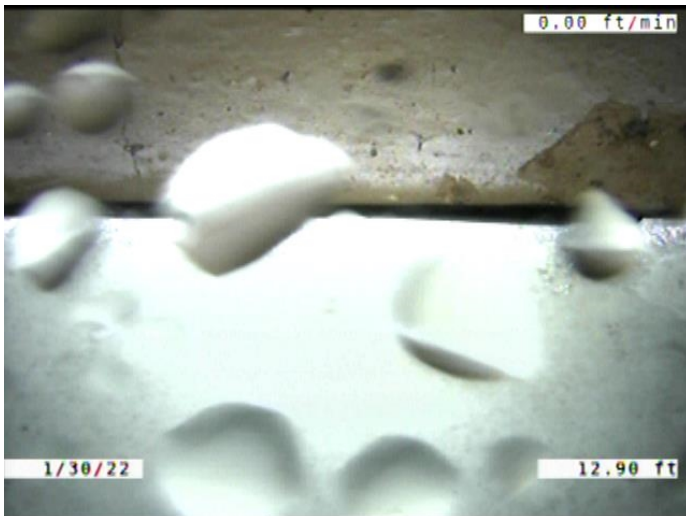
Code: **MMC**  
Description: **Miscellaneous Material Change**

Distance (ft): **12.9**  
Structural Grade: **0**  
O&M Grade: **0**  
Clock Start/From:  
Clock To:  
1st Value:  
2nd Value:  
Value Percent:  
Continuous Index:  
Within 8" of Joint: **NO**  
Remarks: **VCP TO PVC**

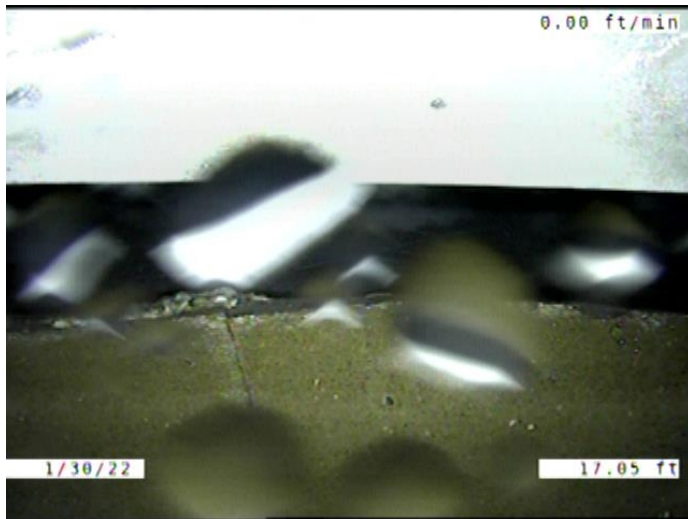
Code: **MMC**  
 Description: **Miscellaneous Material Change**

Distance (ft): **17.1**  
 Structural Grade: **0**  
 O&M Grade: **0**  
 Clock Start/From:  
 Clock To:  
 1st Value:  
 2nd Value:  
 Value Percent:  
 Continuous Index:  
 Within 8" of Joint: **NO**  
 Remarks: **PVC TO VCP**

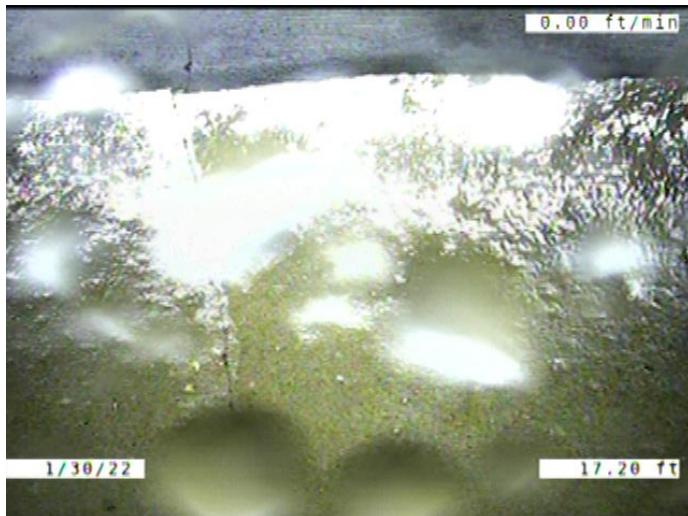
Code: **CL**  
 Description: **Crack Longitudinal**

Distance (ft): **17.2**  
 Structural Grade: **2**  
 O&M Grade: **0**  
 Clock Start/From: **12**  
 Clock To:  
 1st Value:  
 2nd Value:  
 Value Percent:  
 Continuous Index:  
 Within 8" of Joint: **YES**  
 Remarks:

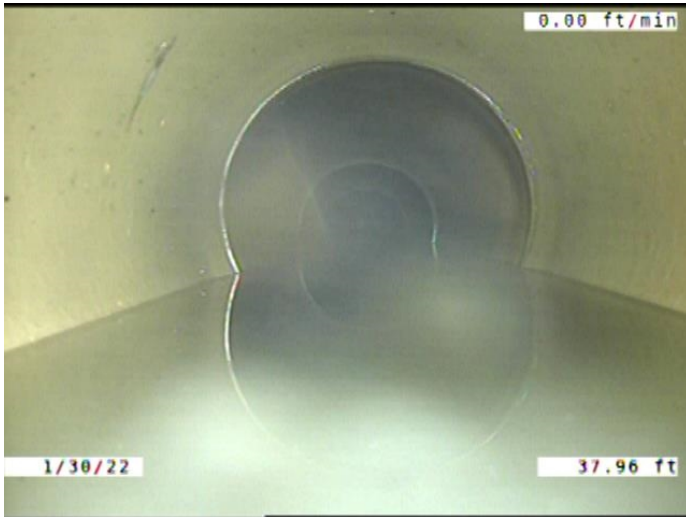
Code: **MWL**  
Description: **Miscellaneous Water Level**

Distance (ft): **38.0**  
Structural Grade: **0**  
O&M Grade: **0**  
Clock Start/From:  
Clock To:  
1st Value:  
2nd Value:  
Value Percent: **15.000**  
Continuous Index:  
Within 8" of Joint: **NO**  
Remarks:

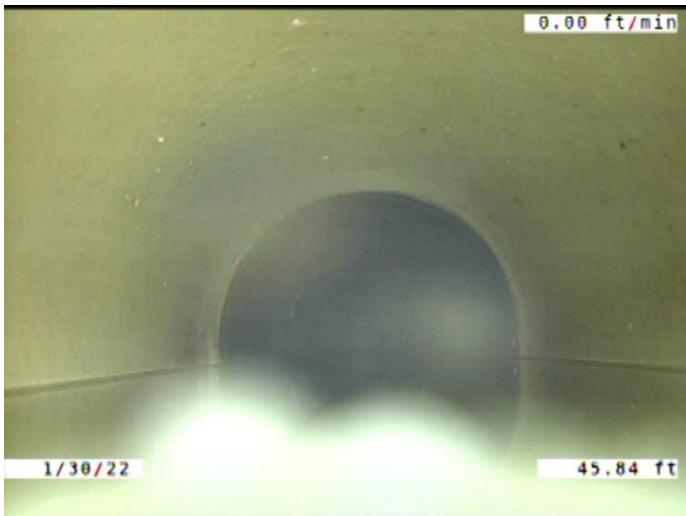
Code: **MWL**  
Description: **Miscellaneous Water Level**

Distance (ft): **45.8**  
Structural Grade: **0**  
O&M Grade: **0**  
Clock Start/From:  
Clock To:  
1st Value:  
2nd Value:  
Value Percent: **25.000**  
Continuous Index:  
Within 8" of Joint: **NO**  
Remarks:

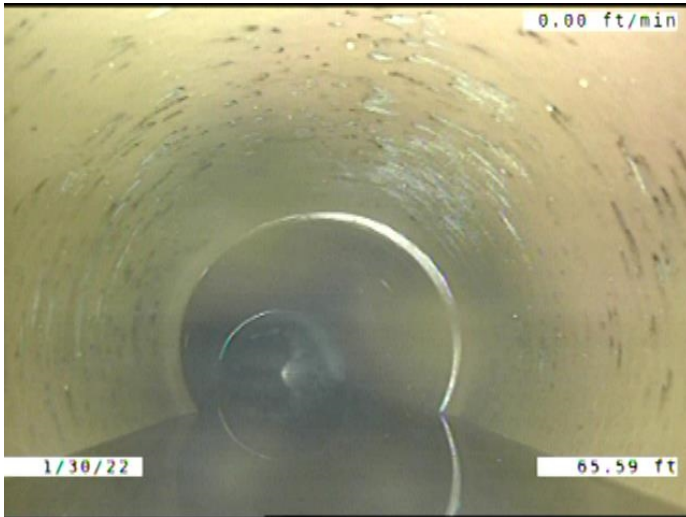
Code: **MWL**  
 Description: **Miscellaneous Water Level**

Distance (ft): **65.6**  
 Structural Grade: **0**  
 O&M Grade: **0**  
 Clock Start/From:  
 Clock To:  
 1st Value:  
 2nd Value:  
 Value Percent: **15.000**  
 Continuous Index:  
 Within 8" of Joint: **NO**  
 Remarks:

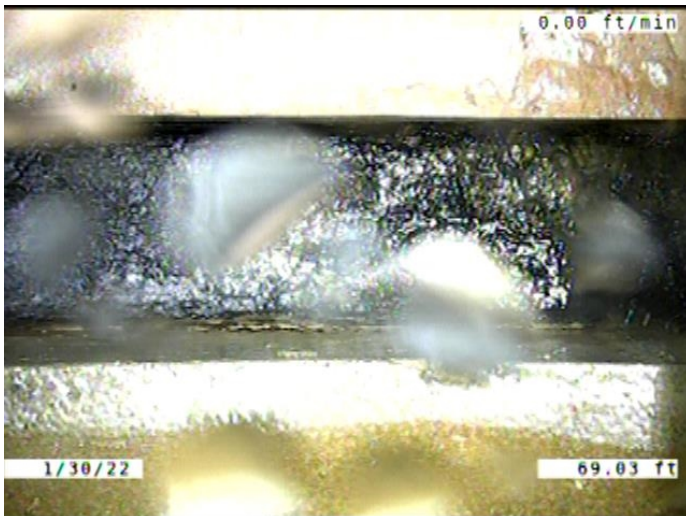
Code: **JAM**  
 Description: **Joint Angular Medium**

Distance (ft): **69.0**  
 Structural Grade: **3**  
 O&M Grade: **0**  
 Clock Start/From:  
 Clock To:  
 1st Value:  
 2nd Value:  
 Value Percent:  
 Continuous Index:  
 Within 8" of Joint: **NO**  
 Remarks:

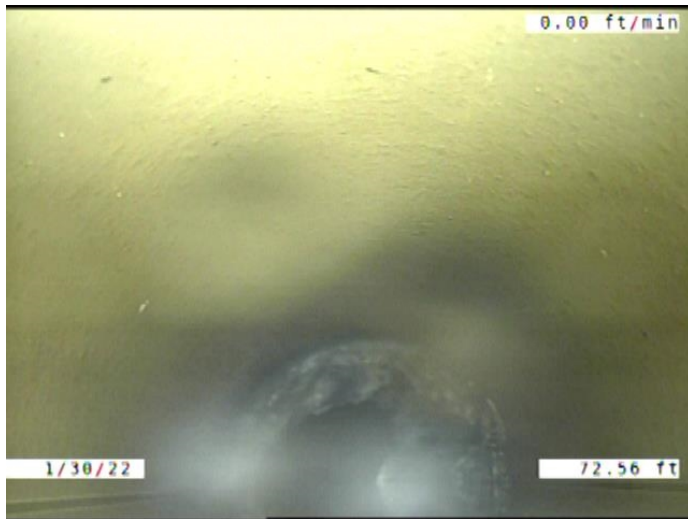
Code: **MWL**  
Description: **Miscellaneous Water Level**

Distance (ft): **72.6**  
Structural Grade: **0**  
O&M Grade: **0**  
Clock Start/From:  
Clock To:  
1st Value:  
2nd Value:  
Value Percent: **30.000**  
Continuous Index:  
Within 8" of Joint: **NO**  
Remarks:

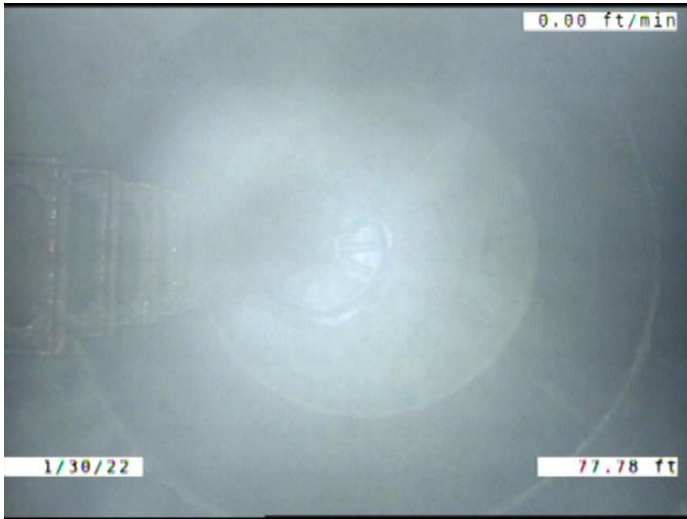
Code:	<b>AMH</b>
Description:	<b>Manhole</b>
Distance (ft):	<b>77.8</b>
Structural Grade:	<b>0</b>
O&M Grade:	<b>0</b>
Clock Start/From:	
Clock To:	
1st Value:	
2nd Value:	
Value Percent:	
Continuous Index:	
Within 8" of Joint:	<b>NO</b>
Remarks:	<b>M-606-089</b>
