Profile/Photo Observation Report

Date:	04/07/2018	Weather:		Coding:	PACP 6.0
Pipe Length (ft):	93.6	Owner:	NA	Pre Clean:	No Pre-Cleaning
P.O.#:		Surveyor:	Jen Costello	PSR:	P-606-090-089
Customer:		Clean Date:	01/01/1900	Shape:	C

Street:	N LAKE SHORE DR	Flow Control:	Not Controlled
City:	Hobart, IN	Year Renewed:	
Location:	Yard	Tape/Media #:	
Purpose:	Routine Assessment	Dia/Height:	10"
Use:	Sanitary	Material:	VCP
Drain Area:	NA	Lining:	
Category:	NA		
Comment:			
Location Details:		Direction of Survey:	Downstream
US MH:	M-606-089	DS MH:	M-606-090
		Total Length Surveyed (ft):	7.3

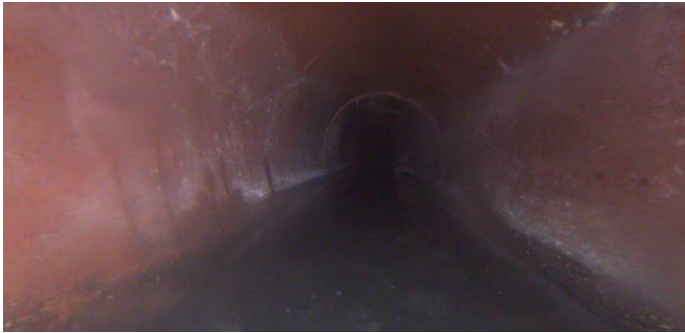
Code:	MWL
Description:	Water Level

Distance (ft):	.0
Structural Grade:	0
O&M Grade:	0
Clock Start/From:	
Clock To:	
1st Value:	
2nd Value:	
Value Percent:	10.000
Continuous Index:	
Within 8" of Joint:	NO
Remarks:

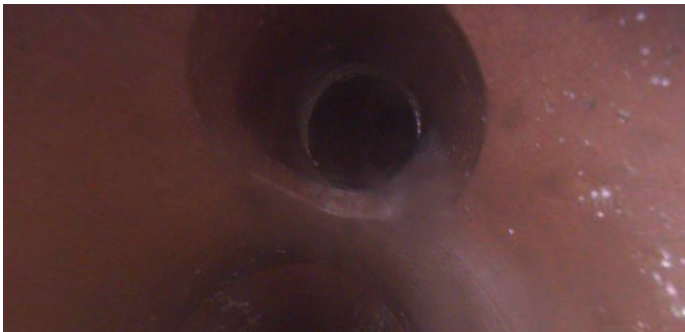
Code:	TF
Description:	Tap Factory

Distance (ft):	4.1
Structural Grade:	0
O&M Grade:	0
Clock Start/From:	12
Clock To:	
1st Value:	4.000
2nd Value:	
Value Percent:	
Continuous Index:	
Within 8" of Joint:	
Remarks:

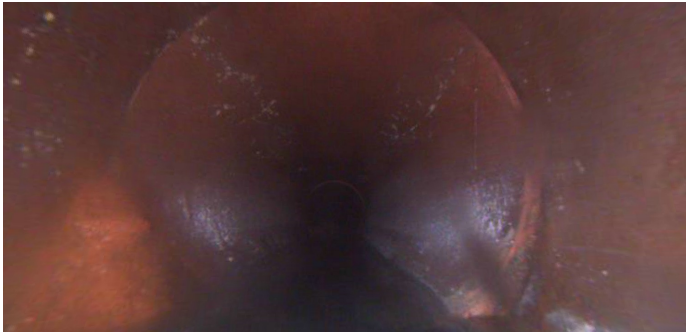
Code: **DAE**
Description: **Deposits Attached Encrustation**

Distance (ft): **4.8**
Structural Grade: **0**
O&M Grade: **2**
Clock Start/From: **8**
Clock To: **9**
1st Value:
2nd Value:
Value Percent: **5.000**
Continuous Index:
Within 8" of Joint: **YES**
Remarks:

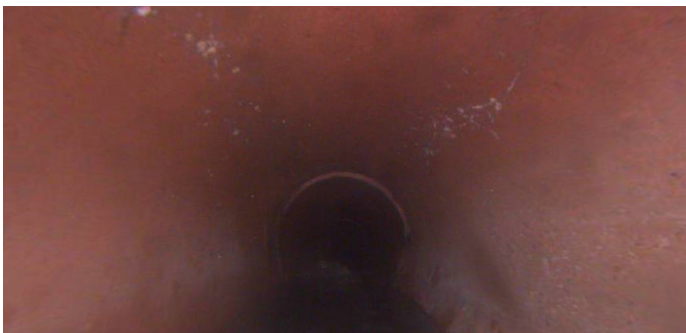
Code: **MSA**
Description: **Abandoned Survey**

Distance (ft): **7.3**
Structural Grade: **0**
O&M Grade: **0**
Clock Start/From:
Clock To:
1st Value:
2nd Value:
Value Percent:
Continuous Index:
Within 8" of Joint: **NO**
Remarks: **DAE**
