Profile/Photo Observation Report

Street:	N LAKE SHORE DR	Flow Control:	Not Controlled
City:	Hobart, IN	Year Renewed:	
Location:	Yard	Tape/Media #:	
Purpose:	Routine Assessment	Dia/Height:	10"
Use:	Sanitary	Material:	VCP
Drain Area:	NA	Lining:	
Category:	NA		
Comment:	F_S_P_C debris/sludge, flow direction is marked wrong.		
Location Details:		Direction of Survey:	Upstream
US MH:	M-606-089	DS MH:	M-606-090
		Total Length Surveyed (ft):	5.3

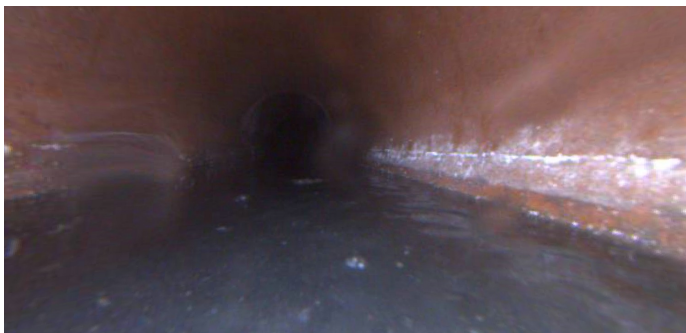
Code: **AMH**
Description: **Manhole**

Distance (ft): **.0**
Structural Grade: **0**
O&M Grade: **0**
Clock Start/From:
Clock To:
1st Value:
2nd Value:
Value Percent:
Continuous Index:
Within 8" of Joint: **NO**
Remarks: **M-606-090**

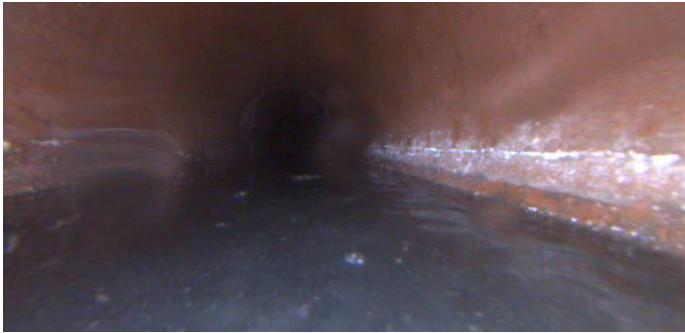
Code:	MWL
Description:	Water Level

Distance (ft):	.0
Structural Grade:	0
O&M Grade:	0
Clock Start/From:	
Clock To:	
1st Value:	
2nd Value:	
Value Percent:	40.000
Continuous Index:	
Within 8" of Joint:	NO
Remarks:

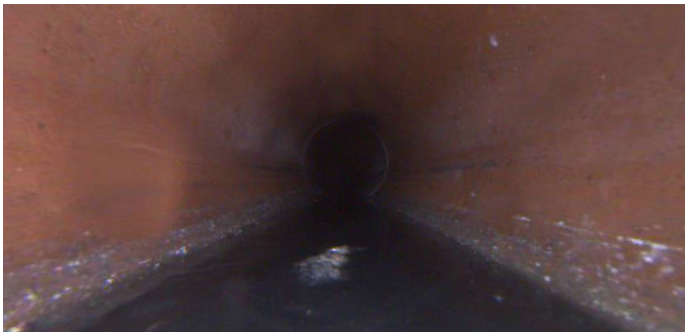
Code:	MSA
Description:	Abandoned Survey

Distance (ft):	5.3
Structural Grade:	0
O&M Grade:	0
Clock Start/From:	
Clock To:	
1st Value:	
2nd Value:	
Value Percent:	
Continuous Index:	
Within 8" of Joint:	NO
Remarks:	DEBRIS UNDER WATER
