Profile/Photo Observation Report

Street:	FOXCROFT STREET	Flow Control:	Not Controlled
City:	Hobart, IN	Year Renewed:	
Location:	Yard	Tape/Media #:	
Purpose:	Routine Assessment	Dia/Height:	10"
Use:	Sanitary	Material:	VCP
Drain Area:	NA	Lining:	
Category:	NA		
Comment:	F_S_P_C debris/sludge, flow direction is marked wrong.		
Location Details:		Direction of Survey:	Upstream
US MH:	M-606-089	DS MH:	M-606-090
		Total Length Surveyed (ft):	5.3

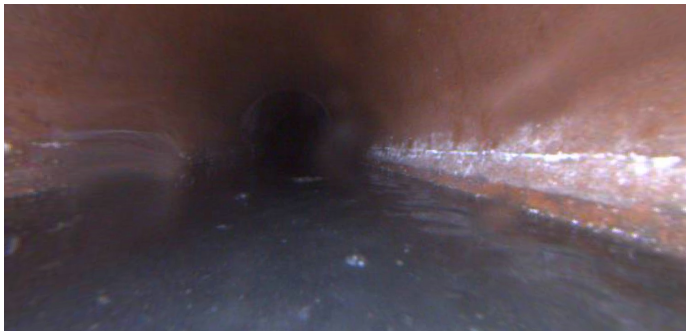
Code: **AMH**
Description: **Manhole**

Distance (ft): **.0**
Structural Grade: **0**
O&M Grade: **0**
Clock Start/From:
Clock To:
1st Value:
2nd Value:
Value Percent:
Continuous Index:
Within 8" of Joint: **NO**
Remarks: **M-606-090**

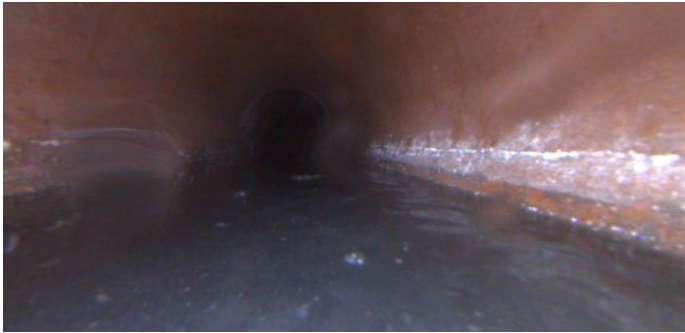
Code:	MWL
Description:	Water Level

Distance (ft):	.0
Structural Grade:	0
O&M Grade:	0
Clock Start/From:	
Clock To:	
1st Value:	
2nd Value:	
Value Percent:	40.000
Continuous Index:	
Within 8" of Joint:	NO
Remarks:

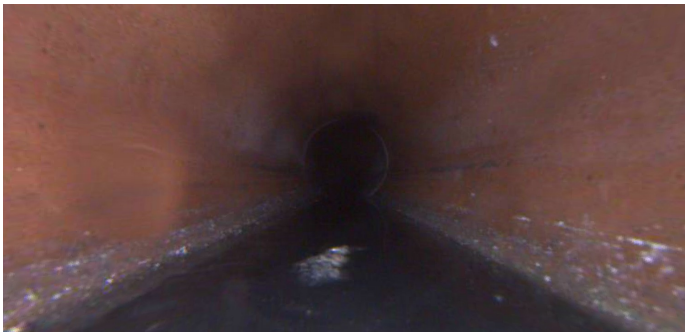
Code:	MSA
Description:	Abandoned Survey

Distance (ft):	5.3
Structural Grade:	0
O&M Grade:	0
Clock Start/From:	
Clock To:	
1st Value:	
2nd Value:	
Value Percent:	
Continuous Index:	
Within 8" of Joint:	NO
Remarks:	DEBRIS UNDER WATER
