Profile/Photo Observation Report

Street:	FOXCROFT STREET	Flow Control:	Not Controlled
City:	Hobart, IN	Year Renewed:	
Location:	Yard	Tape/Media #:	
Purpose:	Routine Assessment	Dia/Height:	10"
Use:	Sanitary	Material:	VCP
Drain Area:	NA	Lining:	
Category:	NA		
Comment:

Location Details:		Direction of Survey:	Upstream
US MH:	M-606-091	DS MH:	M-606-090
		Total Length Surveyed (ft):	38.9

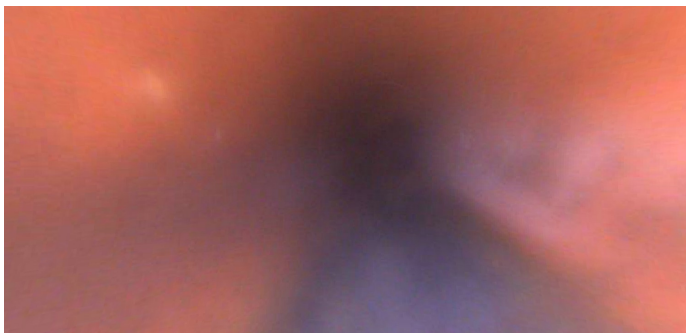
Code: **AMH**
Description: **Manhole**

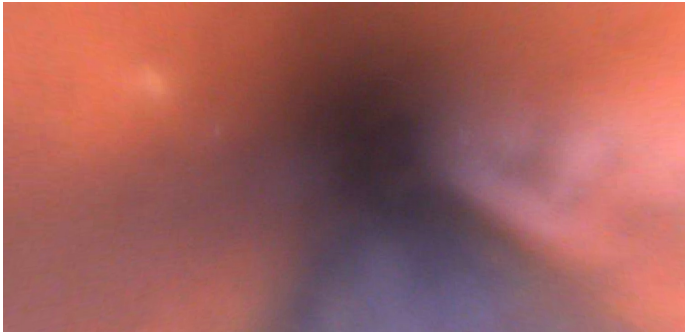
Code:	MWL
Description:	Water Level

Distance (ft):	.0
Structural Grade:	0
O&M Grade:	0
Clock Start/From:	
Clock To:	
1st Value:	
2nd Value:	
Value Percent:	5.000
Continuous Index:	
Within 8" of Joint:	NO
Remarks:

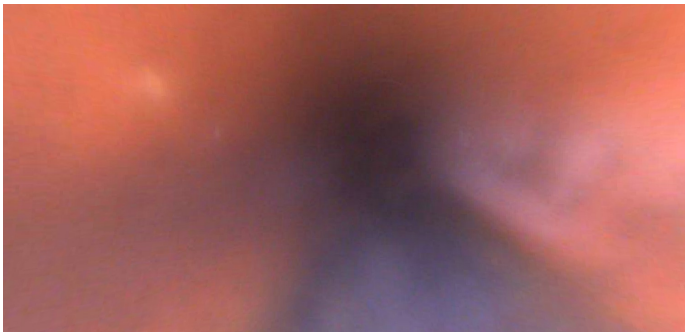
Code:	MGO
Description:	General Observation

Distance (ft):	.0
Structural Grade:	0
O&M Grade:	0
Clock Start/From:	
Clock To:	
1st Value:	
2nd Value:	
Value Percent:	
Continuous Index:	
Within 8" of Joint:	NO
Remarks:	lense foggy

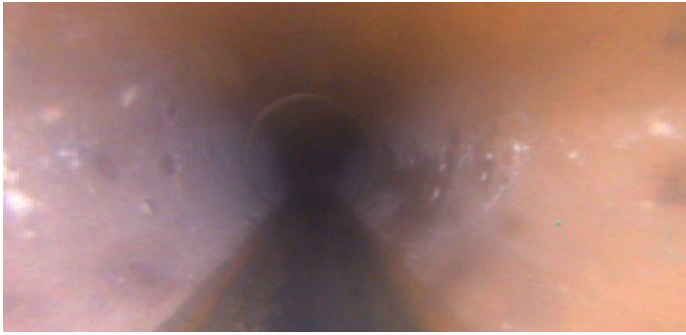
Code: **MGO**
Description: **General Observation**

Distance (ft): **12.8**
Structural Grade: **0**
O&M Grade: **0**
Clock Start/From:
Clock To:
1st Value:
2nd Value:
Value Percent:
Continuous Index:
Within 8" of Joint: **NO**
Remarks: **rear camera/fog**

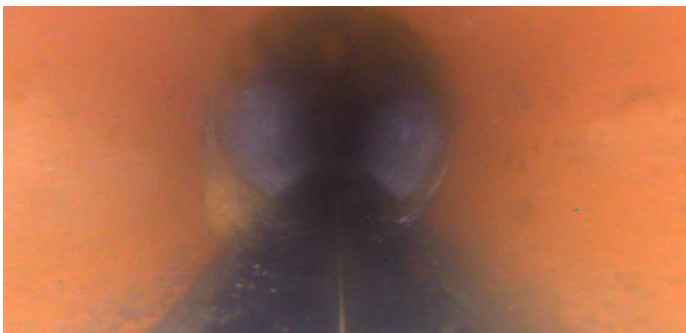
Code: **DAE**
Description: **Deposits Attached Encrustation**

Distance (ft): **15.8**
Structural Grade: **0**
O&M Grade: **2**
Clock Start/From: **3**
Clock To: **5**
1st Value:
2nd Value:
Value Percent: **5.000**
Continuous Index:
Within 8" of Joint: **YES**
Remarks:

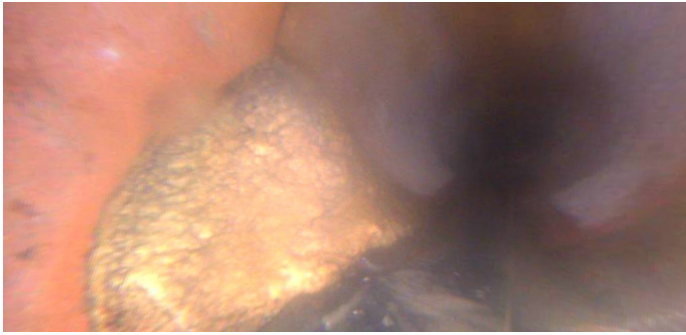
Code: **DAE**
Description: **Deposits Attached Encrustation**

Distance (ft): **31.3**
Structural Grade: **0**
O&M Grade: **2**
Clock Start/From: **7**
Clock To: **5**
1st Value:
2nd Value:
Value Percent: **10.000**
Continuous Index:
Within 8" of Joint: **YES**
Remarks:

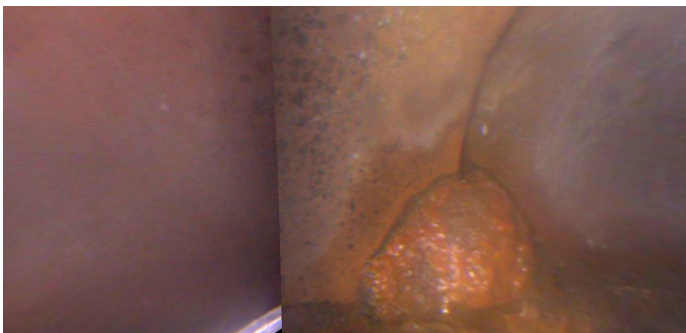
Code: **DAE**
Description: **Deposits Attached Encrustation**

Distance (ft): **35.2**
Structural Grade: **0**
O&M Grade: **2**
Clock Start/From: **5**
Clock To:
1st Value:
2nd Value:
Value Percent: **5.000**
Continuous Index:
Within 8" of Joint: **YES**
Remarks:

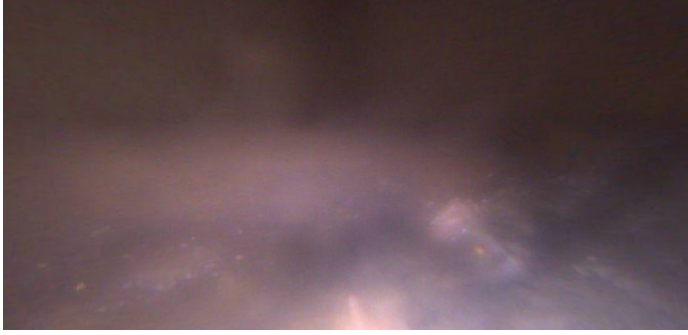
Code:	AMH
Description:	Manhole
Distance (ft):	38.9
Structural Grade:	0
O&M Grade:	0
Clock Start/From:	
Clock To:	
1st Value:	
2nd Value:	
Value Percent:	
Continuous Index:	
Within 8" of Joint:	NO
Remarks:	M-606-091
