Profile/Photo Observation Report

Date:	04/07/2018	Weather:		Coding:	PACP 6.0
Pipe Length (ft):	167.4	Owner:	NA	Pre Clean:	No Pre-Cleaning
P.O.#:		Surveyor:	Jen Costello	PSR:	P-606-095-093
Customer:		Clean Date:	01/01/1900	Shape:	C

Street:	N LAKE SHORE DR	Flow Control:	Not Controlled
City:	Hobart, IN	Year Renewed:	
Location:	Yard	Tape/Media #:	
Purpose:	Routine Assessment	Dia/Height:	10"
Use:	Sanitary	Material:	VCP
Drain Area:	NA	Lining:	
Category:	NA		
Comment:	P_C obstruction, flow direction is marked wrong.		
Location Details:		Direction of Survey:	Upstream
US MH:	M-606-093	DS MH:	M-606-095
		Total Length Surveyed (ft):	22.6

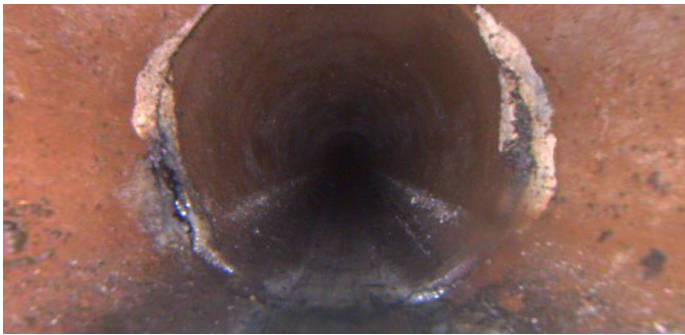
Code:	DAE
Description:	Deposits Attached Encrustation

Distance (ft):	5.5
Structural Grade:	0
O&M Grade:	2
Clock Start/From:	8
Clock To:	4
1st Value:	
2nd Value:	
Value Percent:	5.000
Continuous Index:	
Within 8" of Joint:	YES
Remarks:

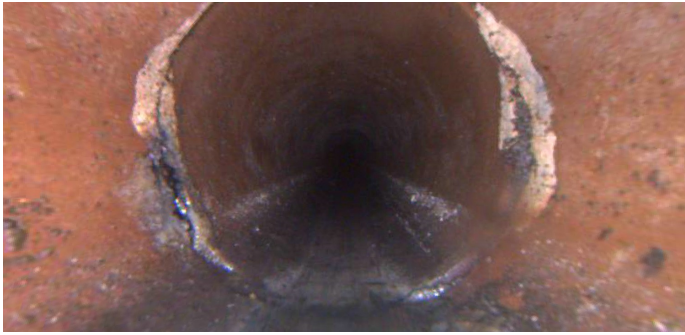
Code: **IW**
Description: **Infil Weeper**

Distance (ft): **5.5**
Structural Grade: **0**
O&M Grade: **2**
Clock Start/From: **8**
Clock To: **4**
1st Value:
2nd Value:
Value Percent:
Continuous Index:
Within 8" of Joint: **YES**
Remarks:

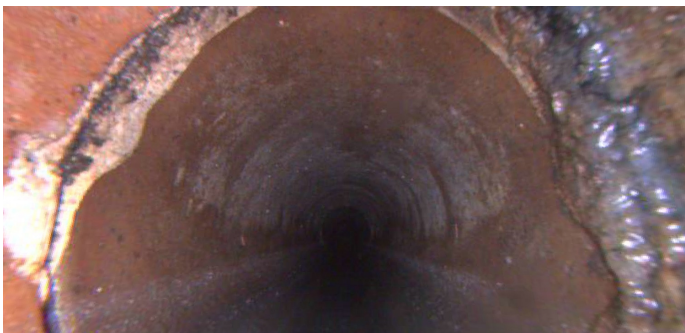
Code: **DAGS**
Description: **Deposits Attached Grease**

Distance (ft): **9.6**
Structural Grade: **0**
O&M Grade: **2**
Clock Start/From: **8**
Clock To: **4**
1st Value:
2nd Value:
Value Percent: **5.000**
Continuous Index:
Within 8" of Joint: **YES**
Remarks:

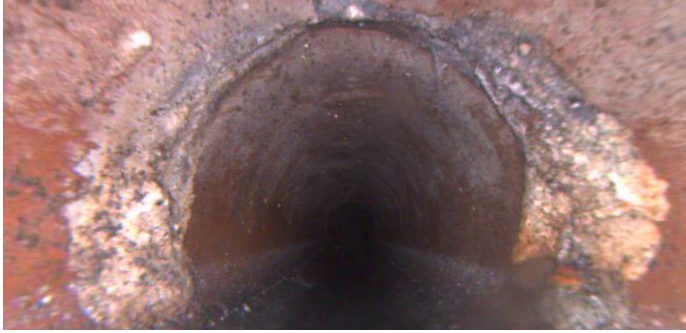
Code: **DAE**
Description: **Deposits Attached Encrustation**

Distance (ft): **13.4**
Structural Grade: **0**
O&M Grade: **2**
Clock Start/From: **8**
Clock To: **4**
1st Value:
2nd Value:
Value Percent: **5.000**
Continuous Index:
Within 8" of Joint: **YES**
Remarks:

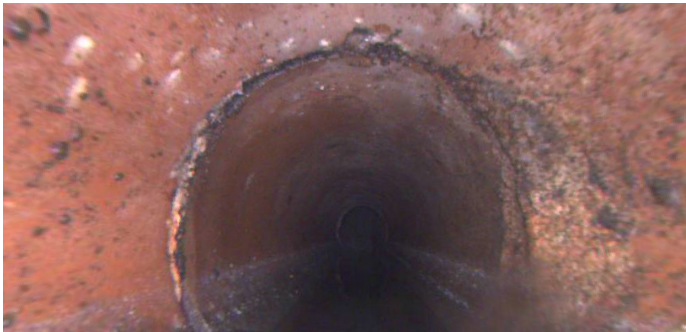
Code: **DAE**
Description: **Deposits Attached Encrustation**

Distance (ft): **17.2**
Structural Grade: **0**
O&M Grade: **2**
Clock Start/From: **8**
Clock To: **4**
1st Value:
2nd Value:
Value Percent: **5.000**
Continuous Index:
Within 8" of Joint: **YES**
Remarks:

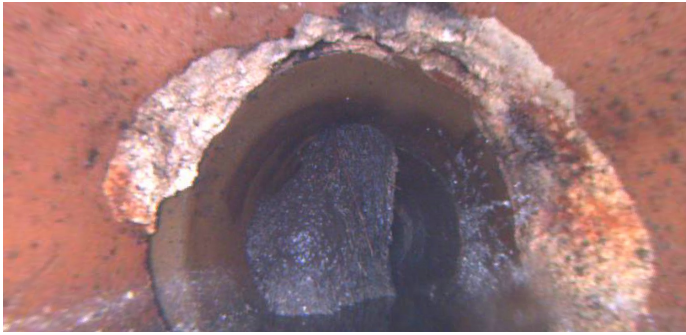
Code: **DAE**
Description: **Deposits Attached Encrustation**

Distance (ft): **21.3**
Structural Grade: **0**
O&M Grade: **2**
Clock Start/From: **8**
Clock To: **4**
1st Value:
2nd Value:
Value Percent: **5.000**
Continuous Index:
Within 8" of Joint: **YES**
Remarks:

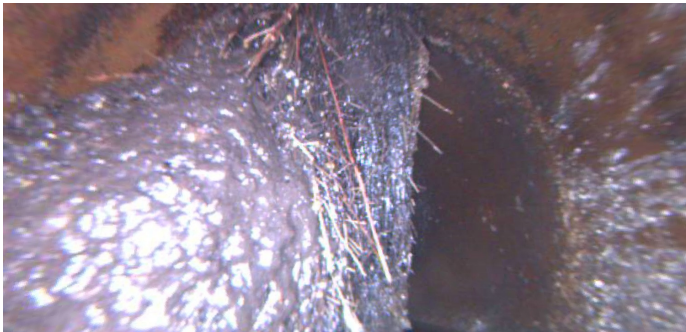
Code: **RBJ**
Description: **Roots Ball Joint**

Distance (ft): **22.0**
Structural Grade: **0**
O&M Grade: **4**
Clock Start/From: **6**
Clock To: **5**
1st Value:
2nd Value:
Value Percent: **60.000**
Continuous Index:
Within 8" of Joint: **YES**
Remarks:

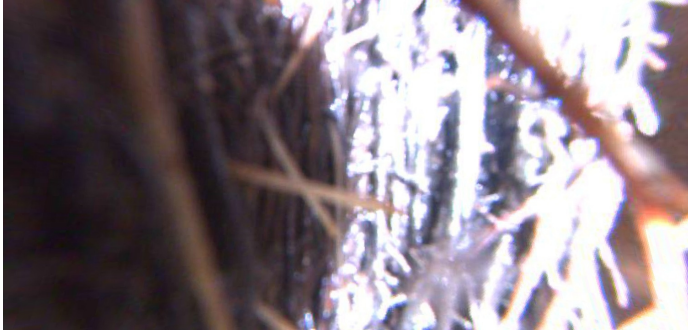
Code:	MSA
Description:	Abandoned Survey
Distance (ft):	22.6
Structural Grade:	0
O&M Grade:	0
Clock Start/From:	
Clock To:	
1st Value:	
2nd Value:	
Value Percent:	
Continuous Index:	
Within 8" of Joint:	NO
Remarks:	rbj
