Profile/Photo Observation Report

Date:	04/07/2018	Weather:		Coding:	PACP 6.0
Pipe Length (ft):	167.4	Owner:	NA	Pre Clean:	No Pre-Cleaning
P.O.#:		Surveyor:	Jen Costello	PSR:	P-606-095-093
Customer:		Clean Date:	01/01/1900	Shape:	C

Street:	FOXCROFT STREET	Flow Control:	Not Controlled
City:	Hobart, IN	Year Renewed:	
Location:	Yard	Tape/Media #:	
Purpose:	Routine Assessment	Dia/Height:	10"
Use:	Sanitary	Material:	VCP
Drain Area:	NA	Lining:	
Category:	NA		
Comment:	P_C obstruction, flow direction is marked wrong.		
Location Details:		Direction of Survey:	Upstream
US MH:	M-606-093	DS MH:	M-606-095
		Total Length Surveyed (ft):	22.6

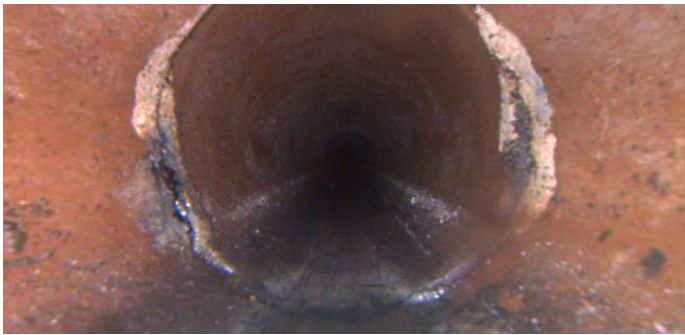
Code:	DAE
Description:	Deposits Attached Encrustation

Distance (ft):	5.5
Structural Grade:	0
O&M Grade:	2
Clock Start/From:	8
Clock To:	4
1st Value:	
2nd Value:	
Value Percent:	5.000
Continuous Index:	
Within 8" of Joint:	YES
Remarks:

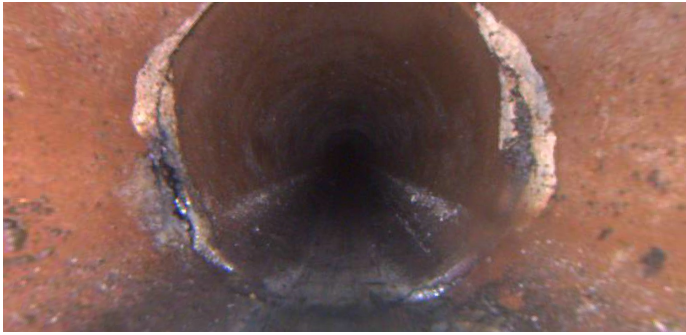
Code: **IW**
Description: **Infil Weeper**

Distance (ft): **5.5**
Structural Grade: **0**
O&M Grade: **2**
Clock Start/From: **8**
Clock To: **4**
1st Value:
2nd Value:
Value Percent:
Continuous Index:
Within 8" of Joint: **YES**
Remarks:

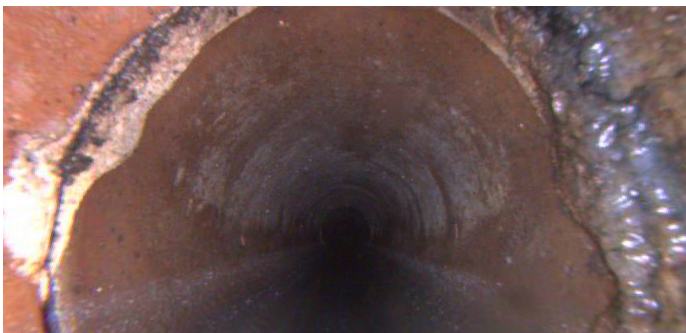
Code: **DAGS**
Description: **Deposits Attached Grease**

Distance (ft): **9.6**
Structural Grade: **0**
O&M Grade: **2**
Clock Start/From: **8**
Clock To: **4**
1st Value:
2nd Value:
Value Percent: **5.000**
Continuous Index:
Within 8" of Joint: **YES**
Remarks:

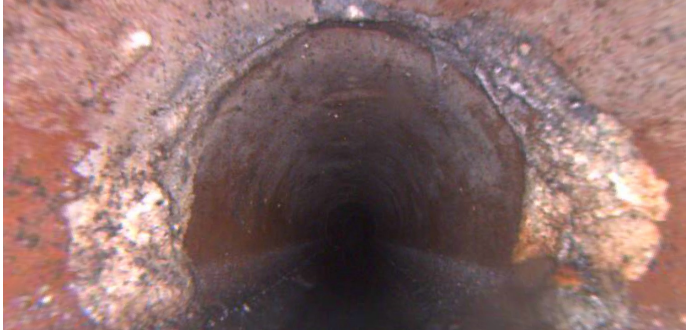
Code: **DAE**
Description: **Deposits Attached Encrustation**

Distance (ft): **13.4**
Structural Grade: **0**
O&M Grade: **2**
Clock Start/From: **8**
Clock To: **4**
1st Value:
2nd Value:
Value Percent: **5.000**
Continuous Index:
Within 8" of Joint: **YES**
Remarks:

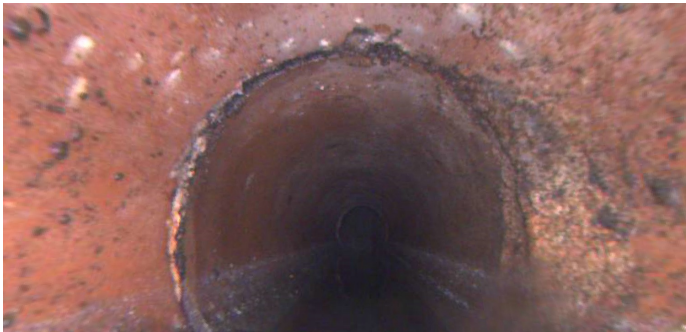
Code: **DAE**
Description: **Deposits Attached Encrustation**

Distance (ft): **17.2**
Structural Grade: **0**
O&M Grade: **2**
Clock Start/From: **8**
Clock To: **4**
1st Value:
2nd Value:
Value Percent: **5.000**
Continuous Index:
Within 8" of Joint: **YES**
Remarks:

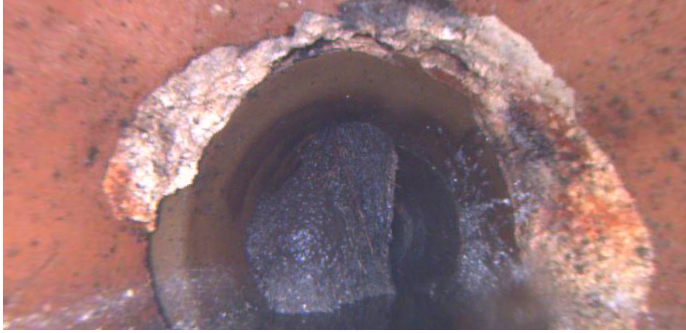
Code: **DAE**
Description: **Deposits Attached Encrustation**

Distance (ft): **21.3**
Structural Grade: **0**
O&M Grade: **2**
Clock Start/From: **8**
Clock To: **4**
1st Value:
2nd Value:
Value Percent: **5.000**
Continuous Index:
Within 8" of Joint: **YES**
Remarks:

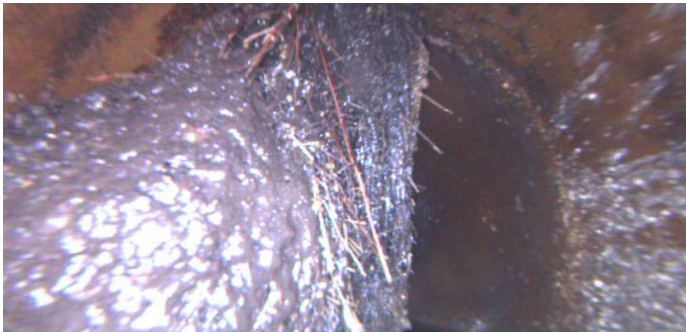
Code: **RBJ**
Description: **Roots Ball Joint**

Distance (ft): **22.0**
Structural Grade: **0**
O&M Grade: **4**
Clock Start/From: **6**
Clock To: **5**
1st Value:
2nd Value:
Value Percent: **60.000**
Continuous Index:
Within 8" of Joint: **YES**
Remarks:

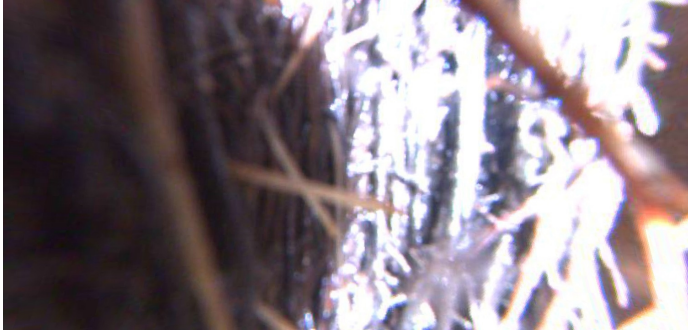
Code:	MSA
Description:	Abandoned Survey
Distance (ft):	22.6
Structural Grade:	0
O&M Grade:	0
Clock Start/From:	
Clock To:	
1st Value:	
2nd Value:	
Value Percent:	
Continuous Index:	
Within 8" of Joint:	NO
Remarks:	rbj
