Profile/Photo Observation Report

Street:	N LAKE SHORE DR	Flow Control:	Not Controlled
City:	Hobart, IN	Year Renewed:	
Location:	Yard	Tape/Media #:	
Purpose:	Routine Assessment	Dia/Height:	10"
Use:	Sanitary	Material:	VCP
Drain Area:	NA	Lining:	
Category:	NA		
Comment:	P_C 150lf rock.		
Location Details:		Direction of Survey:	Upstream
US MH:	M-606-094	DS MH:	M-606-090
		Total Length Surveyed (ft):	151.4

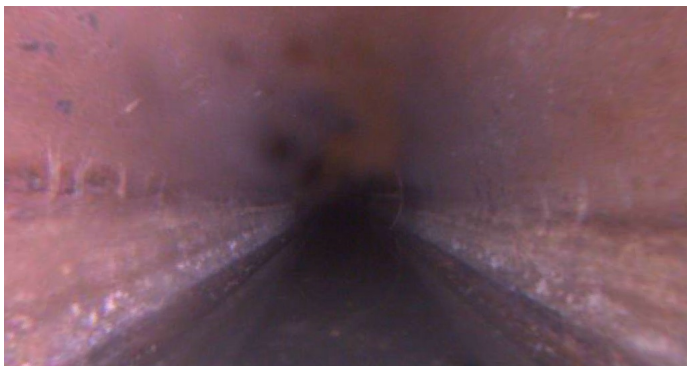
Code: **AMH**
 Description: **Manhole**

Distance (ft): **.0**
 Structural Grade: **0**
 O&M Grade: **0**
 Clock Start/From:
 Clock To:
 1st Value:
 2nd Value:
 Value Percent:
 Continuous Index:
 Within 8" of Joint: **NO**
 Remarks: **M-606-090**

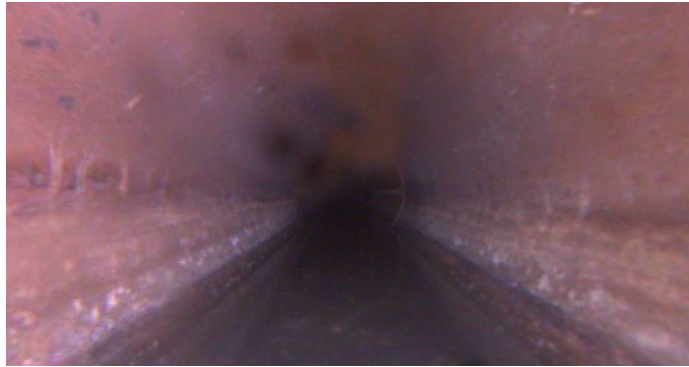
Code:	MWL
Description:	Water Level
Distance (ft):	.0
Structural Grade:	0
O&M Grade:	0
Clock Start/From:	
Clock To:	
1st Value:	
2nd Value:	
Value Percent:	10.000
Continuous Index:	
Within 8" of Joint:	NO
Remarks:

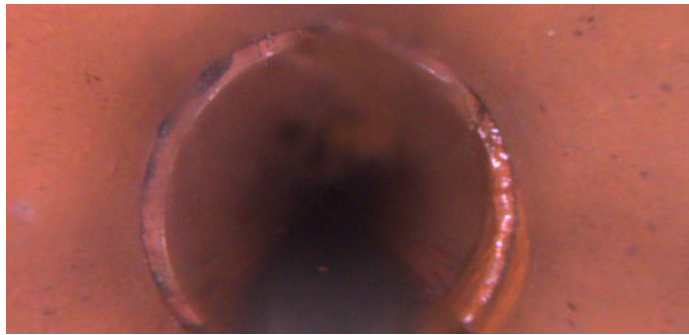
Code:	IW
Description:	Infil Weeper
Distance (ft):	38.6
Structural Grade:	0
O&M Grade:	2
Clock Start/From:	2
Clock To:	4
1st Value:	
2nd Value:	
Value Percent:	
Continuous Index:	
Within 8" of Joint:	YES
Remarks:

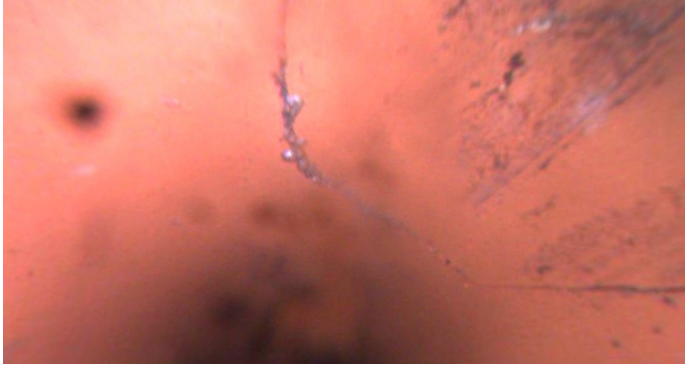
Code: **FM**
Description: **Fracture Multiple**

Distance (ft): **51.2**
Structural Grade: **4**
O&M Grade: **0**
Clock Start/From: **12**
Clock To: **3**
1st Value:
2nd Value:
Value Percent:
Continuous Index:
Within 8" of Joint: **YES**
Remarks:

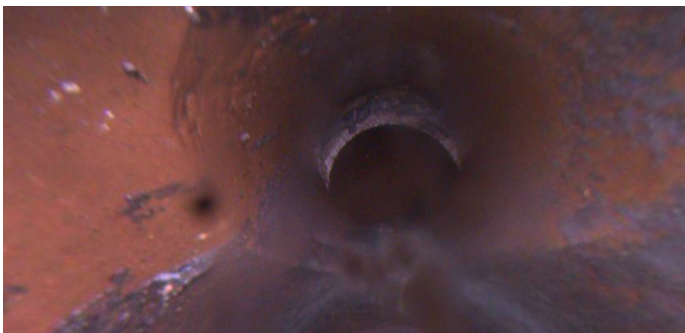
Code: **TF**
Description: **Tap Factory**

Distance (ft): **68.0**
Structural Grade: **0**
O&M Grade: **0**
Clock Start/From: **12**
Clock To:
1st Value: **4.000**
2nd Value:
Value Percent:
Continuous Index:
Within 8" of Joint:
Remarks:

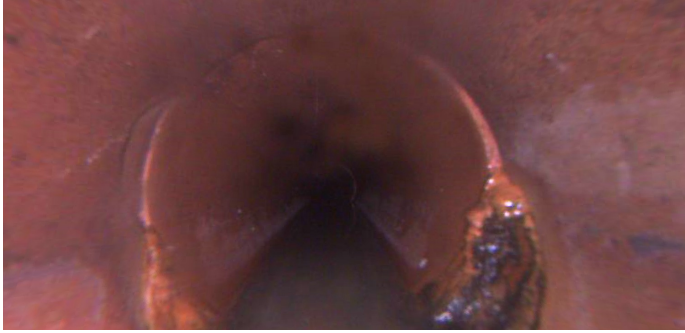
Code: **IW**
Description: **Infil Weeper**

Distance (ft): **112.4**
Structural Grade: **0**
O&M Grade: **2**
Clock Start/From: **8**
Clock To: **4**
1st Value:
2nd Value:
Value Percent:
Continuous Index:
Within 8" of Joint: **YES**
Remarks:

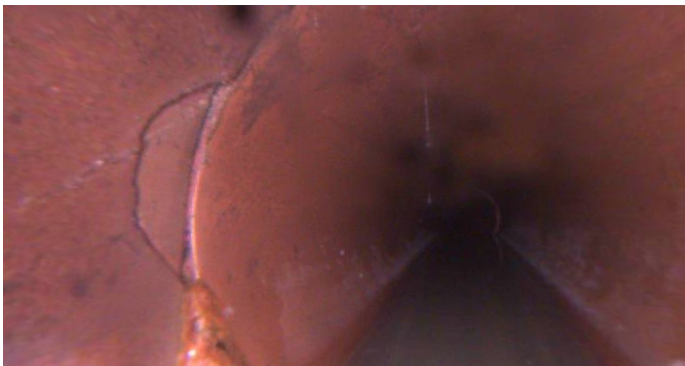
Code: **FS**
Description: **Fracture Spiral**

Distance (ft): **112.7**
Structural Grade: **3**
O&M Grade: **0**
Clock Start/From: **8**
Clock To: **9**
1st Value:
2nd Value:
Value Percent:
Continuous Index:
Within 8" of Joint: **YES**
Remarks:

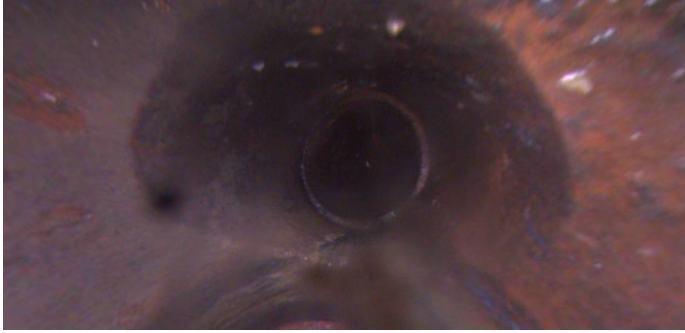
Code: **TF**
Description: **Tap Factory**

Distance (ft): **129.7**
Structural Grade: **0**
O&M Grade: **0**
Clock Start/From: **12**
Clock To:
1st Value: **4.000**
2nd Value:
Value Percent:
Continuous Index:
Within 8" of Joint:
Remarks:

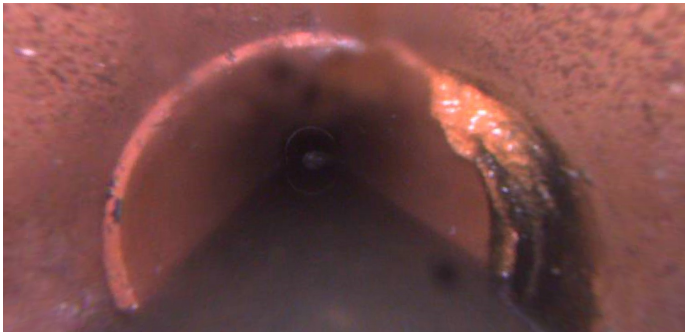
Code: **IW**
Description: **Infil Weeper**

Distance (ft): **142.5**
Structural Grade: **0**
O&M Grade: **2**
Clock Start/From: **1**
Clock To: **4**
1st Value:
2nd Value:
Value Percent:
Continuous Index:
Within 8" of Joint: **YES**
Remarks:

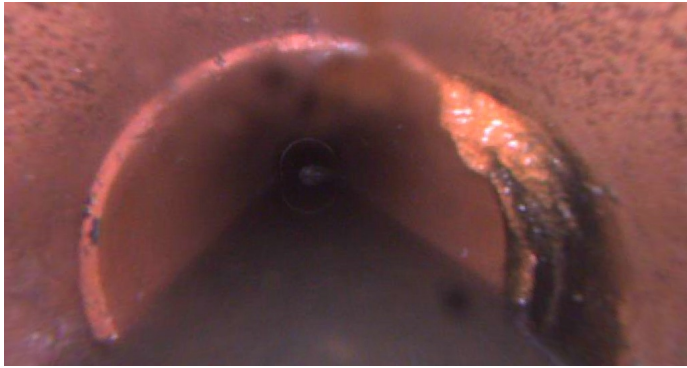
Code:	DAGS
Description:	Deposits Attached Grease
Distance (ft):	142.5
Structural Grade:	0
O&M Grade:	2
Clock Start/From:	1
Clock To:	5
1st Value:	
2nd Value:	
Value Percent:	5.000
Continuous Index:	
Within 8" of Joint:	YES
Remarks:

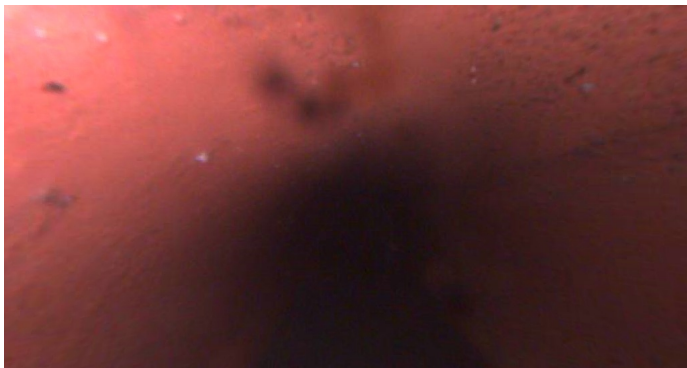
Code:	MSA
Description:	Abandoned Survey
Distance (ft):	151.4
Structural Grade:	0
O&M Grade:	0
Clock Start/From:	
Clock To:	
1st Value:	
2nd Value:	
Value Percent:	
Continuous Index:	
Within 8" of Joint:	NO
Remarks:	Debris
