Profile/Photo Observation Report

| Street: | N LAKE SHORE DR | Flow Control: | Not Controlled |

| US MH: | M-606-094 | DS MH: | M-606-090 |

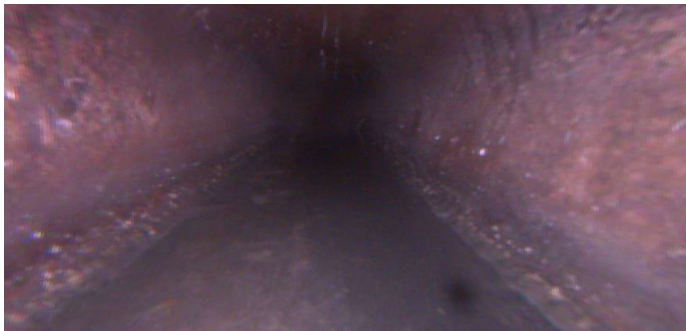
Code: **AMH**
Description: **Manhole**

Distance (ft): **.0**
Structural Grade: **0**
O&M Grade: **0**
Clock Start/From:
Clock To:
1st Value:
2nd Value:
Value Percent:
Continuous Index:
Within 8" of Joint: **NO**
Remarks: **M-606-094**

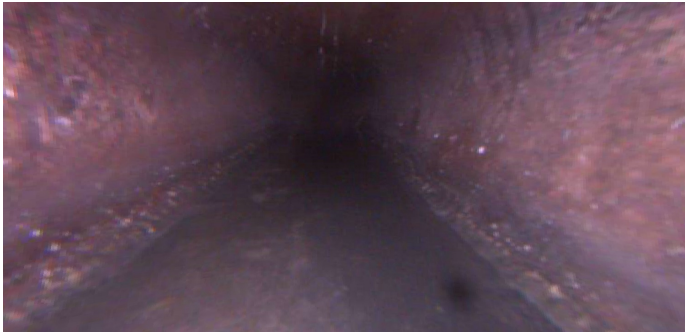
| Code: | MWL |
| Description: | Water Level |

| Value Percent: | 5.000 |

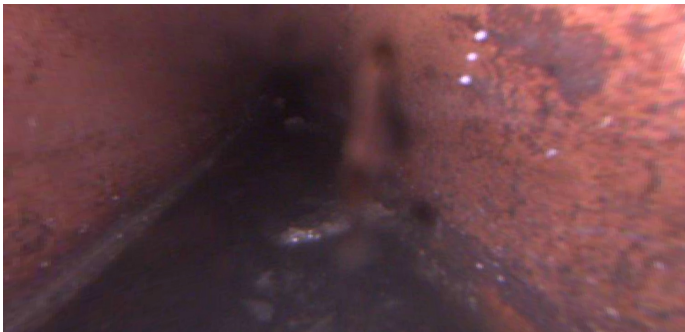
| Code: | DSZ |
| Description: | Deposits Settled Other |

| Distance (ft): | 21.2 |
| O&M Grade: | 2 |
| Clock Start/From: | 6 |
| Remarks: | tissue |

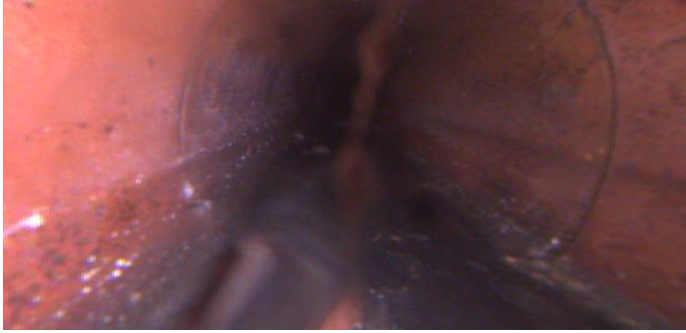
Code: **MSA**
Description: **Abandoned Survey**

Distance (ft): **28.0**
Structural Grade: **0**
O&M Grade: **0**
Clock Start/From:
Clock To:
1st Value:
2nd Value:
Value Percent:
Continuous Index:
Within 8" of Joint: **NO**
Remarks: **debris under water**

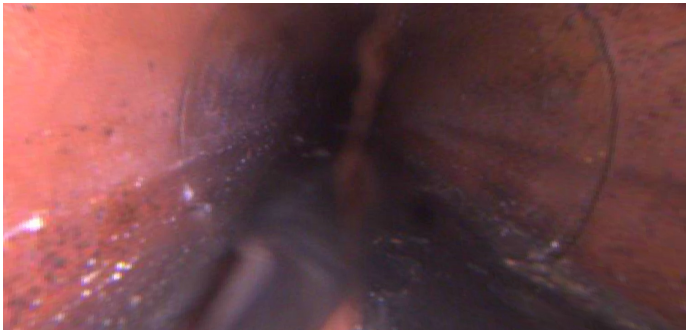
Code: **DSZ**
Description: **Deposits Settled Other**

Distance (ft): **28.0**
Structural Grade: **0**
O&M Grade: **2**
Clock Start/From: **6**
Clock To:
1st Value:
2nd Value:
Value Percent: **5.000**
Continuous Index: **F01**
Within 8" of Joint: **NO**
Remarks: **tissue**
