Profile/Photo Observation Report

Date:	01/30/2022	Weather:		Coding:	PACP 7.0
Pipe Length (ft):	235.3	Owner:	City of Hobart	Pre Clean:	Heavy Cleaning
P.O.#:	YES502259	Surveyor:	S. Bucklin	PSR:	P-606-094-090
Customer:	City of Hobart	Clean Date:	01/30/2022	Shape:	C

Street:	North Lake Shore Drive	Flow Control:	Not Controlled
City:	Hobart, IN	Year Renewed:	
Location:	Local rural streets with light traffic, t	Tape/Media #:	
Purpose:	Routine Assessment	Dia/Height:	10"
Use:	Sanitary Sewage Pipe	Material:	VCP
Drain Area:		Lining:	None
Category:	NA		
Comment:			
Location Details:		Direction of Survey:	Upstream
US MH:	M-606-094	DS MH:	M-606-090
		Total Length Surveyed (ft):	235.3

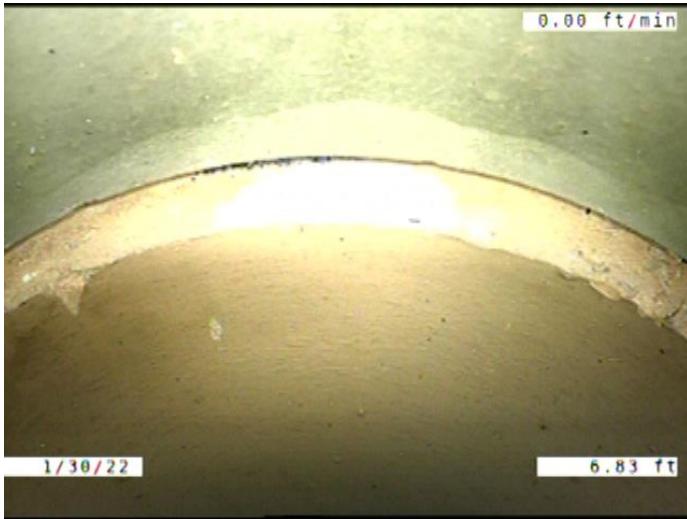
Code: **JOM**
Description: **Joint Offset Medium**

Distance (ft): **6.8**
Structural Grade: **3**
O&M Grade: **0**
Clock Start/From:
Clock To:
1st Value:
2nd Value:
Value Percent:
Continuous Index:
Within 8" of Joint: **NO**
Remarks:

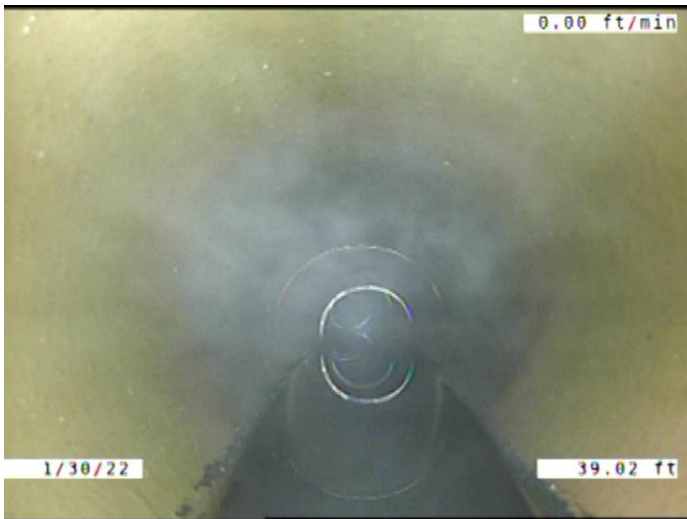
Code: **MWLS**
Description: **Miscellaneous Water Level Sag**

Distance (ft): **39.0**
Structural Grade: **2**
O&M Grade: **0**
Clock Start/From:
Clock To:
1st Value:
2nd Value:
Value Percent: **15.000**
Continuous Index: **S01**
Within 8" of Joint: **NO**
Remarks:

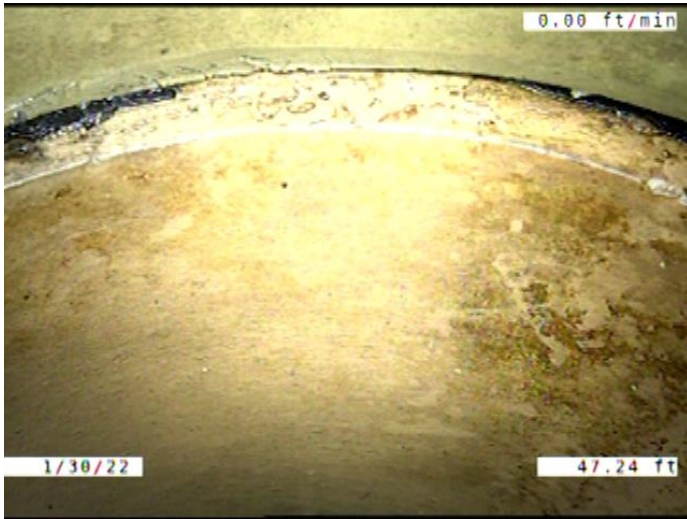
Code: **JOM**
Description: **Joint Offset Medium**

Distance (ft): **47.2**
Structural Grade: **3**
O&M Grade: **0**
Clock Start/From:
Clock To:
1st Value:
2nd Value:
Value Percent:
Continuous Index:
Within 8" of Joint: **NO**
Remarks:

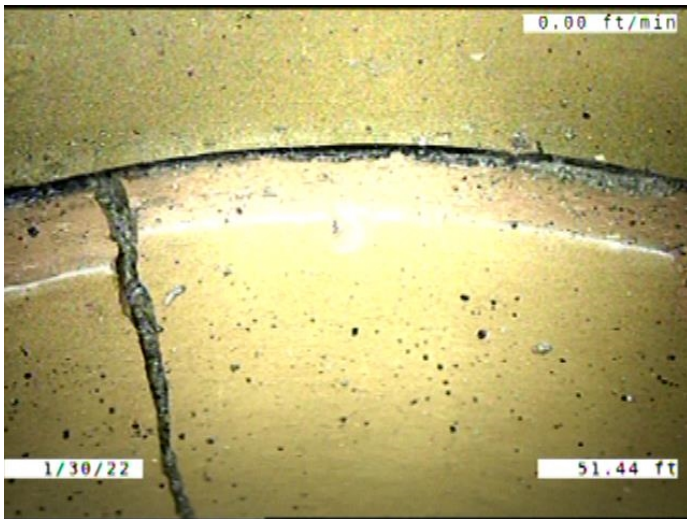
Code: **JOM**
Description: **Joint Offset Medium**

Distance (ft): **51.4**
Structural Grade: **3**
O&M Grade: **0**
Clock Start/From:
Clock To:
1st Value:
2nd Value:
Value Percent:
Continuous Index:
Within 8" of Joint: **NO**
Remarks:

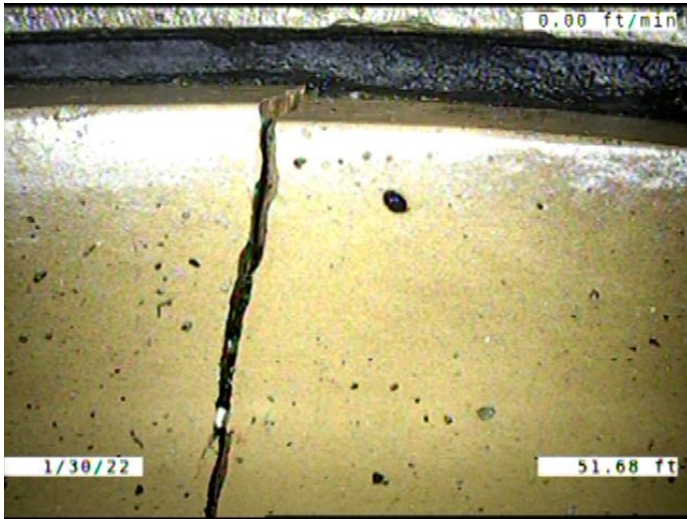
Code: **B**
Description: **Broken**

Distance (ft): **51.7**
Structural Grade: **4**
O&M Grade: **0**
Clock Start/From: **11**
Clock To: **2**
1st Value:
2nd Value:
Value Percent:
Continuous Index:
Within 8" of Joint: **YES**
Remarks:

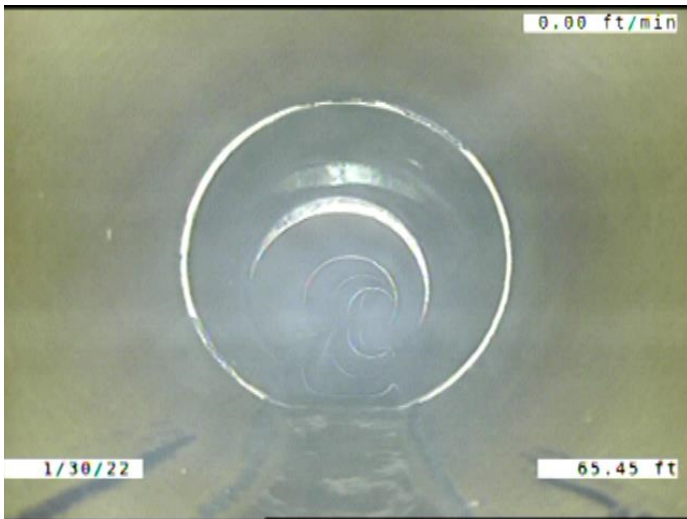
Code: **MWLS**
Description: **Miscellaneous Water Level Sag**

Distance (ft): **65.4**
Structural Grade: **2**
O&M Grade: **0**
Clock Start/From:
Clock To:
1st Value:
2nd Value:
Value Percent: **15.000**
Continuous Index: **F01**
Within 8" of Joint: **NO**
Remarks:

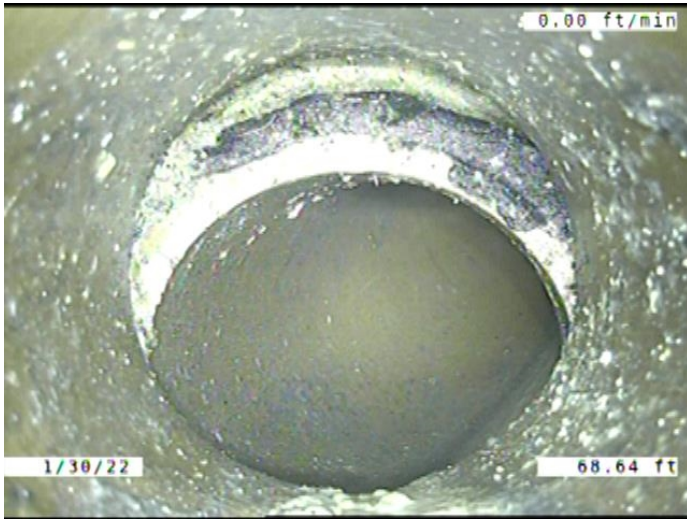
Code: **TF**
Description: **Tap Factory**

Distance (ft): **68.6**
Structural Grade: **0**
O&M Grade: **0**
Clock Start/From: **12**
Clock To:
1st Value: **4.000**
2nd Value:
Value Percent:
Continuous Index:
Within 8" of Joint: **YES**

Remarks: **MAIN TO SERVICE CONNECTION
LARGE OFFSET. SOIL VISIBLE.**

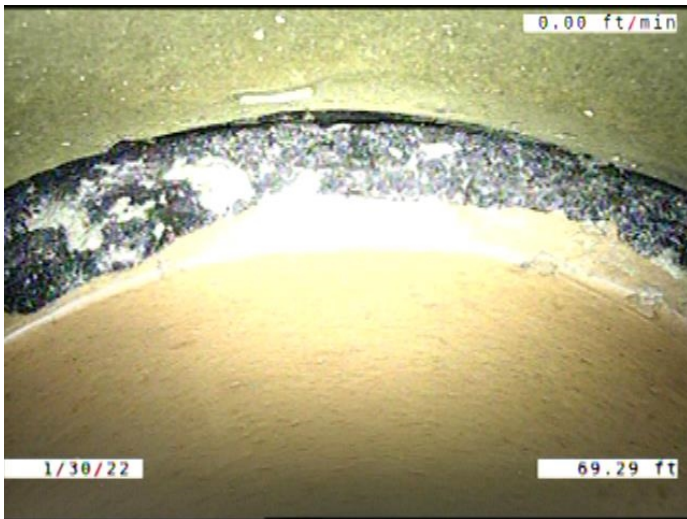
Code: **JOM**
Description: **Joint Offset Medium**

Distance (ft): **69.3**
Structural Grade: **3**
O&M Grade: **0**
Clock Start/From:
Clock To:
1st Value:
2nd Value:
Value Percent:
Continuous Index:
Within 8" of Joint: **NO**

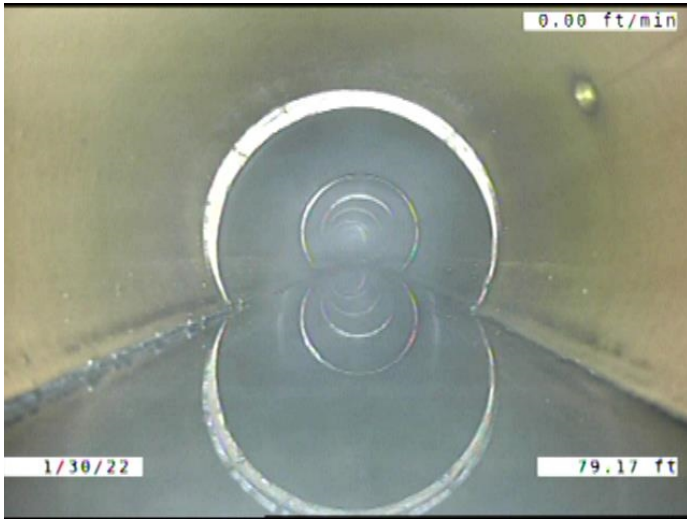
Code: **MWLS**
Description: **Miscellaneous Water Level Sag**

Distance (ft): **79.2**
Structural Grade: **2**
O&M Grade: **0**
Clock Start/From:
Clock To:
1st Value:
2nd Value:
Value Percent: **10.000**
Continuous Index: **S02**
Within 8" of Joint: **NO**
Remarks:

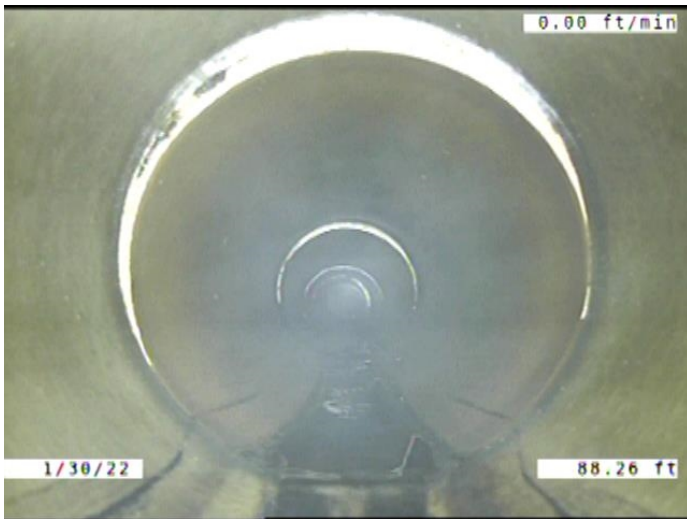
Code: **MWLS**
Description: **Miscellaneous Water Level Sag**

Distance (ft): **88.3**
Structural Grade: **2**
O&M Grade: **0**
Clock Start/From:
Clock To:
1st Value:
2nd Value:
Value Percent: **10.000**
Continuous Index: **F02**
Within 8" of Joint: **NO**
Remarks:

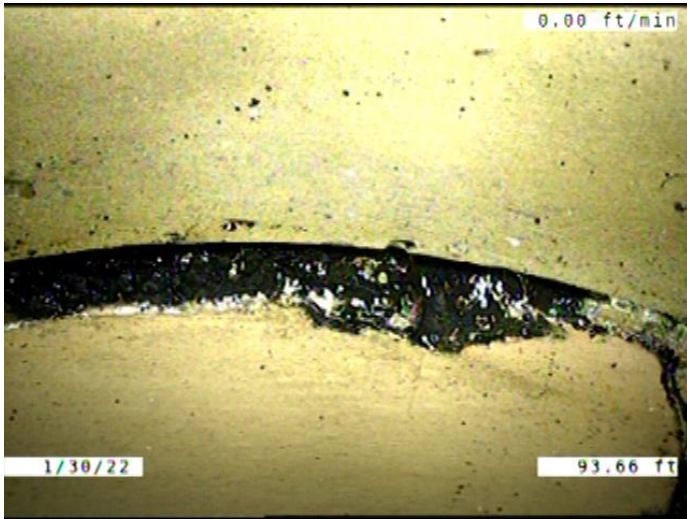
Code: **DAE**
 Description: **Deposits Attached Encrustation**

Distance (ft): **93.7**
 Structural Grade: **0**
 O&M Grade: **2**
 Clock Start/From: **4**
 Clock To: **5**
 1st Value:
 2nd Value:
 Value Percent: **5.000**
 Continuous Index:
 Within 8" of Joint: **YES**
 Remarks:

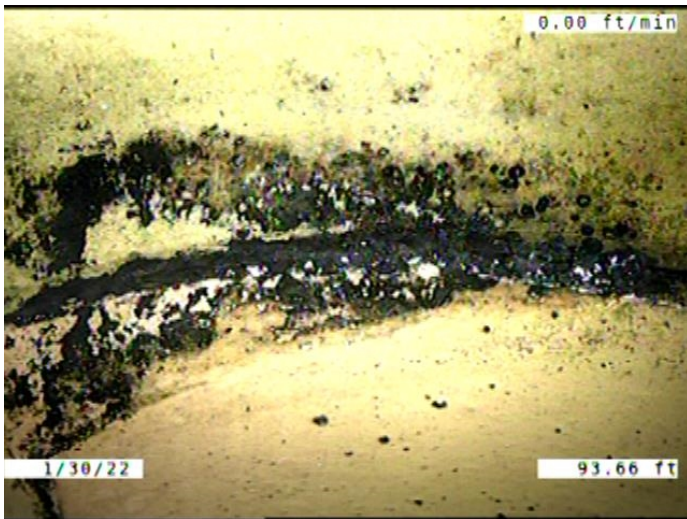
Code: **DAE**
 Description: **Deposits Attached Encrustation**

Distance (ft): **93.7**
 Structural Grade: **0**
 O&M Grade: **2**
 Clock Start/From: **7**
 Clock To: **11**
 1st Value:
 2nd Value:
 Value Percent: **5.000**
 Continuous Index:
 Within 8" of Joint: **YES**
 Remarks:

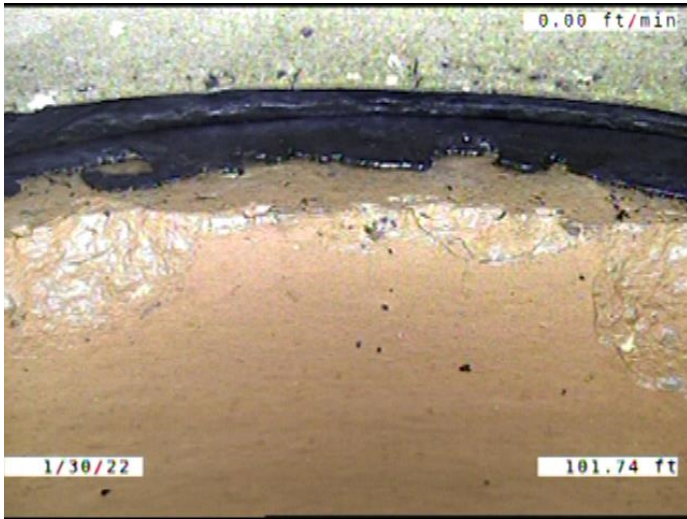
Code: **SZ**
 Description: **Surface Damage Other**

Distance (ft): **101.7**
 Structural Grade: **0**
 O&M Grade: **0**
 Clock Start/From: **11**
 Clock To: **3**

Within 8" of Joint: **YES**
 Remarks: **SEVERAL PIECES CHIPPED AWAY FROM THE JOINT**

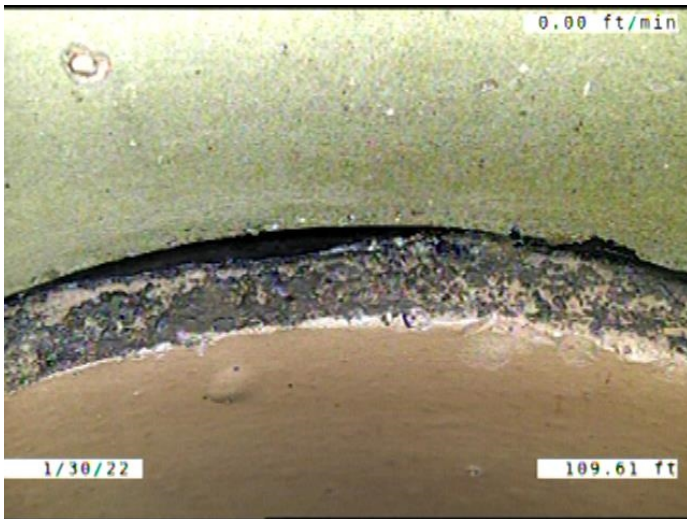
Code: **JOM**
 Description: **Joint Offset Medium**

Distance (ft): **109.6**
 Structural Grade: **3**
 O&M Grade: **0**
 Clock Start/From:
 Clock To:

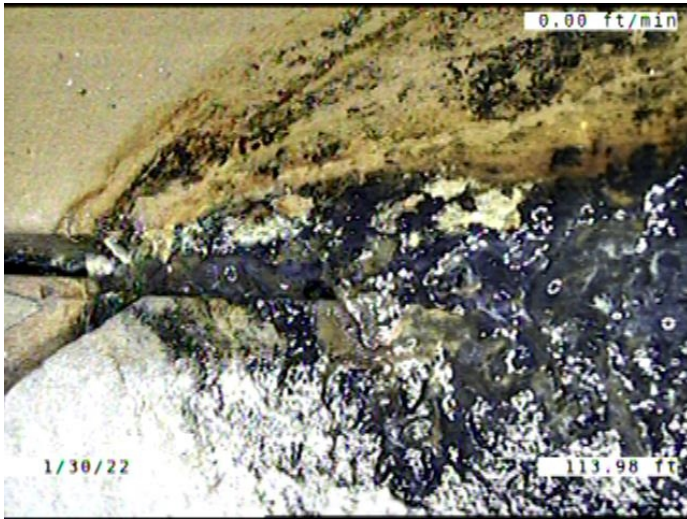
Code: **DAE**
 Description: **Deposits Attached Encrustation**

Distance (ft): **114.0**
 Structural Grade: **0**
 O&M Grade: **2**
 Clock Start/From: **3**
 Clock To: **9**
 1st Value:
 2nd Value:
 Value Percent: **5.000**
 Continuous Index:
 Within 8" of Joint: **YES**
 Remarks:

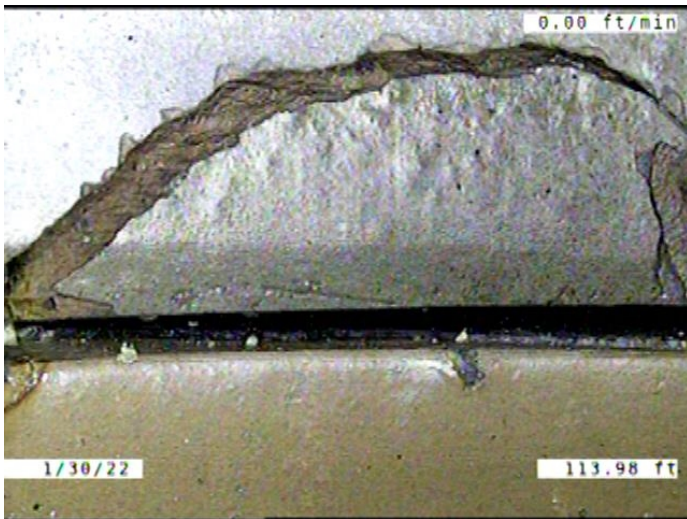
Code: **B**
 Description: **Broken**

Distance (ft): **114.0**
 Structural Grade: **4**
 O&M Grade: **0**
 Clock Start/From: **9**
 Clock To: **10**
 1st Value:
 2nd Value:
 Value Percent:
 Continuous Index:
 Within 8" of Joint: **YES**
 Remarks:

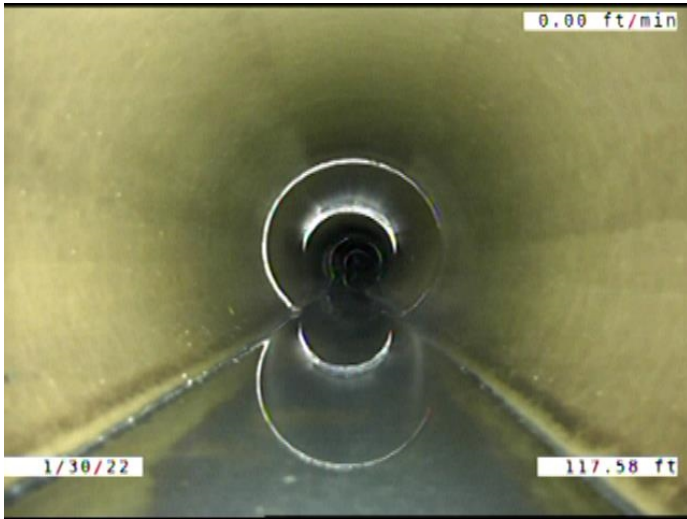
Code: **DSF**
Description: **Deposits Settled Fine**

Distance (ft): **117.6**
Structural Grade: **0**
O&M Grade: **2**
Clock Start/From: **5**
Clock To: **7**
1st Value:
2nd Value:
Value Percent: **5.000**
Continuous Index: **S03**
Within 8" of Joint: **YES**
Remarks:

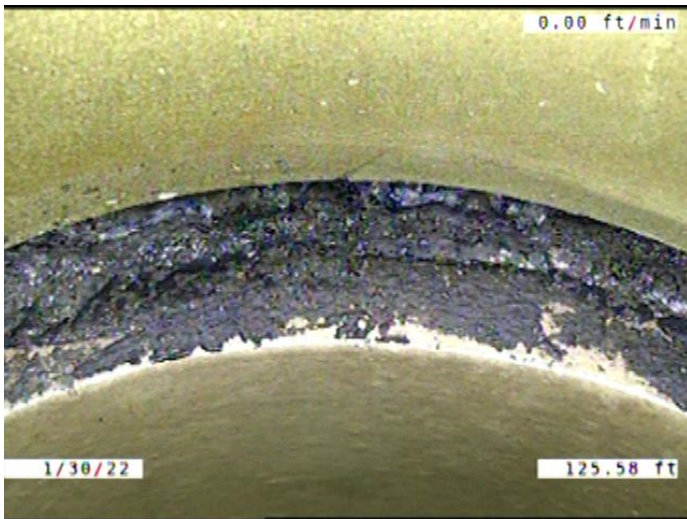
Code: **JOMD**
Description: **Joint Offset Medium Defective**

Distance (ft): **125.6**
Structural Grade: **3**
O&M Grade: **0**
Clock Start/From:
Clock To:
1st Value:
2nd Value:
Value Percent:
Continuous Index:
Within 8" of Joint: **NO**
Remarks: **Soil visible**

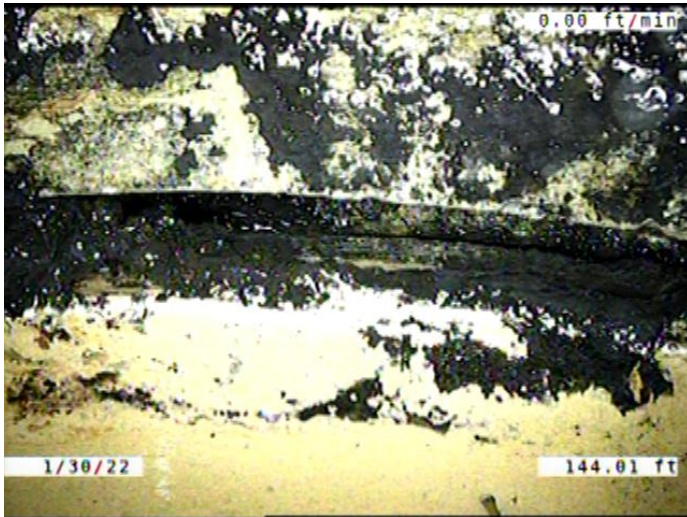
Code: **DAE**
 Description: **Deposits Attached Encrustation**

Distance (ft): **144.0**
 Structural Grade: **0**
 O&M Grade: **2**
 Clock Start/From: **1**
 Clock To: **4**
 1st Value:
 2nd Value:
 Value Percent: **5.000**
 Continuous Index:
 Within 8" of Joint: **YES**
 Remarks:

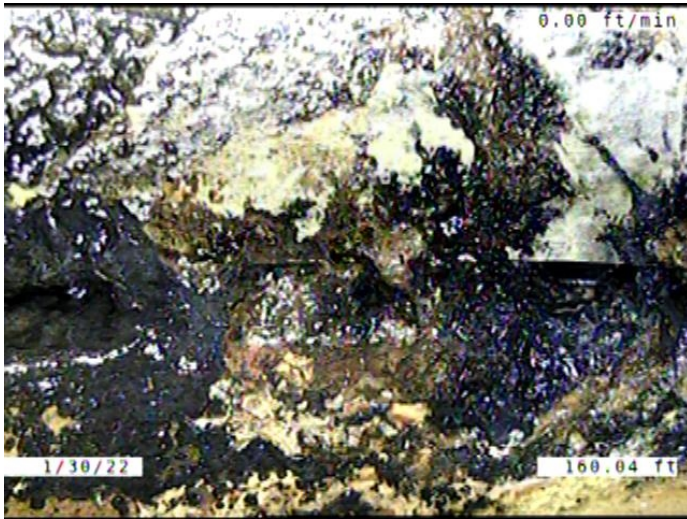
Code: **DAE**
Description: **Deposits Attached Encrustation**

Distance (ft): **160.0**
Structural Grade: **0**
O&M Grade: **2**
Clock Start/From: **8**
Clock To: **10**
1st Value:
2nd Value:
Value Percent: **5.000**
Continuous Index:
Within 8" of Joint: **YES**
Remarks:

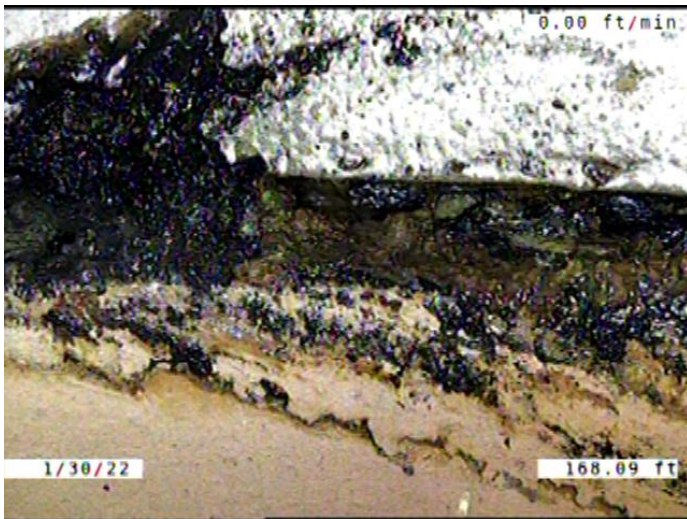
Code: **DAE**
Description: **Deposits Attached Encrustation**

Distance (ft): **168.1**
Structural Grade: **0**
O&M Grade: **2**
Clock Start/From: **7**
Clock To: **5**
1st Value:
2nd Value:
Value Percent: **5.000**
Continuous Index:
Within 8" of Joint: **YES**
Remarks:

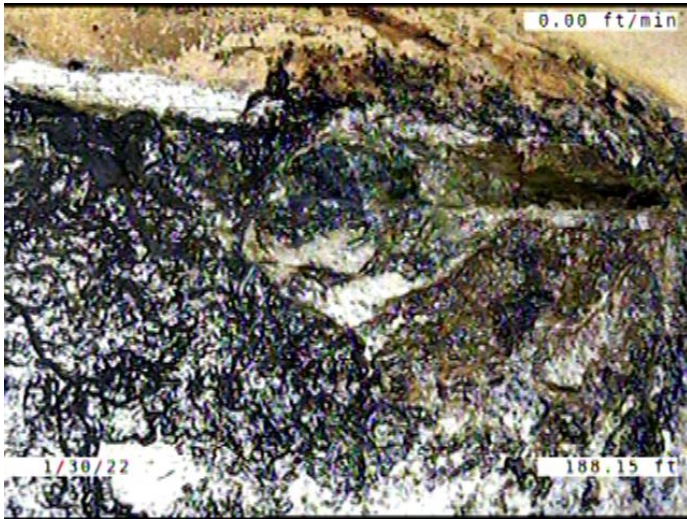
Code: **DAE**
Description: **Deposits Attached Encrustation**

Distance (ft): **188.1**
Structural Grade: **0**
O&M Grade: **2**
Clock Start/From: **3**
Clock To: **8**
1st Value:
2nd Value:
Value Percent: **5.000**
Continuous Index:
Within 8" of Joint: **YES**
Remarks:

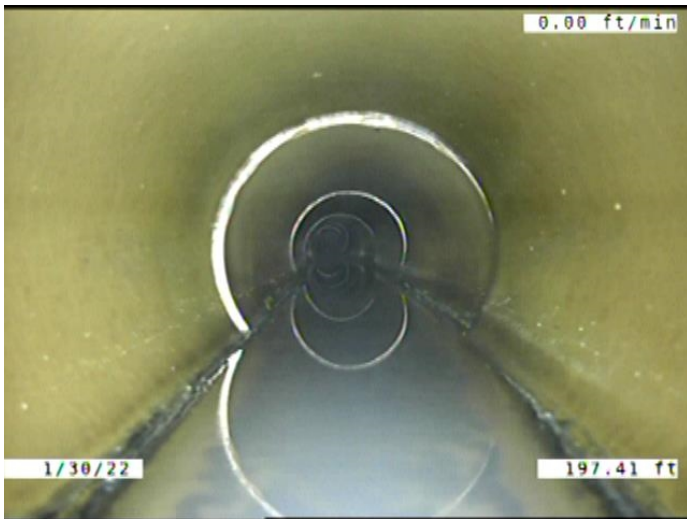
Code: **MWLS**
Description: **Miscellaneous Water Level Sag**

Distance (ft): **197.4**
Structural Grade: **2**
O&M Grade: **0**
Clock Start/From:
Clock To:
1st Value:
2nd Value:
Value Percent: **10.000**
Continuous Index: **S04**
Within 8" of Joint: **NO**
Remarks:

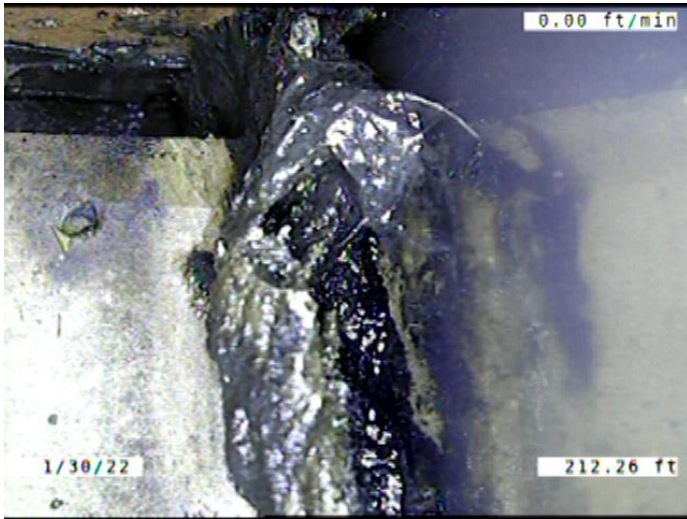
Code: **DAE**
Description: **Deposits Attached Encrustation**

Distance (ft): **212.3**
Structural Grade: **0**
O&M Grade: **2**
Clock Start/From: **8**
Clock To:
1st Value:
2nd Value:
Value Percent: **5.000**
Continuous Index:
Within 8" of Joint: **YES**
Remarks:

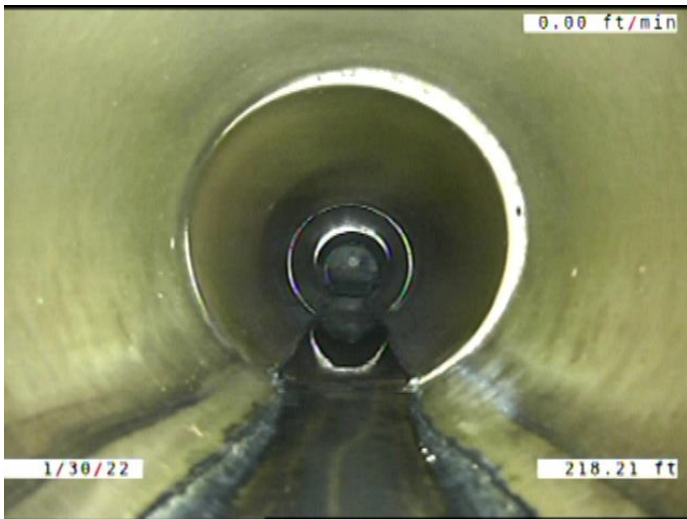
Code: **MWLS**
Description: **Miscellaneous Water Level Sag**

Distance (ft): **218.2**
Structural Grade: **2**
O&M Grade: **0**
Clock Start/From:
Clock To:
1st Value:
2nd Value:
Value Percent: **10.000**
Continuous Index: **F04**
Within 8" of Joint: **NO**
Remarks:

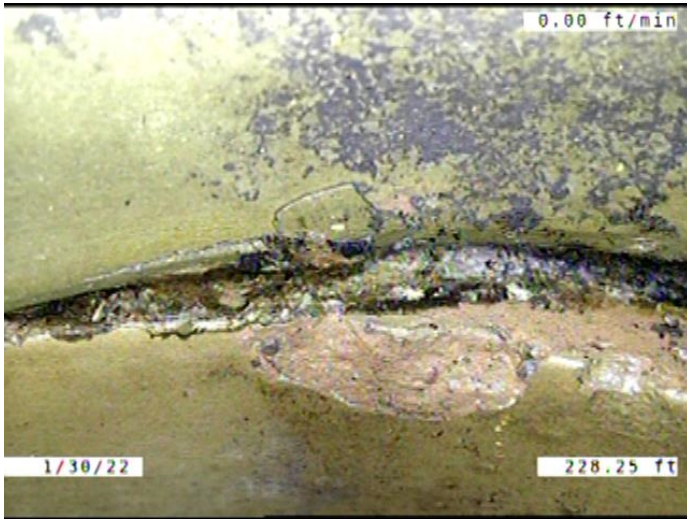
Code: **DAE**
 Description: **Deposits Attached Encrustation**

Distance (ft): **228.2**
 Structural Grade: **0**
 O&M Grade: **2**
 Clock Start/From: **8**
 Clock To: **4**
 1st Value:
 2nd Value:
 Value Percent: **5.000**
 Continuous Index:
 Within 8" of Joint: **YES**
 Remarks:

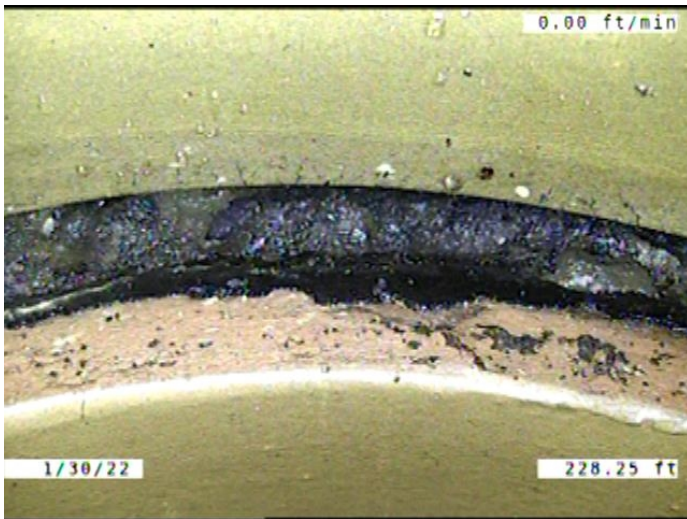
Code: **JOMD**
 Description: **Joint Offset Medium Defective**

Distance (ft): **228.3**
 Structural Grade: **3**
 O&M Grade: **0**
 Clock Start/From:
 Clock To:
 1st Value:
 2nd Value:
 Value Percent:
 Continuous Index:
 Within 8" of Joint: **NO**
 Remarks:

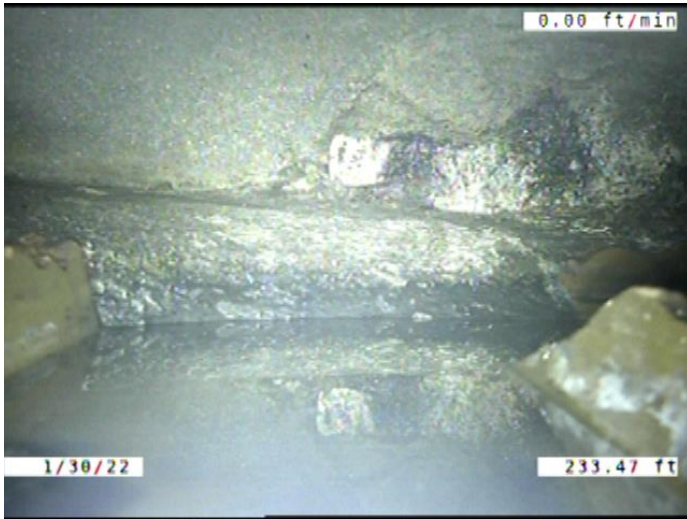
Code: **DSF**
 Description: **Deposits Settled Fine**

Distance (ft): **233.5**
 Structural Grade: **0**
 O&M Grade: **2**
 Clock Start/From: **5**
 Clock To: **7**
 1st Value:
 2nd Value:
 Value Percent: **5.000**
 Continuous Index: **F03**
 Within 8" of Joint: **YES**
 Remarks:
