Profile/Photo Observation Report

Date:	02/06/2022	Weather:		Coding:	PACP 7.0
Pipe Length (ft):	205.0	Owner:	City of Hobart	Pre Clean:	Heavy Cleaning
P.O.#:	YES502259	Surveyor:	S. Bucklin	PSR:	P-606-096-095
Customer:	City of Hobart	Clean Date:	01/27/2022	Shape:	C

Street:	North Lake Shore Drive	Flow Control:	Not Controlled
City:	Hobart, IN	Year Renewed:	
Location:	Alley	Tape/Media #:	
Purpose:	Routine Assessment	Dia/Height:	10"
Use:	Sanitary Sewage Pipe	Material:	VCP
Drain Area:		Lining:	None
Category:	NA		
Comment:

Location Details:		Direction of Survey:	Downstream
US MH:	M-606-095	DS MH:	M-606-096
		Total Length Surveyed (ft):	6.5

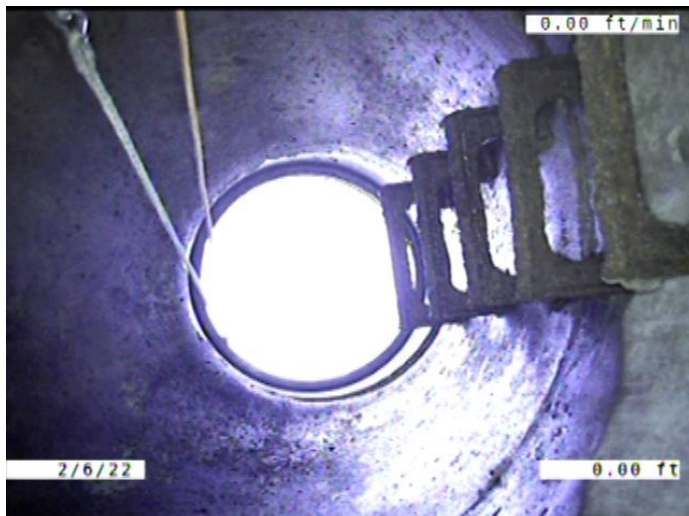
Code: **AMH**
Description: **Manhole**

Distance (ft): **.0**
Structural Grade: **0**
O&M Grade: **0**
Clock Start/From:
Clock To:
1st Value:
2nd Value:
Value Percent:
Continuous Index:
Within 8" of Joint: **NO**
Remarks: **M-606-095**

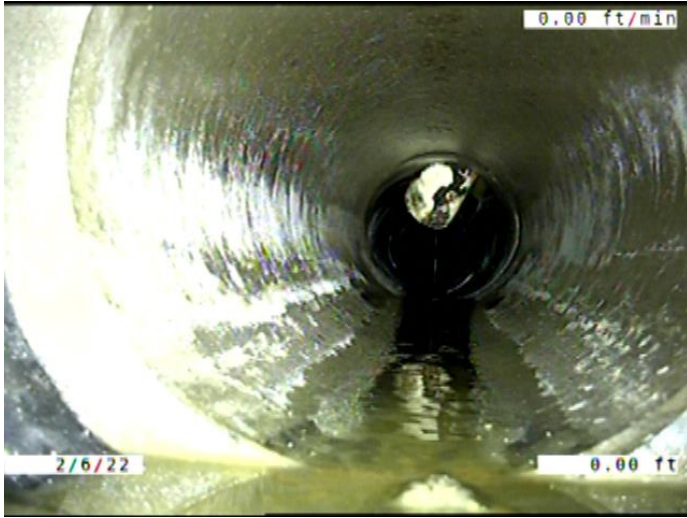
Code: **MWL**
Description: **Miscellaneous Water Level**

Distance (ft): **.0**
Structural Grade: **0**
O&M Grade: **0**
Clock Start/From:
Clock To:
1st Value:
2nd Value:
Value Percent: **5.000**
Continuous Index:
Within 8" of Joint: **NO**
Remarks:

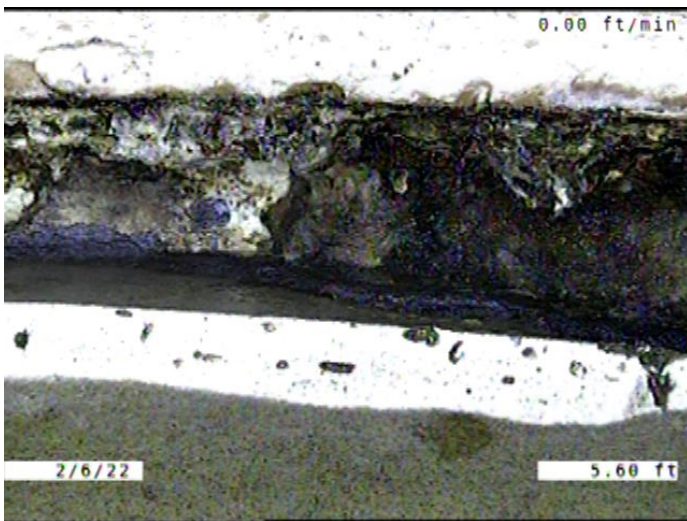
Code: **DAE**
Description: **Deposits Attached Encrustation**

Distance (ft): **5.6**
Structural Grade: **0**
O&M Grade: **2**
Clock Start/From: **10**
Clock To: **3**
1st Value:
2nd Value:
Value Percent: **5.000**
Continuous Index:
Within 8" of Joint: **YES**
Remarks:

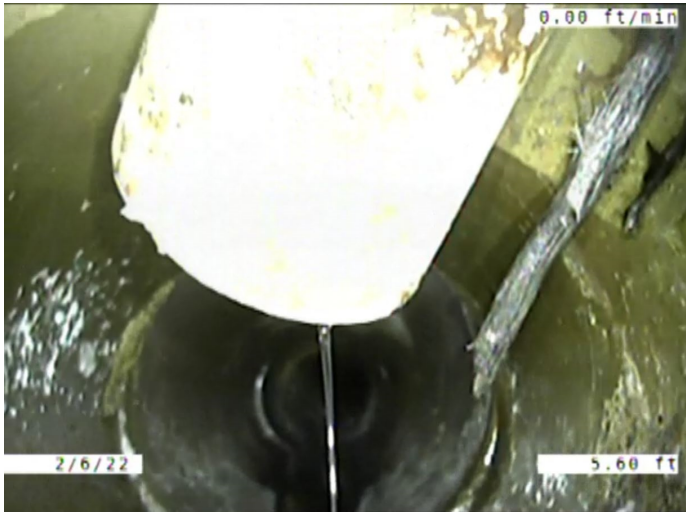
Code: **RTC**
 Description: **Roots Tap Connection**

Distance (ft): **5.6**
 Structural Grade: **0**
 O&M Grade: **2**
 Clock Start/From: **2**
 Clock To:
 1st Value:
 2nd Value:
 Value Percent: **5.000**
 Continuous Index:
 Within 8" of Joint: **NO**
 Remarks:

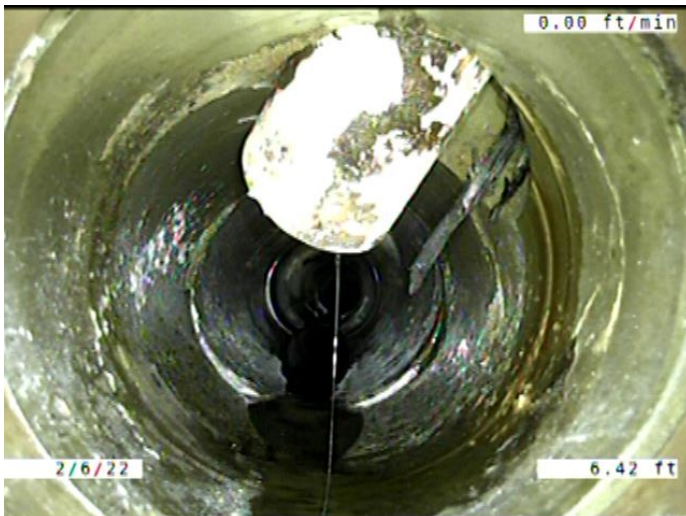
Code: **TFI**
 Description: **Tap Factory Intruding**

Distance (ft): **6.4**
 Structural Grade: **0**
 O&M Grade: **2**
 Clock Start/From: **1**
 Clock To:
 1st Value: **4.000**
 2nd Value: **4.000**
 Value Percent:
 Continuous Index:
 Within 8" of Joint: **YES**
 Remarks: **CONSTANTLY RUNNING WATER OUT OF THE TAP AND OUTSIDE THE PVC**

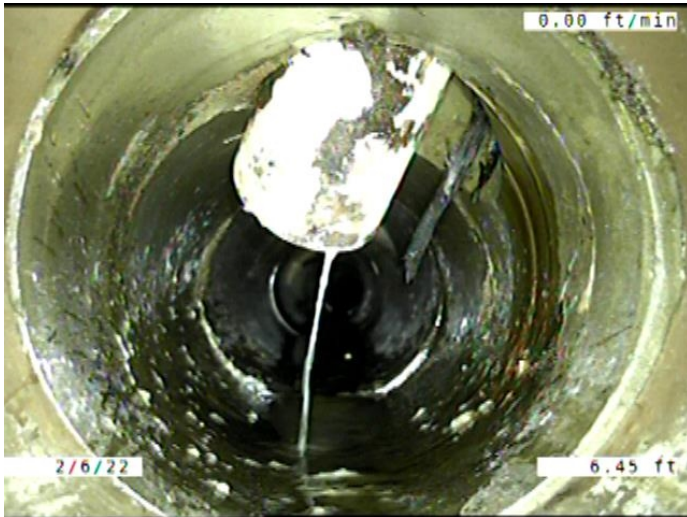
MSA

Miscellaneous Survey Abandoned

6.5

**CAMERA CANT MAKE IT PAST
PROTRUDING TAP. MADE IT TO THE**
