Profile/Photo Observation Report

Date:	04/04/2018	Weather:		Coding:	PACP 6.0
Pipe Length (ft):	348.8	Owner:	NA	Pre Clean:	No Pre-Cleaning
P.O.#:		Surveyor:	Jen Costello	PSR:	P-607-065-001
Customer:		Clean Date:	01/01/1900	Shape:	C

Street:	W 14TH ST	Flow Control:	Not Controlled
City:	Hobart, IN	Year Renewed:	
Location:	Yard	Tape/Media #:	
Purpose:	Routine Assessment	Dia/Height:	12"
Use:	Sanitary	Material:	PVC
Drain Area:	NA	Lining:	
Category:	NA		
Comment:			
Location Details:		Direction of Survey:	Upstream
US MH:	M-607-001	DS MH:	M-607-065
		Total Length Surveyed (ft):	329.3

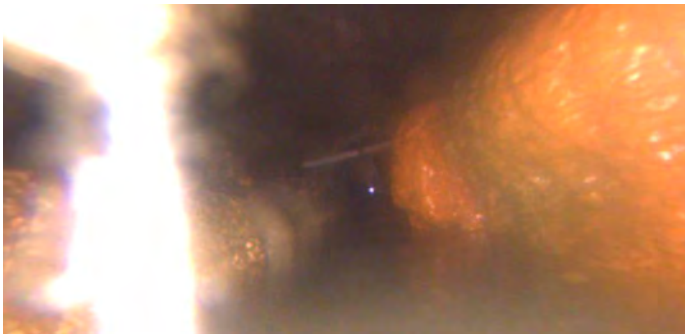
Code:	MGO
Description:	General Observation

Distance (ft):	.0
Structural Grade:	0
O&M Grade:	0
Clock Start/From:	
Clock To:	
1st Value:	
2nd Value:	
Value Percent:	
Continuous Index:	
Within 8" of Joint:	NO
Remarks:	rear camera

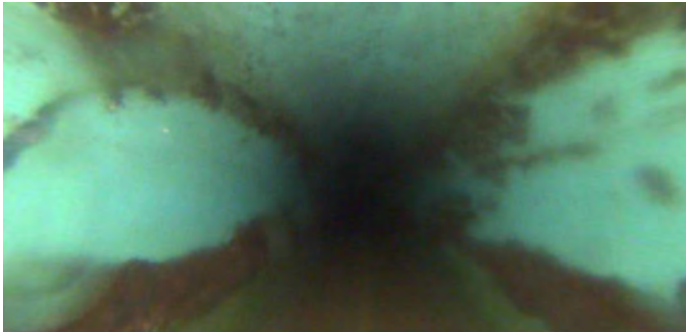
Code: **DAZ**
Description: **Deposits Attached Other**

Distance (ft): **219.6**
Structural Grade: **0**
O&M Grade: **2**
Clock Start/From: **8**
Clock To: **4**
1st Value:
2nd Value:
Value Percent: **5.000**
Continuous Index: **S01**
Within 8" of Joint: **NO**
Remarks:
