Profile/Photo Observation Report

Date:	04/04/2018	Weather:		Coding:	PACP 6.0
Pipe Length (ft):	348.8	Owner:	NA	Pre Clean:	No Pre-Cleaning
P.O.#:		Surveyor:	Jen Costello	PSR:	P-607-065-001
Customer:		Clean Date:	01/01/1900	Shape:	C

Street:	FOXCROFT STREET	Flow Control:	Not Controlled
City:	Hobart, IN	Year Renewed:	
Location:	Yard	Tape/Media #:	
Purpose:	Routine Assessment	Dia/Height:	12"
Use:	Sanitary	Material:	PVC
Drain Area:	NA	Lining:	
Category:	NA		
Comment:

Location Details:		Direction of Survey:	Upstream
US MH:	M-607-001	DS MH:	M-607-065
		Total Length Surveyed (ft):	329.3

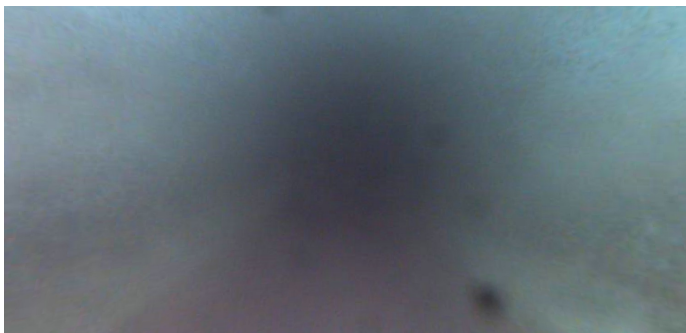
Code: **AMH**
Description: **Manhole**

Distance (ft): **.0**
Structural Grade: **0**
O&M Grade: **0**
Clock Start/From:
Clock To:
1st Value:
2nd Value:
Value Percent:
Continuous Index:
Within 8" of Joint: **NO**
Remarks: **M-607-065**

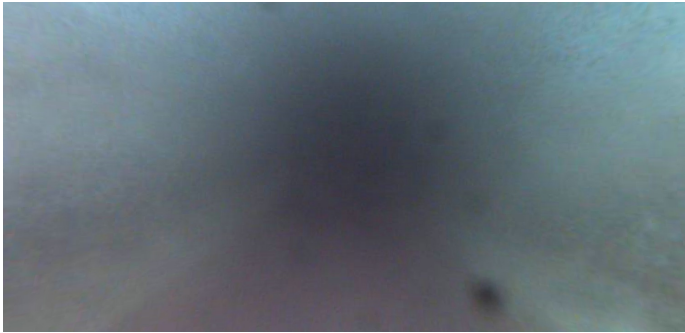
Code:	MWL
Description:	Water Level

Distance (ft):	.0
Structural Grade:	0
O&M Grade:	0
Clock Start/From:	
Clock To:	
1st Value:	
2nd Value:	
Value Percent:	5.000
Continuous Index:	
Within 8" of Joint:	NO
Remarks:

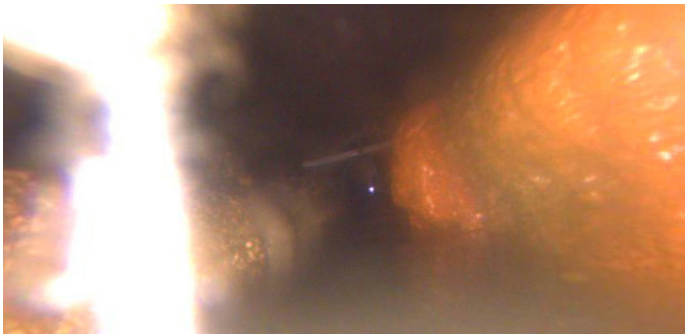
Code:	MGO
Description:	General Observation

Distance (ft):	.0
Structural Grade:	0
O&M Grade:	0
Clock Start/From:	
Clock To:	
1st Value:	
2nd Value:	
Value Percent:	
Continuous Index:	
Within 8" of Joint:	NO
Remarks:	rear camera

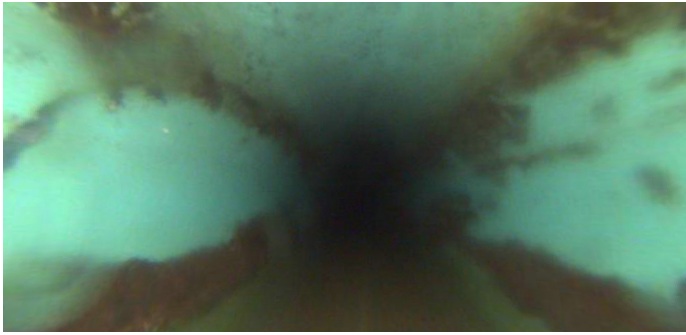
Code: **DAZ**
Description: **Deposits Attached Other**

Distance (ft): **219.6**
Structural Grade: **0**
O&M Grade: **2**
Clock Start/From: **8**
Clock To: **4**
1st Value:
2nd Value:
Value Percent: **5.000**
Continuous Index: **S01**
Within 8" of Joint: **NO**
Remarks:

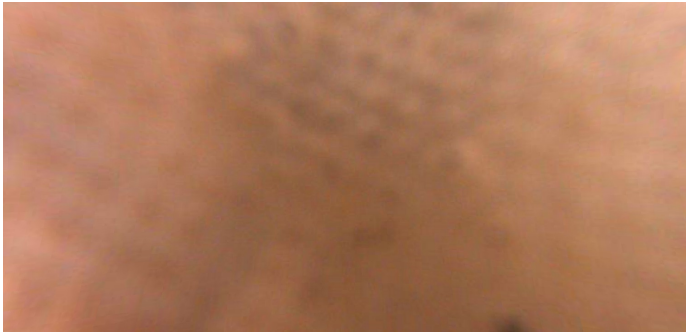
Code: **MWL**
Description: **Water Level**

Distance (ft): **323.1**
Structural Grade: **0**
O&M Grade: **0**
Clock Start/From:
Clock To:
1st Value:
2nd Value:
Value Percent: **100.000**
Continuous Index:
Within 8" of Joint: **NO**
Remarks:
