## Profile/Photo Observation Report

Street:	<b>14th. St.</b>	Flow Control:	<b>Not Controlled</b>
City:	<b>Hobart, IN</b>	Year Renewed:	
Location:	<b>Light Highway</b>	Tape/Media #:	
Purpose:	<b>Routine Assessment</b>	Dia/Height:	<b>12"</b>
Use:	<b>Sanitary</b>	Material:	<b>VCP</b>
Drain Area:	<b>NA</b>	Lining:	
Category:	<b>NA</b>		
Comment:

Location Details:		Direction of Survey:	<b>Upstream</b>
US MH:	<b>M-607-001</b>	DS MH:	<b>M-607-068</b>
		Total Length Surveyed (ft):	<b>31.3</b>

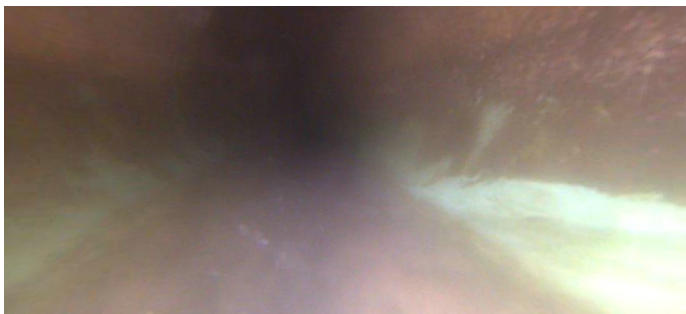
Code: **AMH**  
Description: **Manhole**

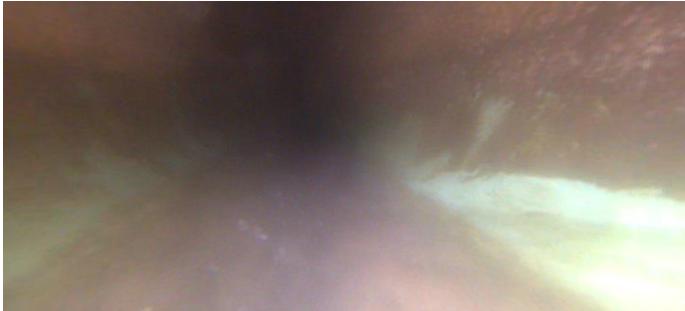
Code:	<b>MWL</b>
Description:	<b>Water Level</b>

Distance (ft):	<b>.0</b>
Structural Grade:	<b>0</b>
O&M Grade:	<b>0</b>
Clock Start/From:	
Clock To:	
1st Value:	
2nd Value:	
Value Percent:	<b>5.000</b>
Continuous Index:	
Within 8" of Joint:	<b>NO</b>
Remarks:

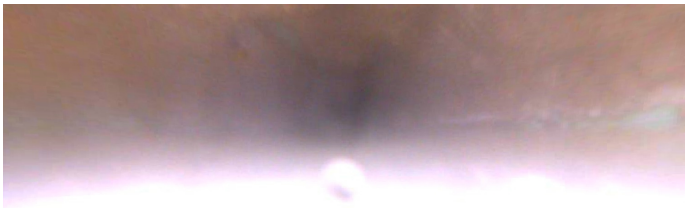
Code:	<b>MWLS</b>
Description:	<b>Water Level Sag</b>

Distance (ft):	<b>19.9</b>
Structural Grade:	<b>2</b>
O&M Grade:	<b>3</b>
Clock Start/From:	
Clock To:	
1st Value:	
2nd Value:	
Value Percent:	<b>20.000</b>
Continuous Index:	<b>S01</b>
Within 8" of Joint:	<b>NO</b>
Remarks:

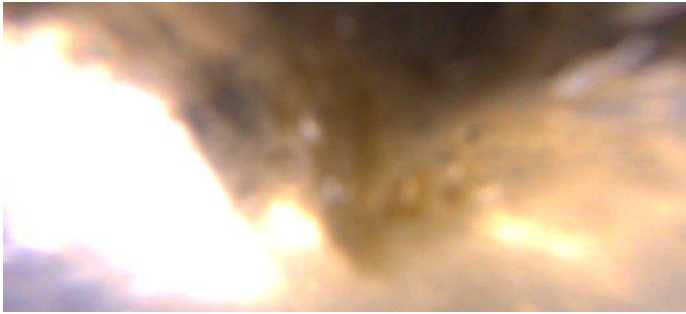
Code: **MWLS**  
Description: **Water Level Sag**

Distance (ft): **31.3**  
Structural Grade: **2**  
O&M Grade: **3**  
Clock Start/From:  
Clock To:  
1st Value:  
2nd Value:  
Value Percent: **20.000**  
Continuous Index: **F01**  
Within 8" of Joint: **NO**  
Remarks:

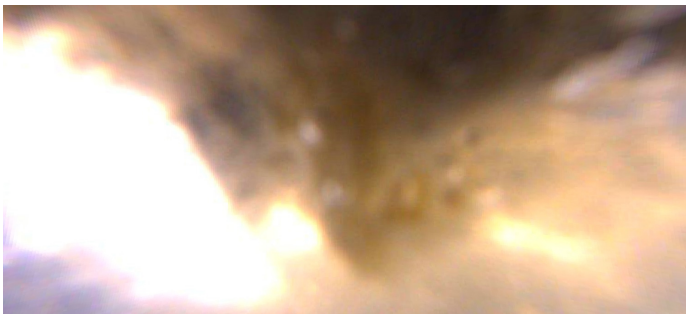
Code: **MSA**  
Description: **Abandoned Survey**

Distance (ft): **31.3**  
Structural Grade: **0**  
O&M Grade: **0**  
Clock Start/From:  
Clock To:  
1st Value:  
2nd Value:  
Value Percent:  
Continuous Index:  
Within 8" of Joint: **NO**  
Remarks: **camera stopped**
