Profile/Photo Observation Report

Street:	W 14TH ST	Flow Control:	Not Controlled
City:	Hobart, IN	Year Renewed:	
Location:	Yard	Tape/Media #:	
Purpose:	Routine Assessment	Dia/Height:	12"
Use:	Sanitary	Material:	PVC
Drain Area:	NA	Lining:	
Category:	NA		
Comment:	Flow direction is wrong.		
Location Details:		Direction of Survey:	Upstream
US MH:	M-607-001	DS MH:	M-608-034
		Total Length Surveyed (ft):	95.0

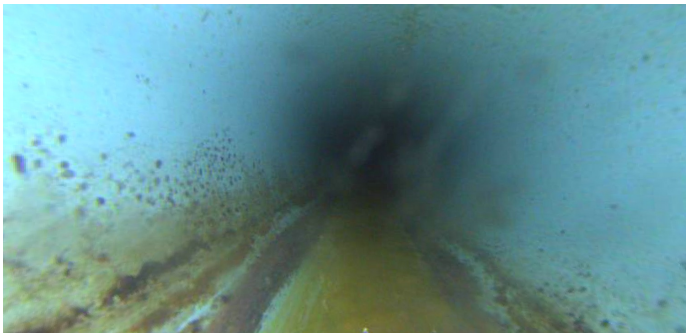
Code:	MWL
Description:	Water Level

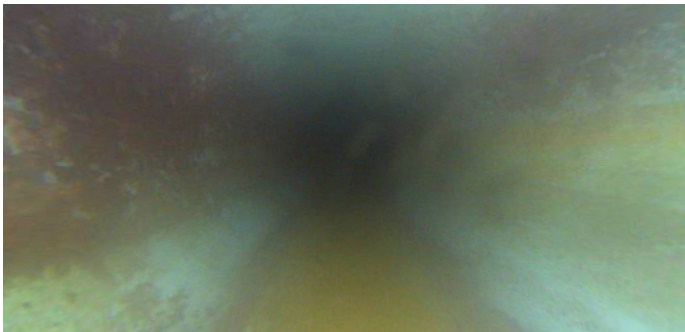
Code:	DAGS
Description:	Deposits Attached Grease

Distance (ft):	53.8
Structural Grade:	0
O&M Grade:	2
Clock Start/From:	8
Clock To:	4
1st Value:	
2nd Value:	
Value Percent:	5.000
Continuous Index:	S01
Within 8" of Joint:	NO
Remarks:

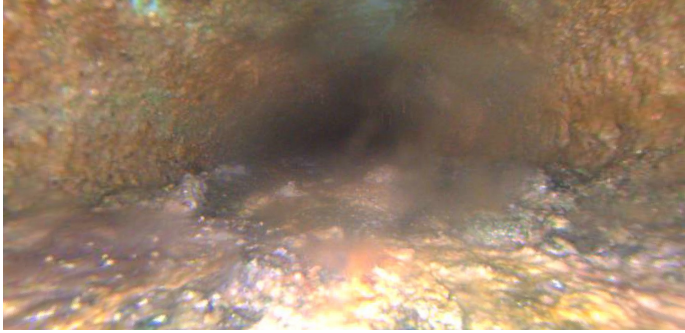
Code: **DSZ**
Description: **Deposits Settled Other**

Distance (ft): **91.7**
Structural Grade: **0**
O&M Grade: **5**
Clock Start/From: **4**
Clock To: **8**
1st Value:
2nd Value:
Value Percent: **40.000**
Continuous Index:
Within 8" of Joint: **NO**
Remarks: **grease**
