Profile/Photo Observation Report

Date:	04/05/2018	Weather:		Coding:	PACP 6.0
Pipe Length (ft):	168.6	Owner:	NA	Pre Clean:	No Pre-Cleaning
P.O.#:		Surveyor:	Jen Costello	PSR:	P-608-034-001
Customer:		Clean Date:	01/01/1900	Shape:	C

Street:	FOXCROFT STREET	Flow Control:	Not Controlled
City:	Hobart, IN	Year Renewed:	
Location:	Yard	Tape/Media #:	
Purpose:	Routine Assessment	Dia/Height:	12"
Use:	Sanitary	Material:	PVC
Drain Area:	NA	Lining:	
Category:	NA		
Comment:	Flow direction is wrong.		
Location Details:		Direction of Survey:	Upstream
US MH:	M-607-001	DS MH:	M-608-034
		Total Length Surveyed (ft):	95.0

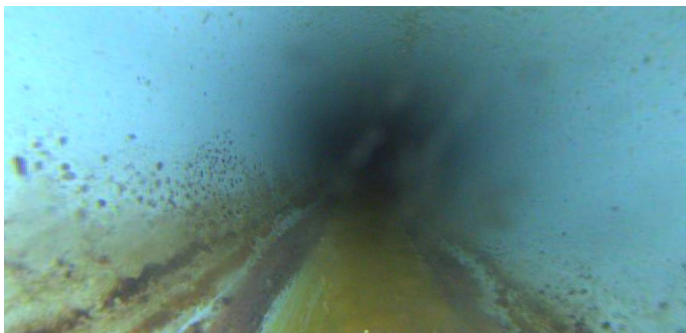
Code: **AMH**
Description: **Manhole**

Distance (ft): **.0**
Structural Grade: **0**
O&M Grade: **0**
Clock Start/From:
Clock To:
1st Value:
2nd Value:
Value Percent:
Continuous Index:
Within 8" of Joint: **NO**
Remarks: **M-608-034**

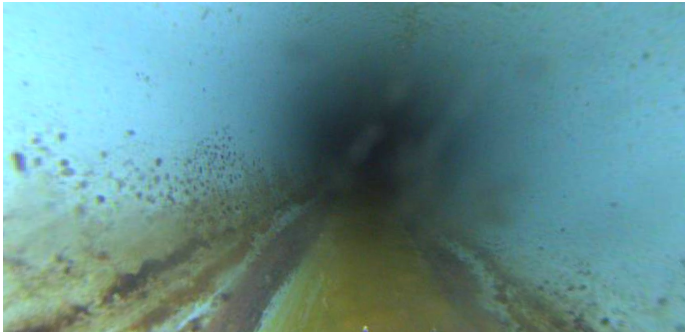
Code:	MWL
Description:	Water Level

Distance (ft):	.0
Structural Grade:	0
O&M Grade:	0
Clock Start/From:	
Clock To:	
1st Value:	
2nd Value:	
Value Percent:	5.000
Continuous Index:	
Within 8" of Joint:	NO
Remarks:

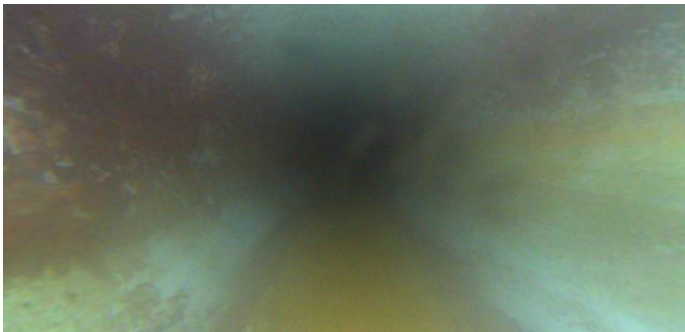
Code:	DAGS
Description:	Deposits Attached Grease

Distance (ft):	53.8
Structural Grade:	0
O&M Grade:	2
Clock Start/From:	8
Clock To:	4
1st Value:	
2nd Value:	
Value Percent:	5.000
Continuous Index:	S01
Within 8" of Joint:	NO
Remarks:

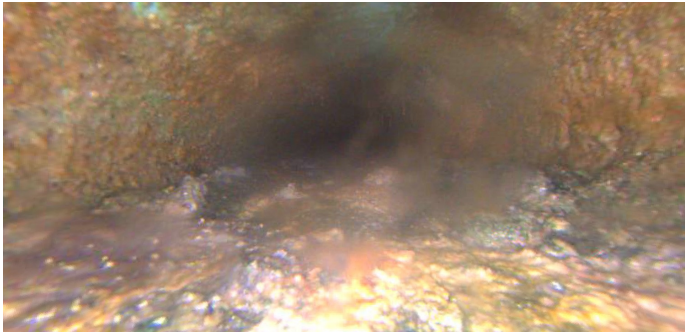
Code: **DSZ**
Description: **Deposits Settled Other**

Distance (ft): **91.7**
Structural Grade: **0**
O&M Grade: **5**
Clock Start/From: **4**
Clock To: **8**
1st Value:
2nd Value:
Value Percent: **40.000**
Continuous Index:
Within 8" of Joint: **NO**
Remarks: **grease**
