Profile/Photo Observation Report

Street:	W 14TH ST	Flow Control:	Not Controlled
City:	Hobart, IN	Year Renewed:	
Location:	Light Highway	Tape/Media #:	
Purpose:	Routine Assessment	Dia/Height:	12"
Use:	Sanitary	Material:	PVC
Drain Area:	NA	Lining:	
Category:	NA		
Comment:

Location Details:		Direction of Survey:	Upstream
US MH:	M-607-001	DS MH:	M-608-034
		Total Length Surveyed (ft):	95.2

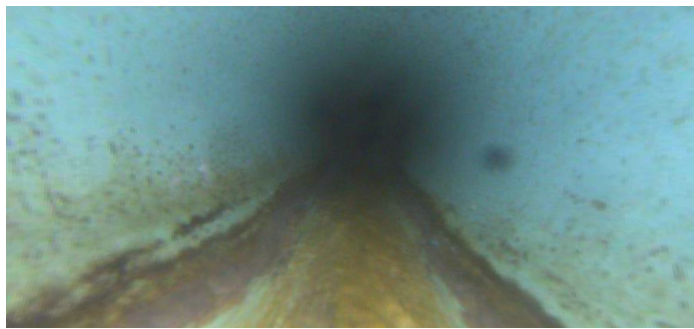
Code: **AMH**
Description: **Manhole**

Distance (ft): **.0**
Structural Grade: **0**
O&M Grade: **0**
Clock Start/From:
Clock To:
1st Value:
2nd Value:
Value Percent:
Continuous Index:
Within 8" of Joint: **NO**
Remarks: **M-608-034**

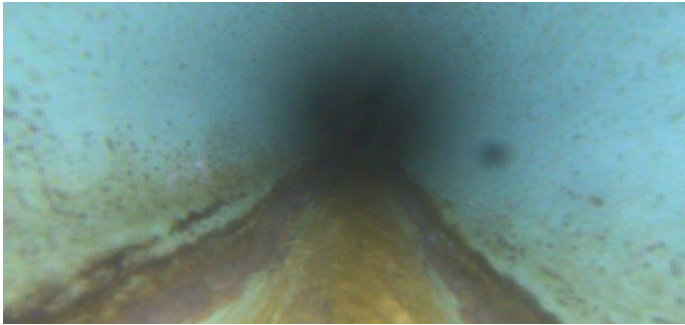
Code:	MWL
Description:	Water Level

Distance (ft):	.0
Structural Grade:	0
O&M Grade:	0
Clock Start/From:	
Clock To:	
1st Value:	
2nd Value:	
Value Percent:	5.000
Continuous Index:	
Within 8" of Joint:	NO
Remarks:

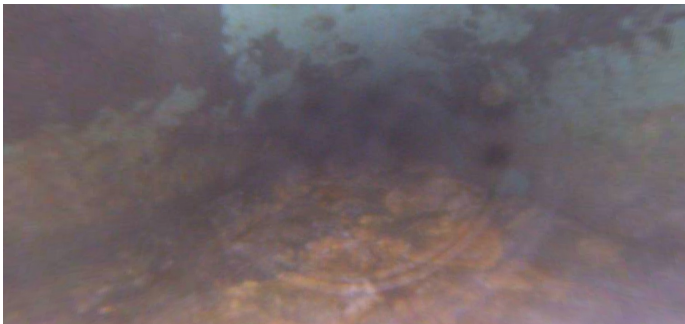
Code:	DSZ
Description:	Deposits Settled Other

Distance (ft):	91.7
Structural Grade:	0
O&M Grade:	3
Clock Start/From:	4
Clock To:	8
1st Value:	
2nd Value:	
Value Percent:	20.000
Continuous Index:	
Within 8" of Joint:	YES
Remarks:	grease
