Profile/Photo Observation Report

Street:	14th. St.	Flow Control:	Not Controlled
City:	Hobart, IN	Year Renewed:	
Location:	Light Highway	Tape/Media #:	
Purpose:	Routine Assessment	Dia/Height:	12"
Use:	Sanitary	Material:	PVC
Drain Area:	NA	Lining:	
Category:	NA		
Comment:

Location Details:		Direction of Survey:	Upstream
US MH:	M-607-001	DS MH:	M-608-034
		Total Length Surveyed (ft):	95.2

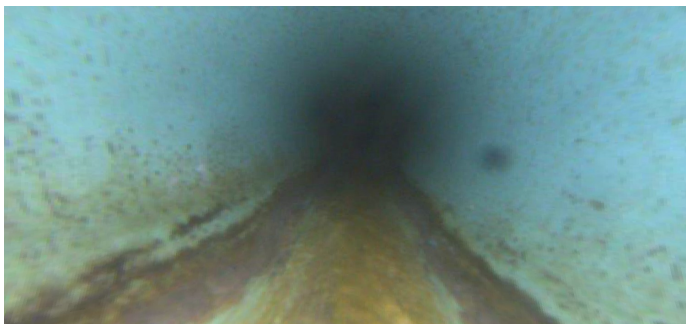
Code: **AMH**
Description: **Manhole**

Distance (ft): **.0**
Structural Grade: **0**
O&M Grade: **0**
Clock Start/From:
Clock To:
1st Value:
2nd Value:
Value Percent:
Continuous Index:
Within 8" of Joint: **NO**
Remarks: **M-608-034**

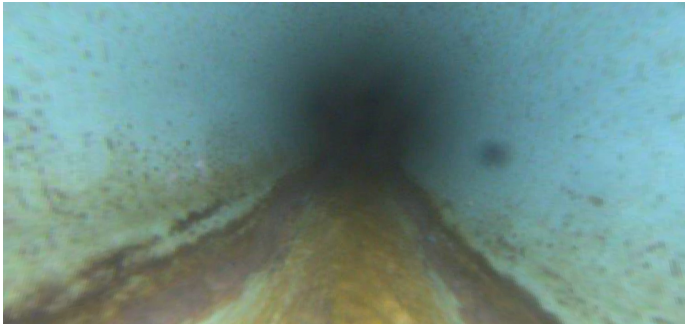
Code:	MWL
Description:	Water Level

Distance (ft):	.0
Structural Grade:	0
O&M Grade:	0
Clock Start/From:	
Clock To:	
1st Value:	
2nd Value:	
Value Percent:	5.000
Continuous Index:	
Within 8" of Joint:	NO
Remarks:

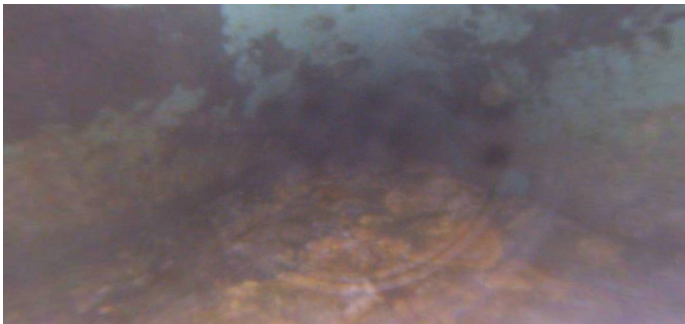
Code:	DSZ
Description:	Deposits Settled Other

Distance (ft):	91.7
Structural Grade:	0
O&M Grade:	3
Clock Start/From:	4
Clock To:	8
1st Value:	
2nd Value:	
Value Percent:	20.000
Continuous Index:	
Within 8" of Joint:	YES
Remarks:	grease
