Profile/Photo Observation Report

Date:	04/09/2018	Weather:		Coding:	PACP 6.0
Pipe Length (ft):		Owner:	City of Hobart	Pre Clean:	Not Known
P.O.#:	218	Surveyor:	B. Helbling	PSR:	P-608-035-001
Customer:	City of Hobart	Clean Date:		Shape:	C

Street:	West 14th Street	Flow Control:	Not Controlled
City:	Hobart, IN	Year Renewed:	
Location:	Light Highway	Tape/Media #:	DEP218
Purpose:	Routine Assessment	Dia/Height:	12"
Use:	Sanitary	Material:	PVC
Drain Area:		Lining:	
Category:	NA		
Comment:	YES501824 Submittal 2		
Location Details:		Direction of Survey:	Downstream
US MH:	M-607-001	DS MH:	M-608-035
		Total Length Surveyed (ft):	247.9

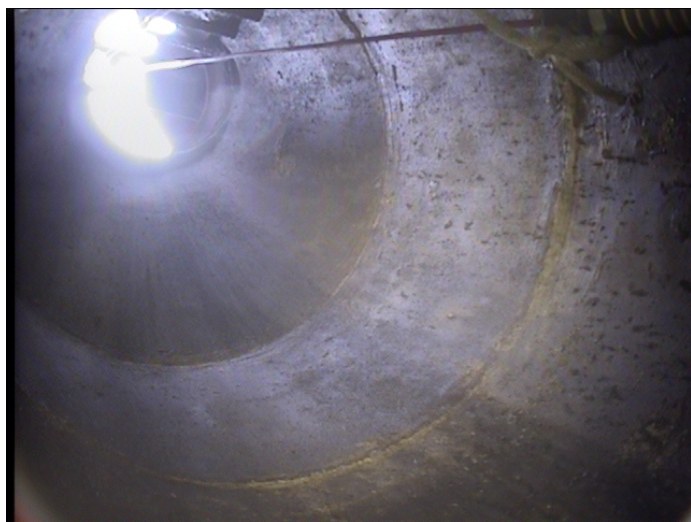
Code: **AMH**
Description: **Manhole**

Distance (ft): **.0**
Structural Grade: **0**
O&M Grade: **0**
Clock Start/From:
Clock To:
1st Value:
2nd Value:
Value Percent:
Continuous Index:
Within 8" of Joint: **NO**
Remarks: **M-608-035**

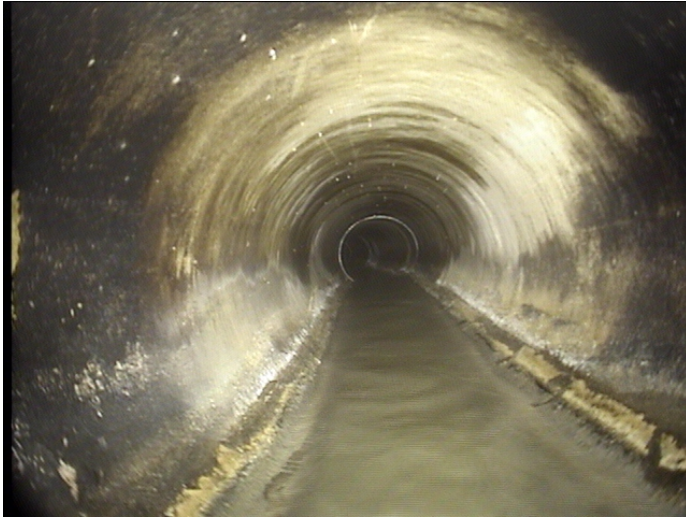
Code:	MWL
Description:	Water Level
Distance (ft):	.0
Structural Grade:	0
O&M Grade:	0
Clock Start/From:	
Clock To:	
1st Value:	
2nd Value:	
Value Percent:	5.000
Continuous Index:	
Within 8" of Joint:	NO
Remarks:

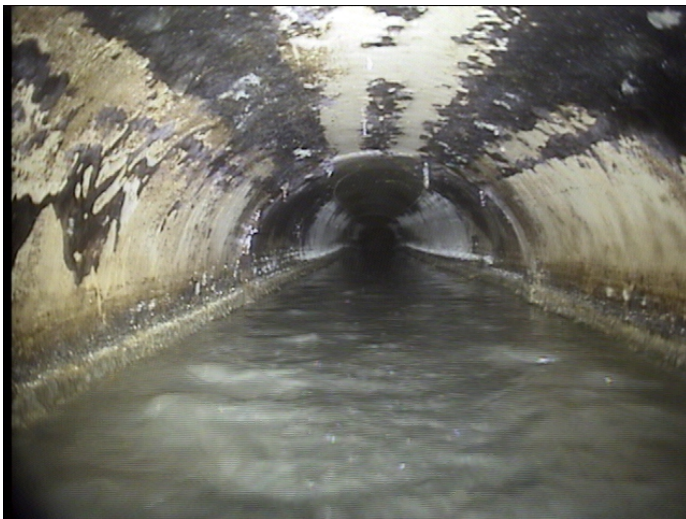
Code:	MWL
Description:	Water Level
Distance (ft):	244.1
Structural Grade:	0
O&M Grade:	0
Clock Start/From:	
Clock To:	
1st Value:	
2nd Value:	
Value Percent:	20.000
Continuous Index:	
Within 8" of Joint:	NO
Remarks:

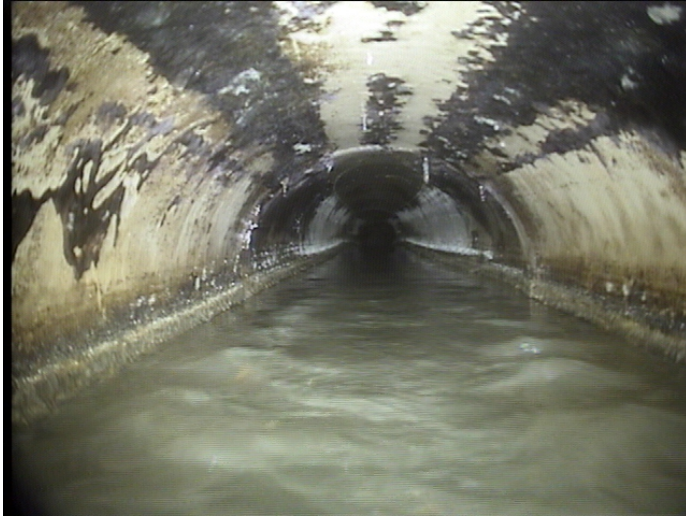
Code: **DSF**
Description: **Deposits Settled Fine**

Distance (ft): **244.1**
Structural Grade: **0**
O&M Grade: **2**
Clock Start/From: **4**
Clock To: **8**
1st Value:
2nd Value:
Value Percent: **10.000**
Continuous Index:
Within 8" of Joint: **NO**
Remarks:

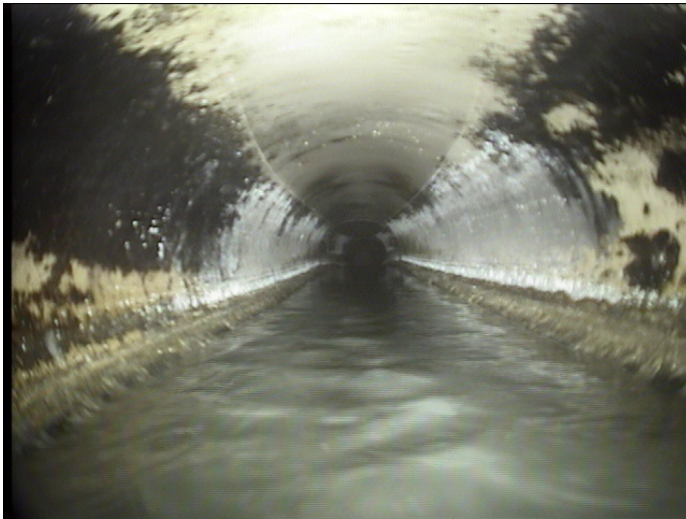
Code: **MSA**
Description: **Abandoned Survey**

Distance (ft): **247.9**
Structural Grade: **0**
O&M Grade: **0**
Clock Start/From:
Clock To:
1st Value:
2nd Value:
Value Percent:
Continuous Index:
Within 8" of Joint: **NO**
Remarks: **Cannot pass debris under flow**
