## Profile/Photo Observation Report

Date:	<b>04/13/2018</b>	Weather:		Coding:	<b>PACP 6.0</b>
Pipe Length (ft):		Owner:	<b>City of Hobart</b>	Pre Clean:	<b>Not Known</b>
P.O.#:	<b>247</b>	Surveyor:	<b>B. Helbling</b>	PSR:	<b>P-607-001-002</b>
Customer:	<b>City of Hobart</b>	Clean Date:		Shape:	<b>C</b>

Street:	<b>South Lake Park Avenue</b>	Flow Control:	<b>Not Controlled</b>
City:	<b>Hobart, IN</b>	Year Renewed:	
Location:	<b>Parking Lot</b>	Tape/Media #:	<b>DEP247</b>
Purpose:	<b>Routine Assessment</b>	Dia/Height:	<b>18"</b>
Use:	<b>Sanitary</b>	Material:	<b>VCP</b>
Drain Area:		Lining:	
Category:	<b>NA</b>		
Comment:	<b>YES501824 Submittal 2</b>		
Location Details:		Direction of Survey:	<b>Upstream</b>
US MH:	<b>M-607-002</b>	DS MH:	<b>M-607-001</b>
		Total Length Surveyed (ft):	<b>34.5</b>

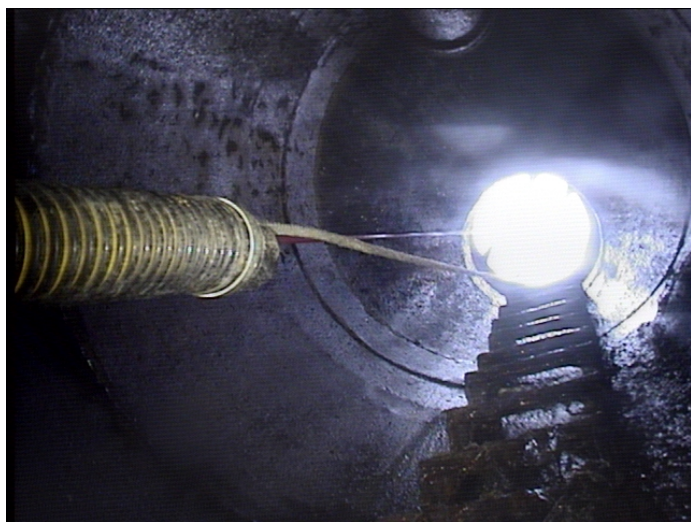
Code: **AMH**  
Description: **Manhole**

Distance (ft): **.0**  
Structural Grade: **0**  
O&M Grade: **0**  
Clock Start/From:  
Clock To:  
1st Value:  
2nd Value:  
Value Percent:  
Continuous Index:  
Within 8" of Joint: **NO**  
Remarks: **M-607-002**

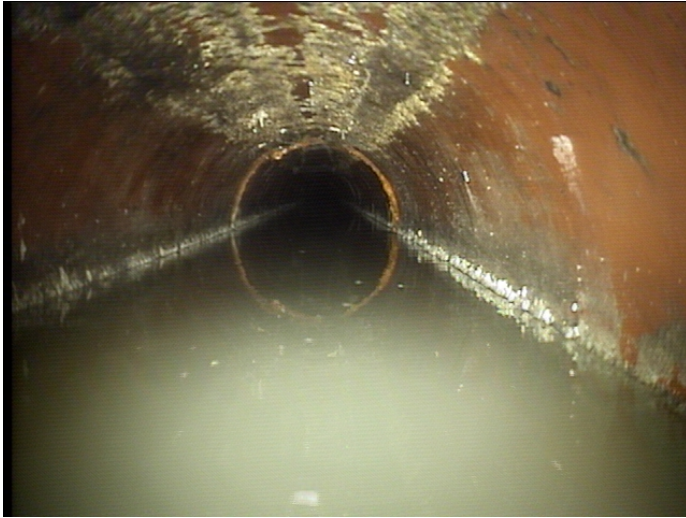
Code: **MWL**  
Description: **Water Level**

Distance (ft): **.0**  
Structural Grade: **0**  
O&M Grade: **0**  
Clock Start/From:  
Clock To:  
1st Value:  
2nd Value:  
Value Percent: **40.000**  
Continuous Index:  
Within 8" of Joint: **NO**  
Remarks:

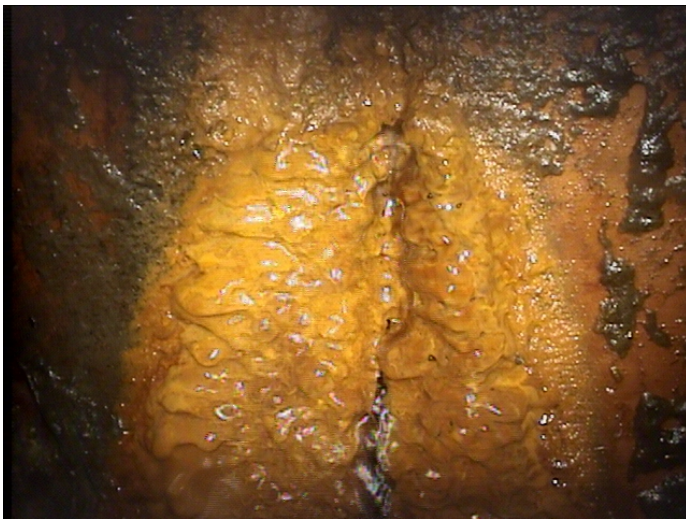
Code: **IR**  
Description: **Infil Runner**

Distance (ft): **5.6**  
Structural Grade: **0**  
O&M Grade: **4**  
Clock Start/From: **2**  
Clock To:  
1st Value:  
2nd Value:  
Value Percent:  
Continuous Index:  
Within 8" of Joint: **YES**  
Remarks:

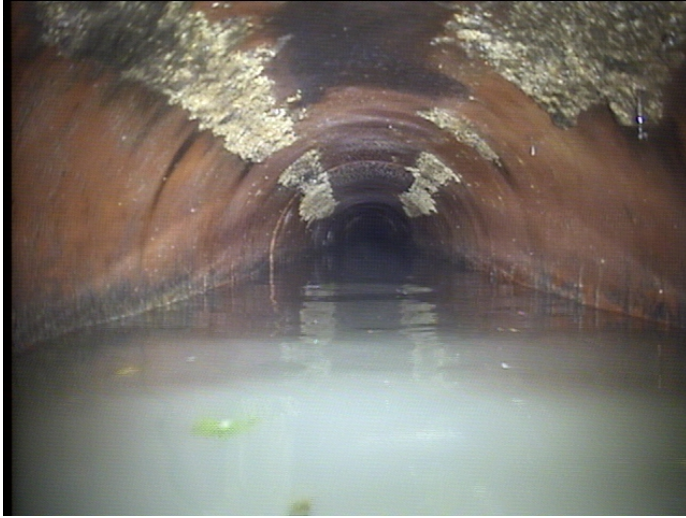
Code:	MSA
Description:	Abandoned Survey
Distance (ft):	34.5
Structural Grade:	0
O&M Grade:	0
Clock Start/From:	
Clock To:	
1st Value:	
2nd Value:	
Value Percent:	
Continuous Index:	
Within 8" of Joint:	NO
Remarks:	Cannot pass debris under flow
