## Profile/Photo Observation Report

Date:	05/01/2018	Weather:		Coding:	PACP 6.0
Pipe Length (ft):		Owner:	City of Hobart	Pre Clean:	Not Known
P.O.#:	272	Surveyor:	B. Helbling	PSR:	P-607-002-003
Customer:	City of Hobart	Clean Date:		Shape:	C

Street:	South Lake Park	Flow Control:	Not Controlled
City:	Hobart, IN	Year Renewed:	
Location:	Yard	Tape/Media #:	DEP272
Purpose:	Routine Assessment	Dia/Height:	18"
Use:	Sanitary	Material:	VCP
Drain Area:		Lining:	
Category:	NA		
Comment:	5-21-2018		
Location Details:		Direction of Survey:	Upstream
US MH:	M-607-002	DS MH:	M-607-003
		Total Length Surveyed (ft):	3.6

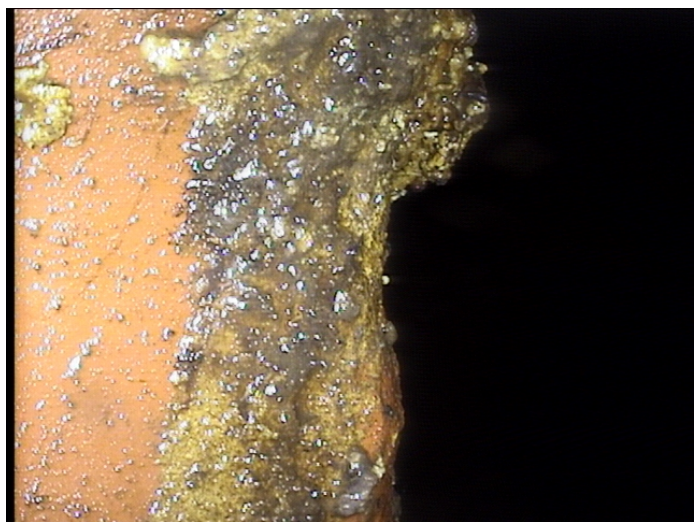
Code: **AMH**  
Description: **Manhole**

Distance (ft): **.0**  
Structural Grade: **0**  
O&M Grade: **0**  
Clock Start/From:  
Clock To:  
1st Value:  
2nd Value:  
Value Percent:  
Continuous Index:  
Within 8" of Joint: **NO**  
Remarks: **M-607-003**

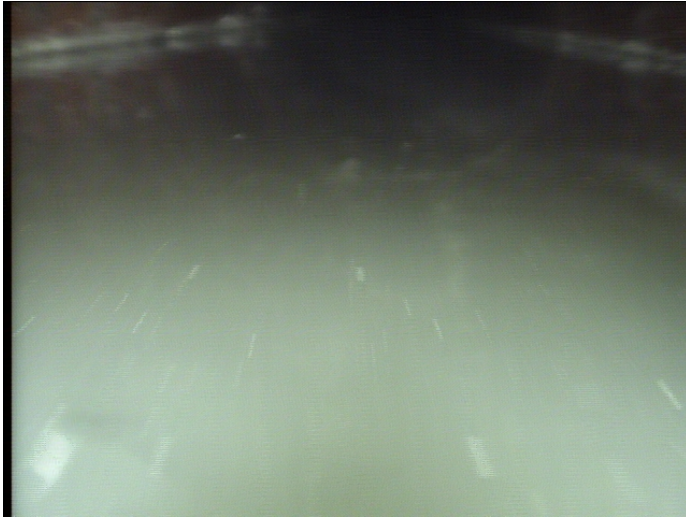
Code: **MWL**  
Description: **Water Level**

Distance (ft): **.0**  
Structural Grade: **0**  
O&M Grade: **0**  
Clock Start/From:  
Clock To:  
1st Value:  
2nd Value:  
Value Percent: **45.000**  
Continuous Index:  
Within 8" of Joint: **NO**  
Remarks:

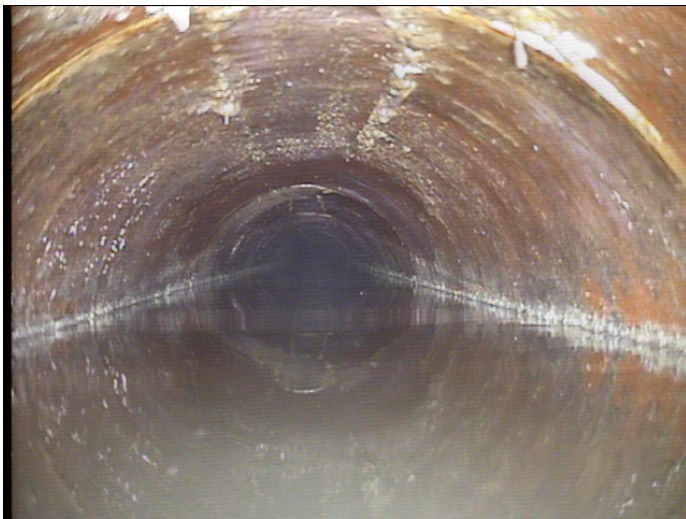
Code: **DSF**  
Description: **Deposits Settled Fine**

Distance (ft): **1.9**  
Structural Grade: **0**  
O&M Grade: **4**  
Clock Start/From: **4**  
Clock To: **8**  
1st Value:  
2nd Value:  
Value Percent: **25.000**  
Continuous Index:  
Within 8" of Joint: **NO**  
Remarks:

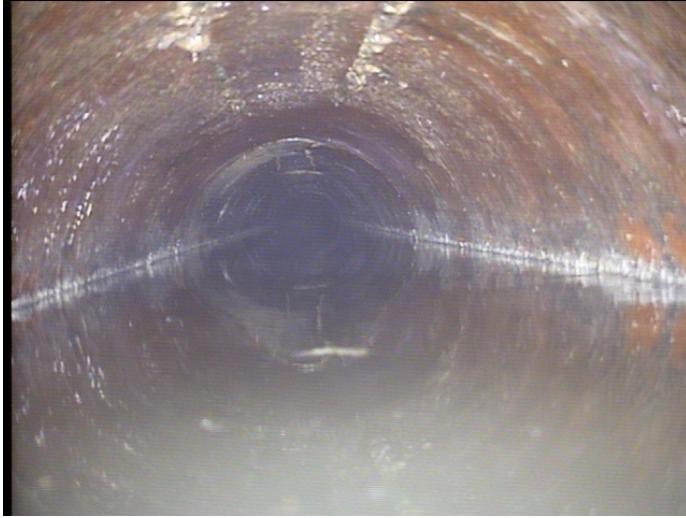
Code:	<b>MSA</b>
Description:	<b>Abandoned Survey</b>
Distance (ft):	<b>1.9</b>
Structural Grade:	<b>0</b>
O&M Grade:	<b>0</b>
Clock Start/From:	
Clock To:	
1st Value:	
2nd Value:	
Value Percent:	
Continuous Index:	
Within 8" of Joint:	<b>NO</b>
Remarks:	<b>Heavy sediment</b>
