Profile/Photo Observation Report

Date:	05/01/2018	Weather:		Coding:	PACP 6.0
Pipe Length (ft):		Owner:	City of Hobart	Pre Clean:	Not Known
P.O.#:	271	Surveyor:	B. Helbling	PSR:	P-607-003-004
Customer:	City of Hobart	Clean Date:		Shape:	C

Street:	South Lake Park	Flow Control:	Not Controlled
City:	Hobart, IN	Year Renewed:	
Location:	Yard	Tape/Media #:	DEP271
Purpose:	Routine Assessment	Dia/Height:	18"
Use:	Sanitary	Material:	VCP
Drain Area:		Lining:	
Category:	NA		
Comment:	5-21-2018

Location Details:		Direction of Survey:	Downstream
US MH:	M-607-004	DS MH:	M-607-003
		Total Length Surveyed (ft):	11.7

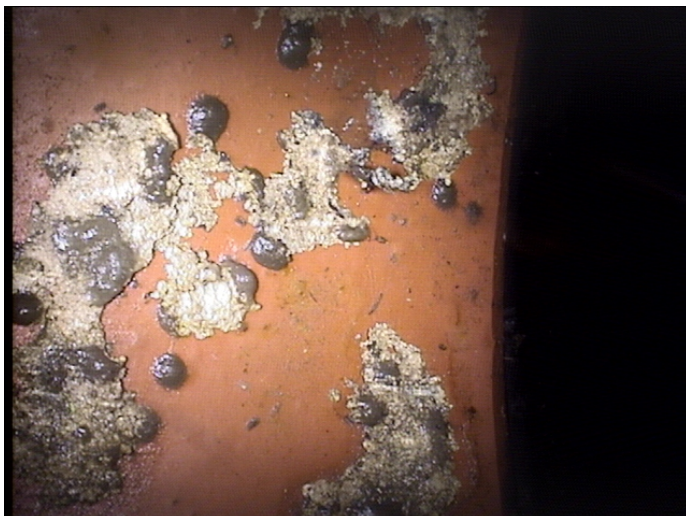
Code: **AMH**
Description: **Manhole**

Distance (ft): **.0**
Structural Grade: **0**
O&M Grade: **0**
Clock Start/From:
Clock To:
1st Value:
2nd Value:
Value Percent:
Continuous Index:
Within 8" of Joint: **NO**
Remarks: **M-607-003**

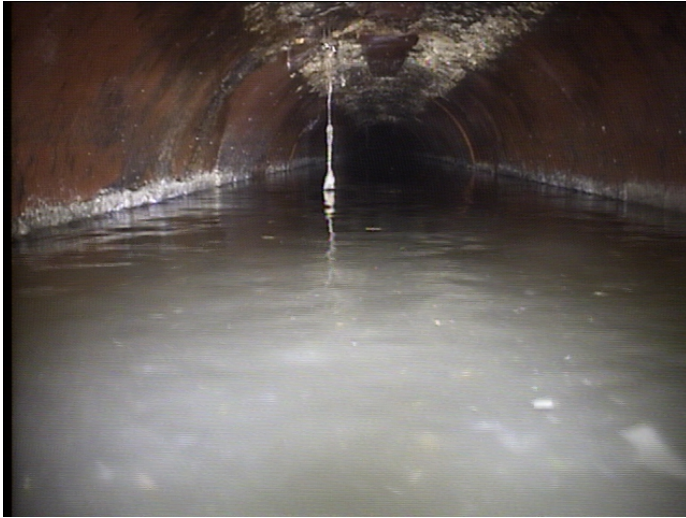
Code: **MWL**
Description: **Water Level**

Distance (ft): **.0**
Structural Grade: **0**
O&M Grade: **0**
Clock Start/From:
Clock To:
1st Value:
2nd Value:
Value Percent: **45.000**
Continuous Index:
Within 8" of Joint: **NO**
Remarks:

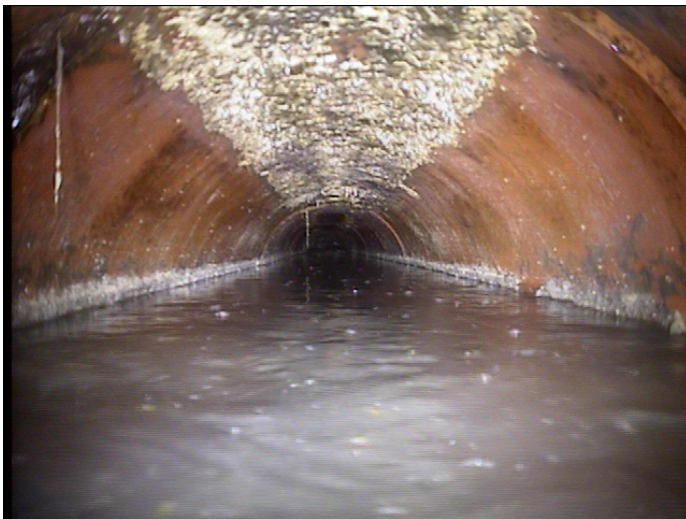
Code: **DSF**
Description: **Deposits Settled Fine**

Distance (ft): **3.5**
Structural Grade: **0**
O&M Grade: **3**
Clock Start/From: **4**
Clock To: **8**
1st Value:
2nd Value:
Value Percent: **20.000**
Continuous Index: **S01**
Within 8" of Joint: **NO**
Remarks:

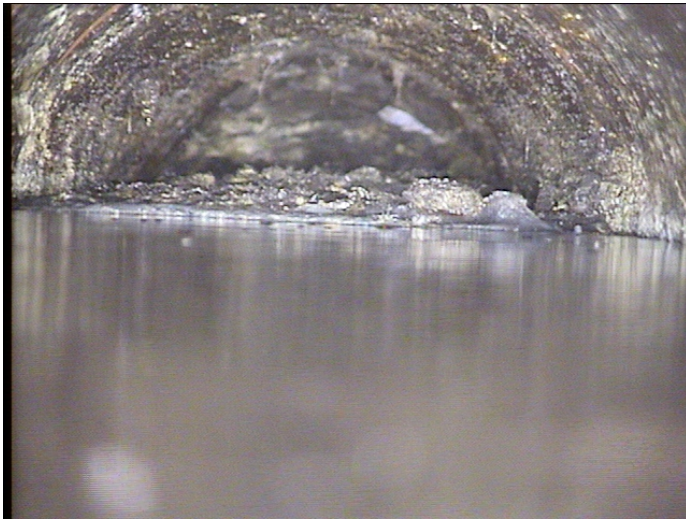
Code: **DSF**
 Description: **Deposits Settled Fine**

Distance (ft): **11.1**
 Structural Grade: **0**
 O&M Grade: **3**
 Clock Start/From: **4**
 Clock To: **8**
 1st Value:
 2nd Value:
 Value Percent: **20.000**
 Continuous Index: **F01**
 Within 8" of Joint: **NO**
 Remarks:

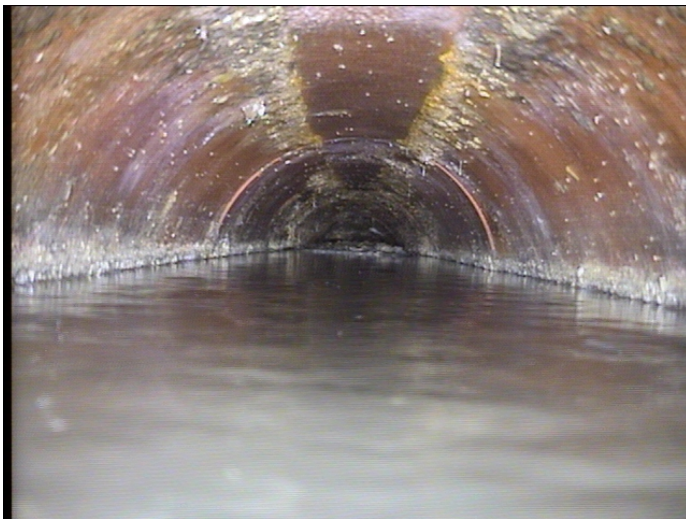
Code: **MSA**
 Description: **Abandoned Survey**

Distance (ft): **11.2**
 Structural Grade: **0**
 O&M Grade: **0**
 Clock Start/From:
 Clock To:
 1st Value:
 2nd Value:
 Value Percent:
 Continuous Index:
 Within 8" of Joint: **NO**
 Remarks: **Heavy sediment. Appears to be a blockage ahead.**
