| Date: Pipe Length (f | 04/30/2018 | Weather: Owner: | City of Hob | art | Coding: Pre Clean: | PACP 6.0 Not Known |
| P.O.#: | 270 | Surveyor: | B. Helbling | | PSR: | P-607-004-005 |
| Street: | South Lake Park | | Flow Control | : | Not Controlled | |
| US MH: | M-607-005 | DS MH: | M-607-004 | Т | otal Length Surveyed (ft) | : 151.9 |

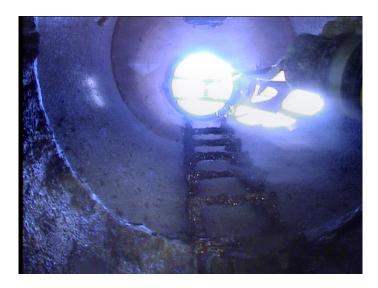
| Code: Description: | AMH Manhole |
| Remarks: | M-607-005 |

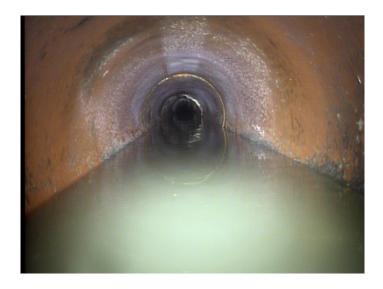
| Code: | MWL |
| Description: | Water Level |
| Value Percent: | 15.000 |

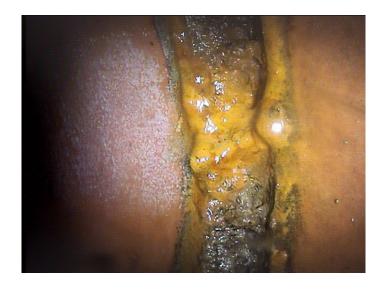
| | Position | Code | Observation | Video (sec) | Grad |
|---|---|---|---|---|---|
| | $\left(\frac{5.8}{5.8} \right)$ | ID | Infil Dripper | 62 | M 3 |

| Code: Description: | ID Infil Dripper |
| Distance (ft): Structural Grade: O&M Grade: Clock Start/From: Clock To: 1st Value: 2nd Value: Value Percent: | 5.8 0 3 12 |
| Continuous Index: Within 8" of Joint: Remarks: | YES |

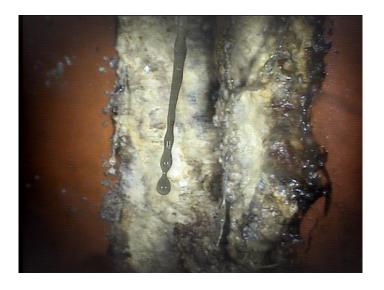
| | Position | Code | Observation | Video (sec) | Grad |
|---|---|---|---|---|---|
| | \ 13.0 | DAE | Deposits Attached Encrustation | 91 | M 2 |

| Code: Description: | DAE Deposits Attached Encrustation |
| Distance (ft): | 13.0 |
| O&M Grade: | 2 |
| Value Percent: | 5.000 |

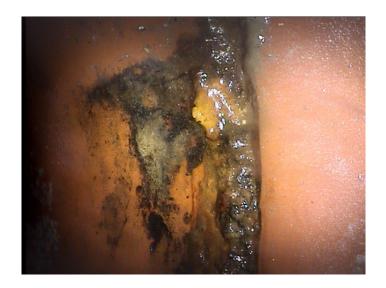
| | Position | Code | Observation | Video (sec) | Grad |
|---|---|---|---|---|---|
| | 90.1 | ID | Infil Dripper | 297 | M 3 |

| ID Infil Dripper |
| 90.1 |
| 3 |

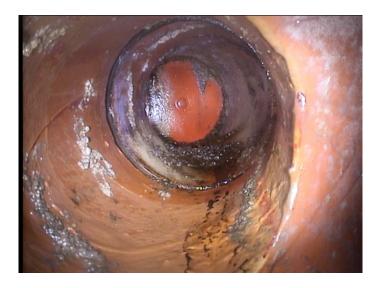
| | Position | Code | Observation | Video (sec) | Grad |
|---|---|---|---|---|---|
| | 134.7 | TFC | Tap Factory Capped | 701 | NA |

| TFC Tap Factory Capped |
| 134.7 |

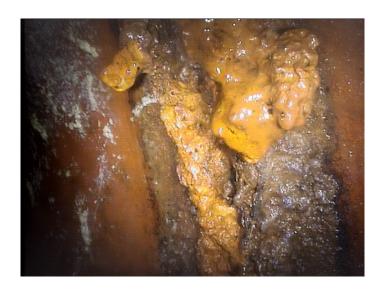
| | Position | Code | Observation | Video (sec) | Grad |
|---|---|---|---|---|---|
| | 149.2 | ID | Infil Dripper | 1072 | M 3 |

| Code: Description: | ID Infil Dripper |
| Distance (ft): | 149.2 |
| O&M Grade: | 3 |

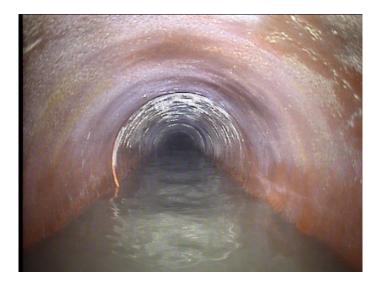
| | Position | Code | Observation | Video (sec) | Grad |
|---|---|---|---|---|---|
| | 151.9 | MSA | Abandoned Survey | 1344 | NA |

| Code: | MSA |
| Description: | Abandoned Survey |
| Distance (ft): Structural Grade: O&M Grade: Clock Start/From: Clock To: 1st Value: 2nd Value: Value Percent: Continuous Index: | 151.9 0 0 |
| Remarks: | Unable to pass debris under flow |
