Profile/Photo Observation Report

Date:	04/07/2018	Weather:		Coding:	PACP 6.0
Pipe Length (ft):		Owner:	City of Hobart	Pre Clean:	Not Known
P.O.#:	204	Surveyor:	B. Helbling	PSR:	P-607-005-006
Customer:	City of Hobart	Clean Date:		Shape:	C

Street:	Polly Lane	Flow Control:	Not Controlled
City:	Hobart, IN	Year Renewed:	
Location:	Easement/Right of Way	Tape/Media #:	DEP204
Purpose:	Routine Assessment	Dia/Height:	18"
Use:	Sanitary	Material:	VCP
Drain Area:		Lining:	
Category:	NA		
Comment:	YES501824 Submittal 2		
Location Details:		Direction of Survey:	Upstream
US MH:	M-607-006	DS MH:	M-607-005
		Total Length Surveyed (ft):	1.7

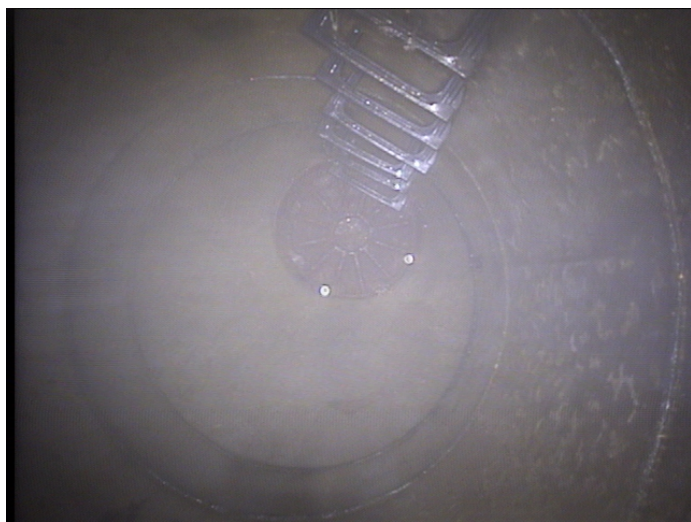
Code: **AMH**
Description: **Manhole**

Distance (ft): **.0**
Structural Grade: **0**
O&M Grade: **0**
Clock Start/From:
Clock To:
1st Value:
2nd Value:
Value Percent:
Continuous Index:
Within 8" of Joint: **NO**
Remarks: **M-607-005**

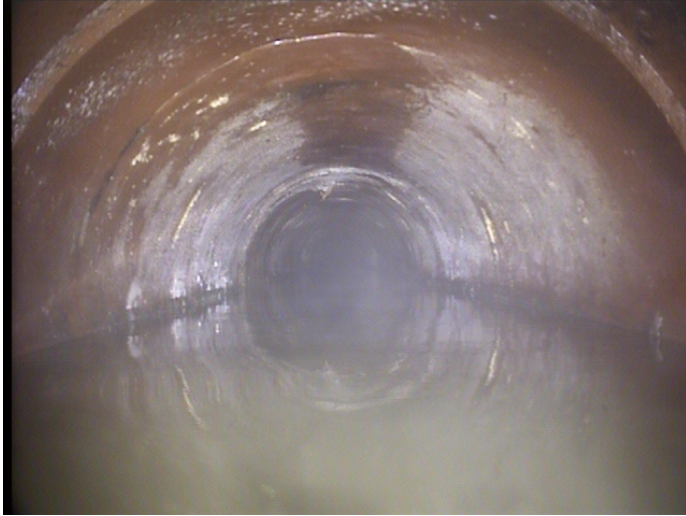
Code: **MWL**
Description: **Water Level**

Distance (ft): **.0**
Structural Grade: **0**
O&M Grade: **0**
Clock Start/From:
Clock To:
1st Value:
2nd Value:
Value Percent: **20.000**
Continuous Index:
Within 8" of Joint: **NO**
Remarks:

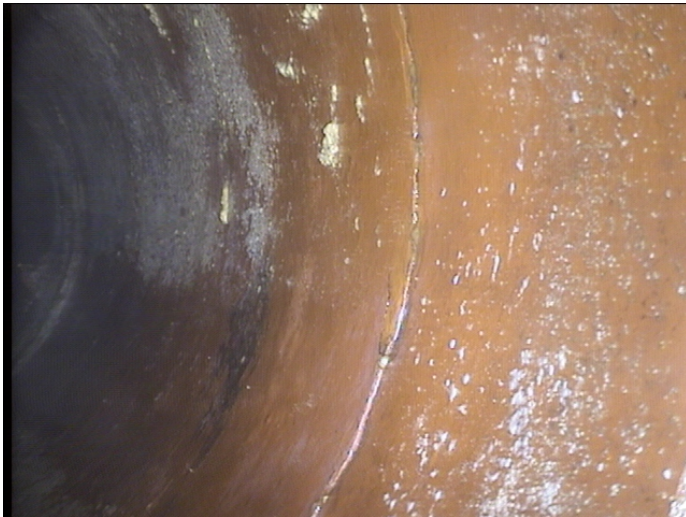
Code: **CC**
Description: **Crack Circumferential**

Distance (ft): **1.7**
Structural Grade: **1**
O&M Grade: **0**
Clock Start/From: **11**
Clock To: **3**
1st Value:
2nd Value:
Value Percent:
Continuous Index:
Within 8" of Joint: **NO**
Remarks:

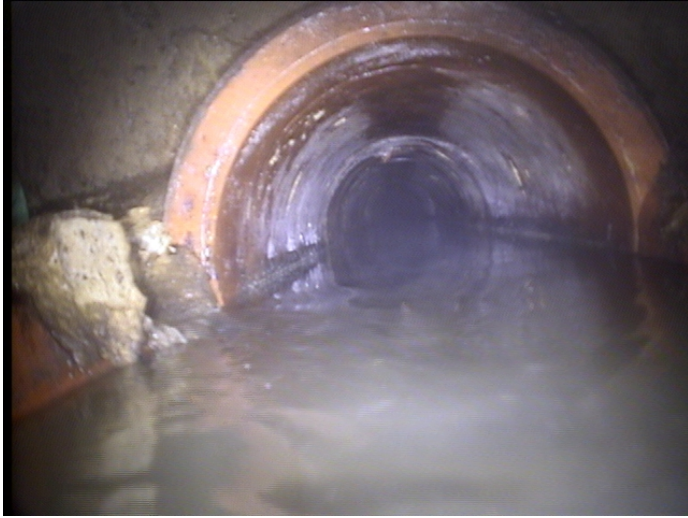
Code:	MSA
Description:	Abandoned Survey
Distance (ft):	1.7
Structural Grade:	0
O&M Grade:	0
Clock Start/From:	
Clock To:	
1st Value:	
2nd Value:	
Value Percent:	
Continuous Index:	
Within 8" of Joint:	NO
Remarks:	Robot Issue. Disregard inspection
