Profile/Photo Observation Report

Date:	04/30/2018	Weather:		Coding:	PACP 6.0
Pipe Length (ft):		Owner:	City of Hobart	Pre Clean:	Not Known
P.O.#:	269	Surveyor:	B. Helbling	PSR:	P-607-005-006
Customer:	City of Hobart	Clean Date:		Shape:	C

Street:	South Lake Park	Flow Control:	Not Controlled
City:	Hobart, IN	Year Renewed:	
Location:	Yard	Tape/Media #:	DEP269
Purpose:	Routine Assessment	Dia/Height:	18"
Use:	Sanitary	Material:	VCP
Drain Area:		Lining:	
Category:	NA		
Comment:	5-21-2018		
Location Details:		Direction of Survey:	Downstream
US MH:	M-607-006	DS MH:	M-607-005
		Total Length Surveyed (ft):	151.2

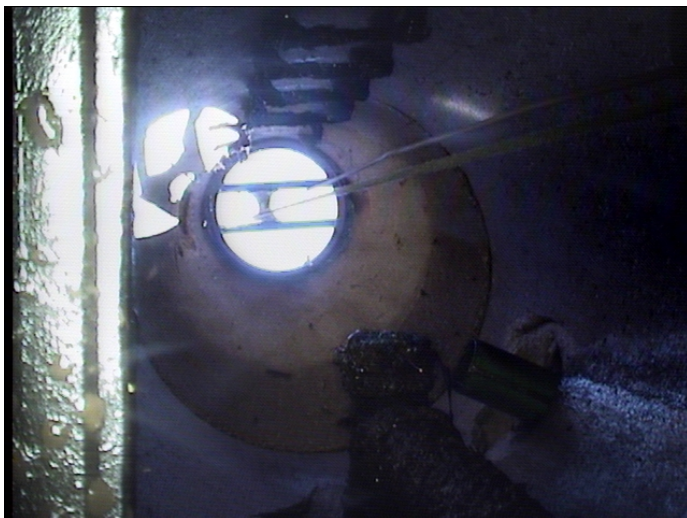
Code: **AMH**
 Description: **Manhole**

Distance (ft): **.0**
 Structural Grade: **0**
 O&M Grade: **0**
 Clock Start/From:
 Clock To:
 1st Value:
 2nd Value:
 Value Percent:
 Continuous Index:
 Within 8" of Joint: **NO**
 Remarks: **M-607-005**

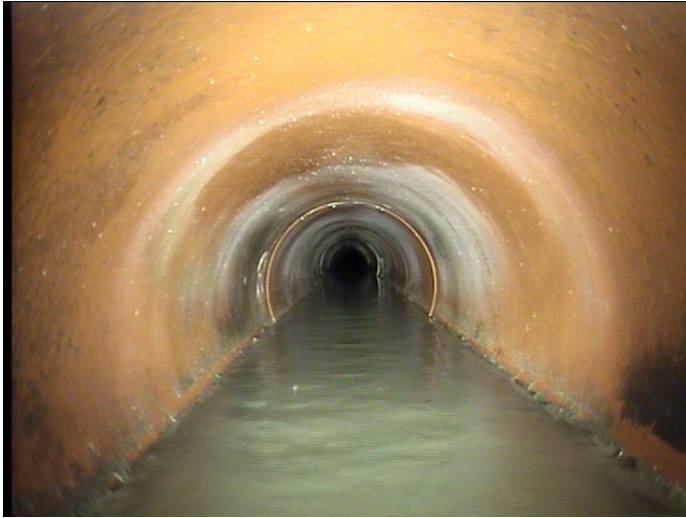
Code: **MWL**
Description: **Water Level**

Distance (ft): **.0**
Structural Grade: **0**
O&M Grade: **0**
Clock Start/From:
Clock To:
1st Value:
2nd Value:
Value Percent: **15.000**
Continuous Index:
Within 8" of Joint: **NO**
Remarks:

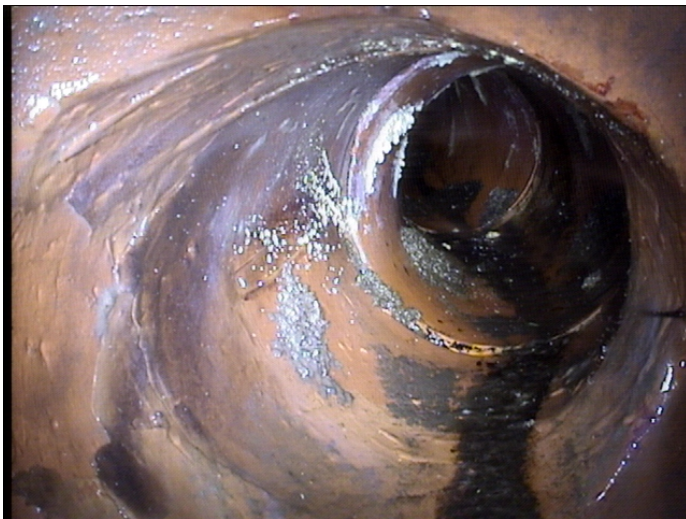
Code: **TF**
Description: **Tap Factory**

Distance (ft): **21.5**
Structural Grade: **0**
O&M Grade: **0**
Clock Start/From: **2**
Clock To:
1st Value: **6.000**
2nd Value:
Value Percent:
Continuous Index:
Within 8" of Joint: **NO**
Remarks:

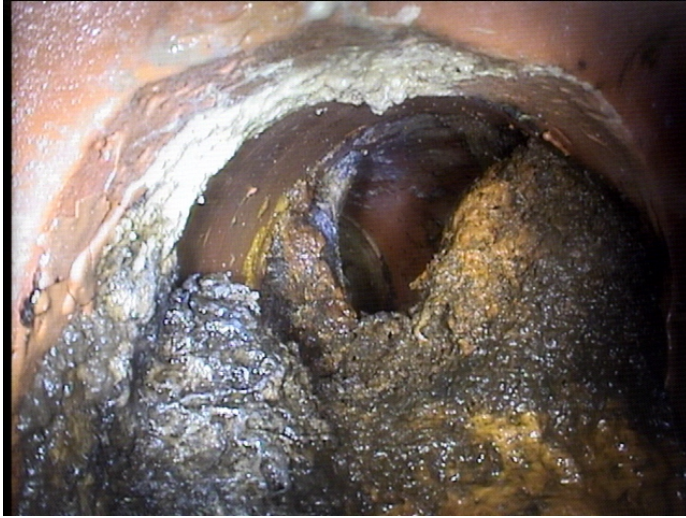
Code: **TFD**
Description: **Tap Factory Defective**

Distance (ft): **94.5**
Structural Grade: **0**
O&M Grade: **2**
Clock Start/From: **2**
Clock To:
1st Value: **6.000**
2nd Value:
Value Percent:
Continuous Index:
Within 8" of Joint: **NO**
Remarks: **Defective**

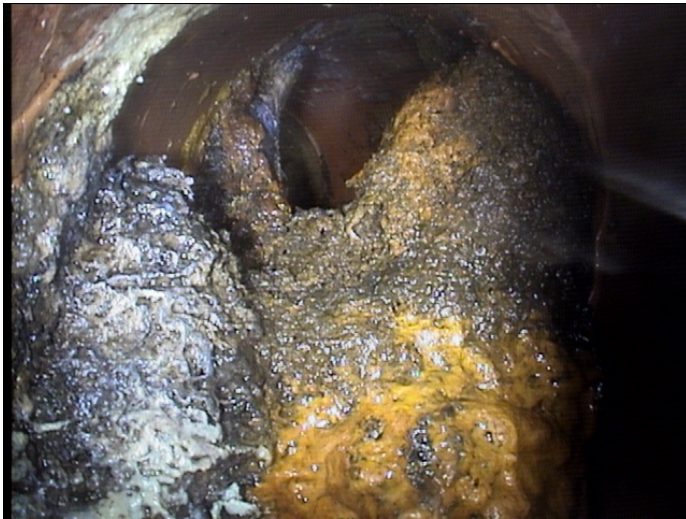
Code: **DAE**
Description: **Deposits Attached Encrustation**

Distance (ft): **94.5**
Structural Grade: **0**
O&M Grade: **2**
Clock Start/From: **2**
Clock To: **5**
1st Value:
2nd Value:
Value Percent: **5.000**
Continuous Index:
Within 8" of Joint: **NO**
Remarks:

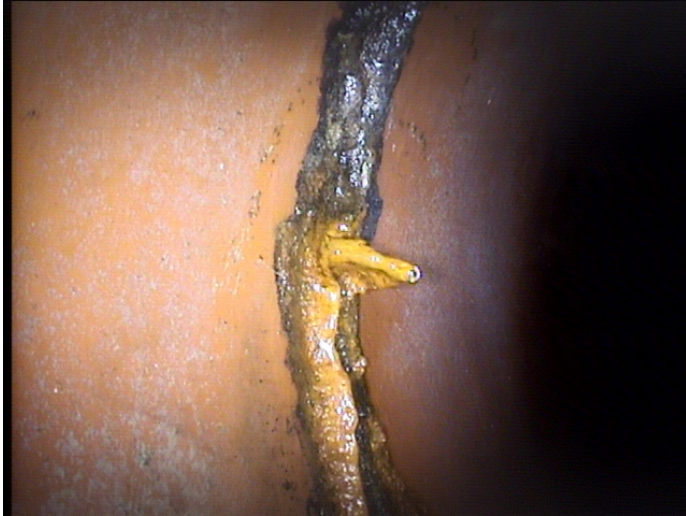
Code: **ID**
Description: **Infil Dripper**

Distance (ft): **109.5**
Structural Grade: **0**
O&M Grade: **3**
Clock Start/From: **12**
Clock To:
1st Value:
2nd Value:
Value Percent:
Continuous Index:
Within 8" of Joint: **YES**
Remarks:

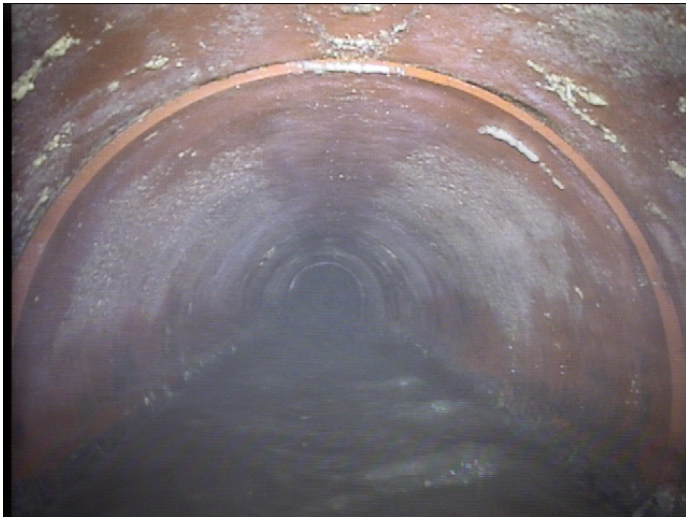
Code: **DSF**
Description: **Deposits Settled Fine**

Distance (ft): **136.6**
Structural Grade: **0**
O&M Grade: **2**
Clock Start/From: **4**
Clock To: **8**
1st Value:
2nd Value:
Value Percent: **10.000**
Continuous Index:
Within 8" of Joint: **NO**
Remarks:

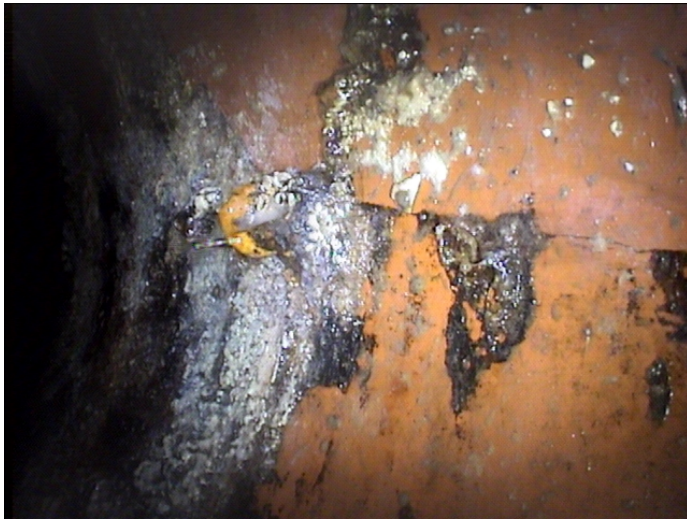
Code: **CL**
Description: **Crack Longitudinal**

Distance (ft): **146.4**
Structural Grade: **2**
O&M Grade: **0**
Clock Start/From: **12**
Clock To:
1st Value:
2nd Value:
Value Percent:
Continuous Index:
Within 8" of Joint: **NO**
Remarks:

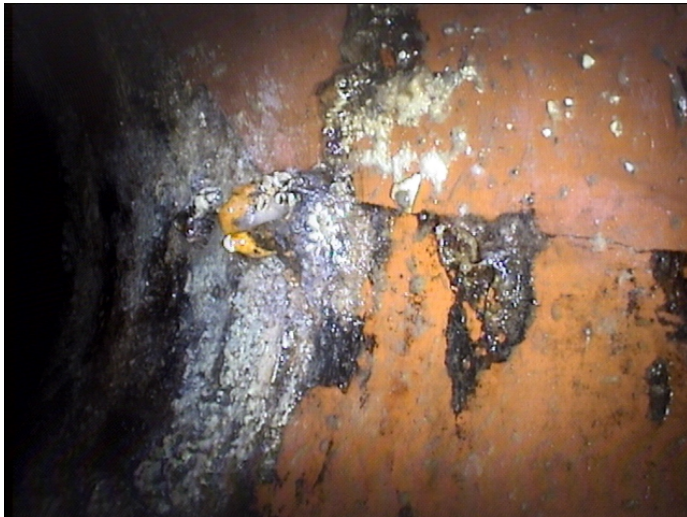
Code: **ID**
Description: **Infil Dripper**

Distance (ft): **146.4**
Structural Grade: **0**
O&M Grade: **3**
Clock Start/From: **12**
Clock To:
1st Value:
2nd Value:
Value Percent:
Continuous Index:
Within 8" of Joint: **NO**
Remarks:

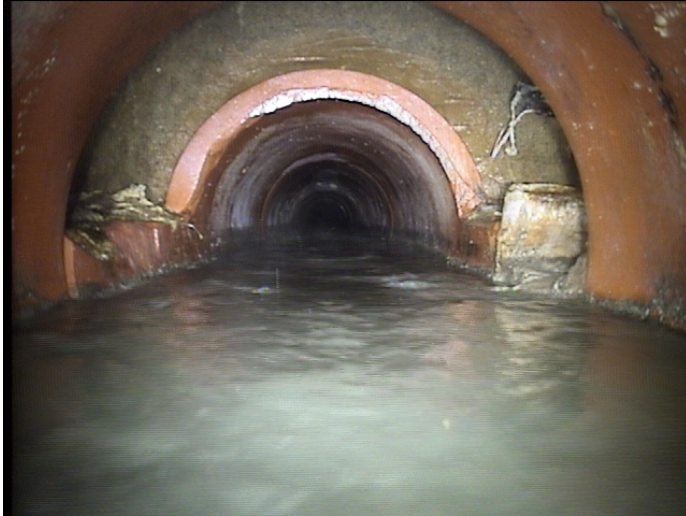
Code: **DNF**
 Description: **Deposits Ingressed Fine**

Distance (ft): **150.1**
 Structural Grade: **0**
 O&M Grade: **2**
 Clock Start/From: **4**
 Clock To: **8**
 1st Value:
 2nd Value:
 Value Percent: **10.000**
 Continuous Index:
 Within 8" of Joint: **NO**
 Remarks:

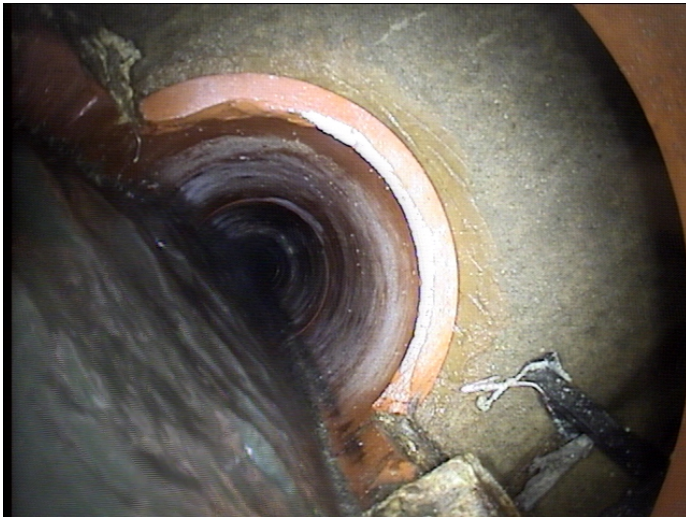
Code: **AMH**
 Description: **Manhole**

Distance (ft): **151.2**
 Structural Grade: **0**
 O&M Grade: **0**
 Clock Start/From:
 Clock To:
 1st Value:
 2nd Value:
 Value Percent:
 Continuous Index:
 Within 8" of Joint: **NO**
 Remarks: **M-607-006**
