Profile/Photo Observation Report

Date:	04/07/2018	Weather:		Coding:	PACP 6.0
Pipe Length (ft):		Owner:	City of Hobart	Pre Clean:	Not Known
P.O.#:	202	Surveyor:	B. Helbling	PSR:	P-607-023-008
Customer:	City of Hobart	Clean Date:		Shape:	C

Street:	Laura Lane	Flow Control:	Not Controlled
City:	Hobart, IN	Year Renewed:	
Location:	Easement/Right of Way	Tape/Media #:	DEP202
Purpose:	Routine Assessment	Dia/Height:	18"
Use:	Sanitary	Material:	VCP
Drain Area:		Lining:	
Category:	NA		
Comment:	YES501824 Submittal 2		
Location Details:		Direction of Survey:	Upstream
US MH:	M-607-008	DS MH:	M-607-023
		Total Length Surveyed (ft):	231.0

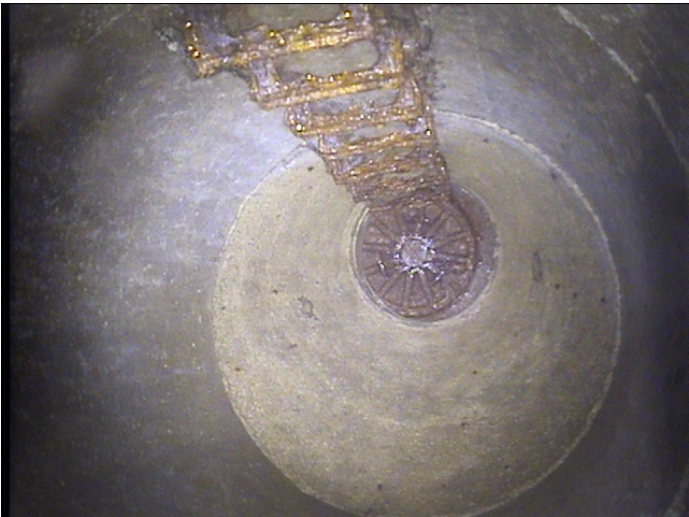
AMH

Manhole

M-607-008

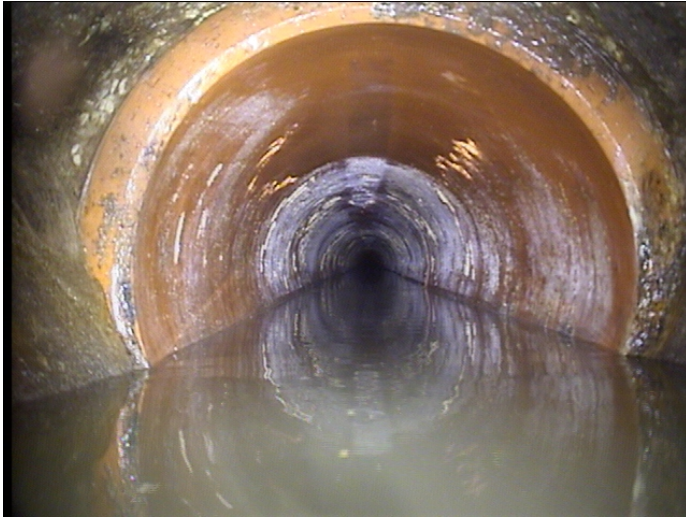
Code: **MWL**
Description: **Water Level**

Distance (ft): **.0**
Structural Grade: **0**
O&M Grade: **0**
Clock Start/From:
Clock To:
1st Value:
2nd Value:
Value Percent: **15.000**
Continuous Index:
Within 8" of Joint: **NO**
Remarks:

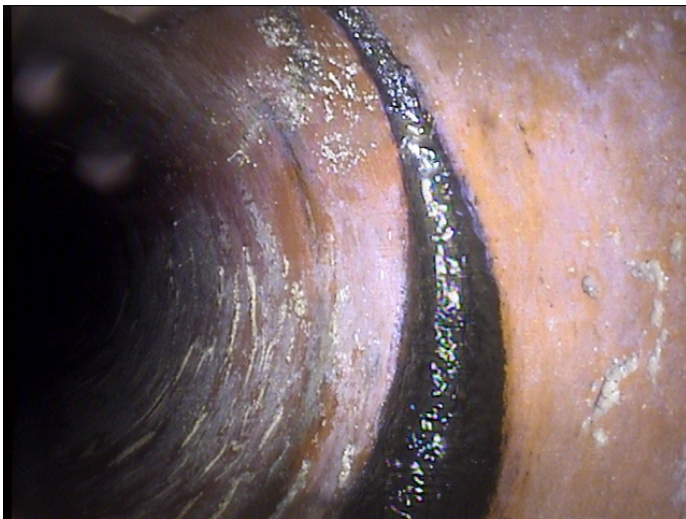
Code: **IR**
Description: **Infil Runner**

Distance (ft): **141.1**
Structural Grade: **0**
O&M Grade: **4**
Clock Start/From: **1**
Clock To: **4**
1st Value:
2nd Value:
Value Percent:
Continuous Index:
Within 8" of Joint: **YES**
Remarks:

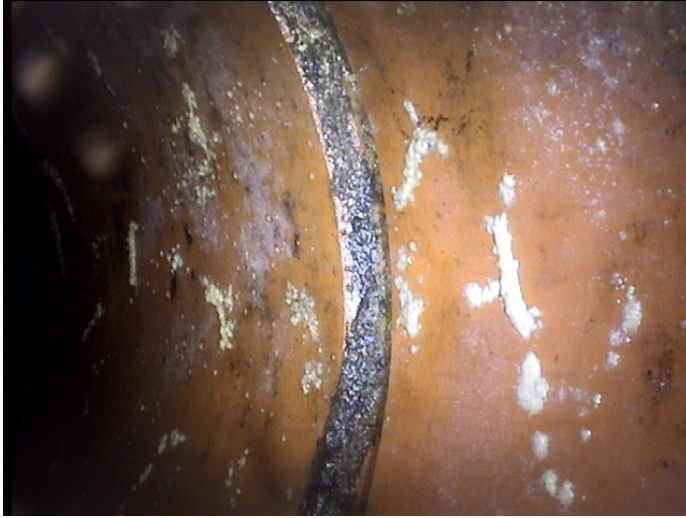
Code: **ID**
Description: **Infil Dripper**

Distance (ft): **218.4**
Structural Grade: **0**
O&M Grade: **3**
Clock Start/From: **1**
Clock To: **4**
1st Value:
2nd Value:
Value Percent:
Continuous Index:
Within 8" of Joint: **YES**
Remarks:

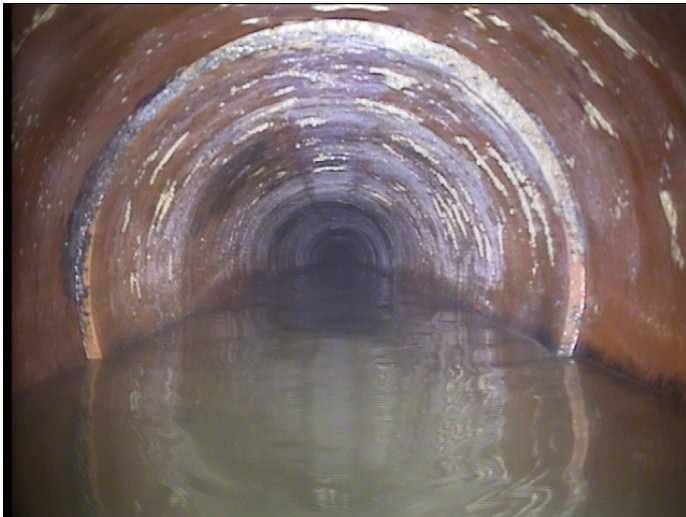
Code: **OBZ**
Description: **Obstacle Other**

Distance (ft): **231.0**
Structural Grade: **0**
O&M Grade: **2**
Clock Start/From: **5**
Clock To: **7**
1st Value:
2nd Value:
Value Percent: **5.000**
Continuous Index:
Within 8" of Joint: **NO**
Remarks: **Underwater debris**

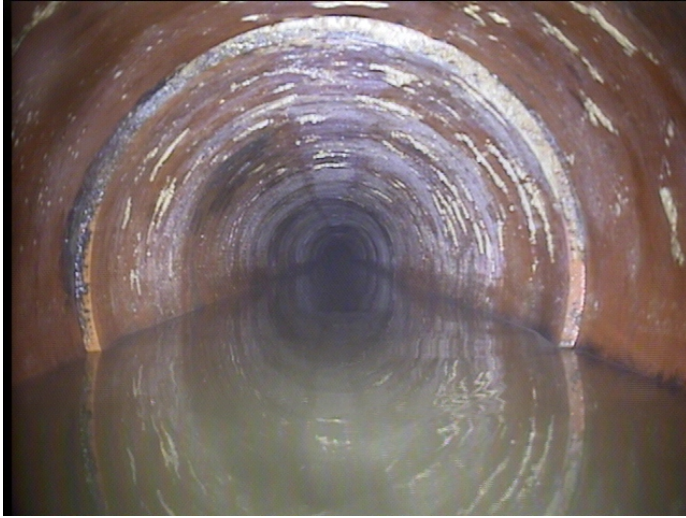
Code:	MSA
Description:	Abandoned Survey
Distance (ft):	231.0
Structural Grade:	0
O&M Grade:	0
Clock Start/From:	
Clock To:	
1st Value:	
2nd Value:	
Value Percent:	
Continuous Index:	
Within 8" of Joint:	NO
Remarks:	Cannot pass debris under flow
