Profile/Photo Observation Report

Date:	05/03/2018	Weather:		Coding:	PACP 6.0
Pipe Length (ft):		Owner:	City of Hobart	Pre Clean:	Not Known
P.O.#:	292	Surveyor:	B. Helbling	PSR:	P-607-010-011
Customer:	City of Hobart	Clean Date:		Shape:	C

Street:	South Lake Park	Flow Control:	Not Controlled
City:	Hobart, IN	Year Renewed:	
Location:	Yard	Tape/Media #:	DEP292
Purpose:	Routine Assessment	Dia/Height:	18"
Use:	Sanitary	Material:	VCP
Drain Area:		Lining:	
Category:	NA		
Comment:	5-21-2018		
Location Details:		Direction of Survey:	Upstream
US MH:	M-607-011	DS MH:	M-607-010
		Total Length Surveyed (ft):	236.8

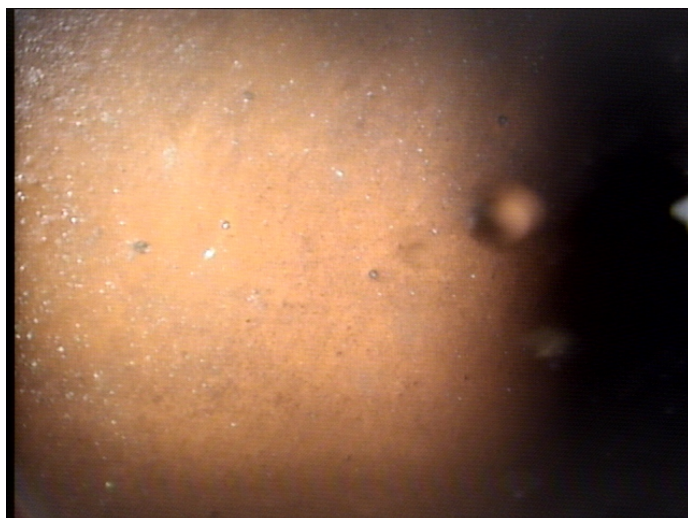
Code: **AMH**
Description: **Manhole**

Distance (ft): **.0**
Structural Grade: **0**
O&M Grade: **0**
Clock Start/From:
Clock To:
1st Value:
2nd Value:
Value Percent:
Continuous Index:
Within 8" of Joint: **NO**
Remarks: **M-607-011**

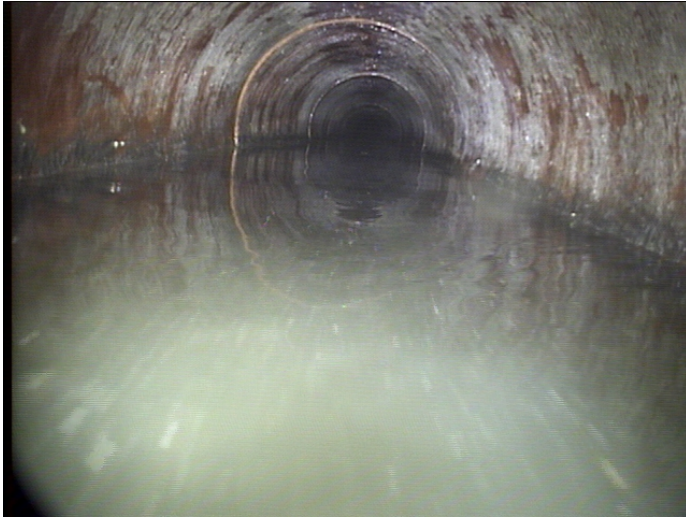
Code:	MWL
Description:	Water Level
Distance (ft):	.0
Structural Grade:	0
O&M Grade:	0
Clock Start/From:	
Clock To:	
1st Value:	
2nd Value:	
Value Percent:	25.000
Continuous Index:	
Within 8" of Joint:	NO
Remarks:

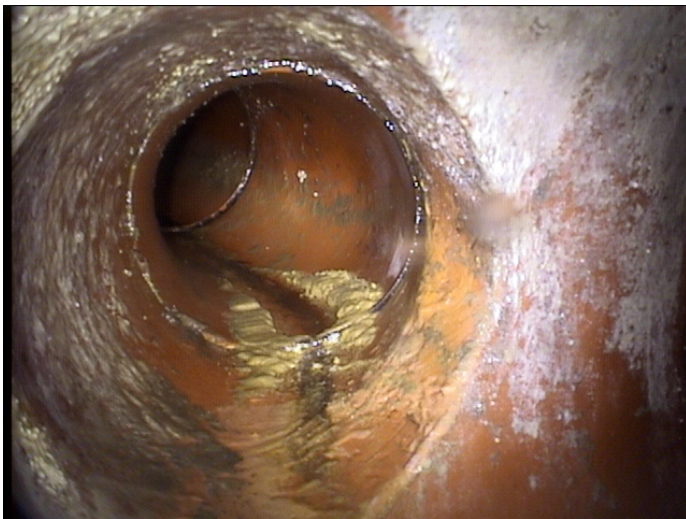
Code:	TF
Description:	Tap Factory
Distance (ft):	15.5
Structural Grade:	0
O&M Grade:	0
Clock Start/From:	10
Clock To:	
1st Value:	6.000
2nd Value:	
Value Percent:	
Continuous Index:	
Within 8" of Joint:	NO
Remarks:

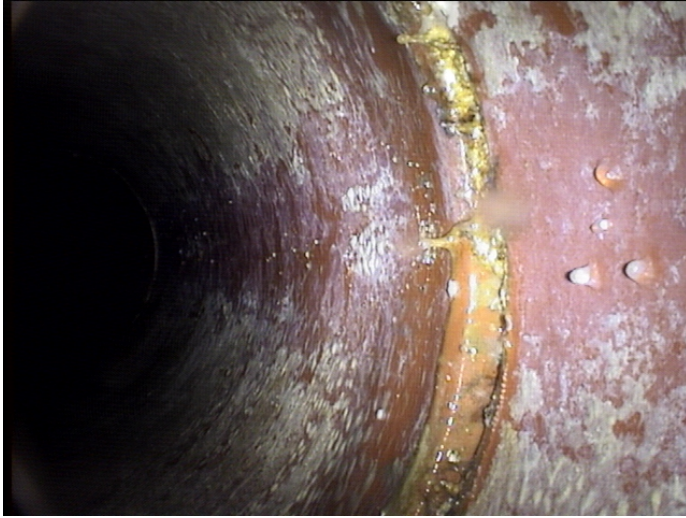
Code: **ID**
Description: **Infil Dripper**

Distance (ft): **15.8**
Structural Grade: **0**
O&M Grade: **3**
Clock Start/From: **12**
Clock To:
1st Value:
2nd Value:
Value Percent:
Continuous Index:
Within 8" of Joint: **YES**
Remarks:

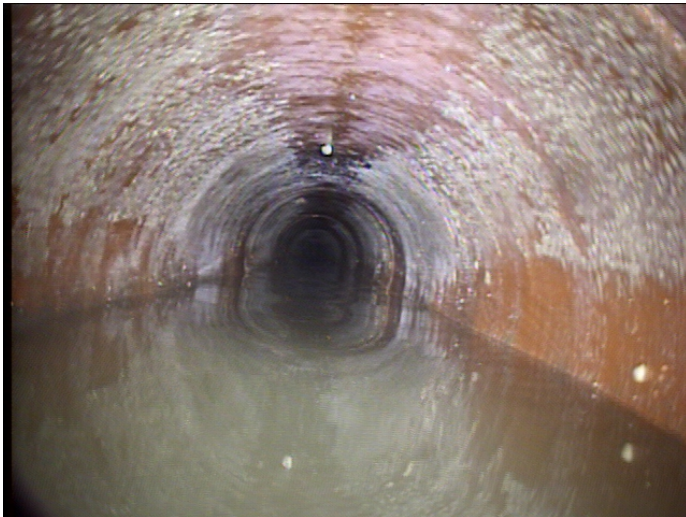
Code: **DSF**
Description: **Deposits Settled Fine**

Distance (ft): **73.0**
Structural Grade: **0**
O&M Grade: **2**
Clock Start/From: **5**
Clock To: **7**
1st Value:
2nd Value:
Value Percent: **5.000**
Continuous Index: **S01**
Within 8" of Joint: **NO**
Remarks:

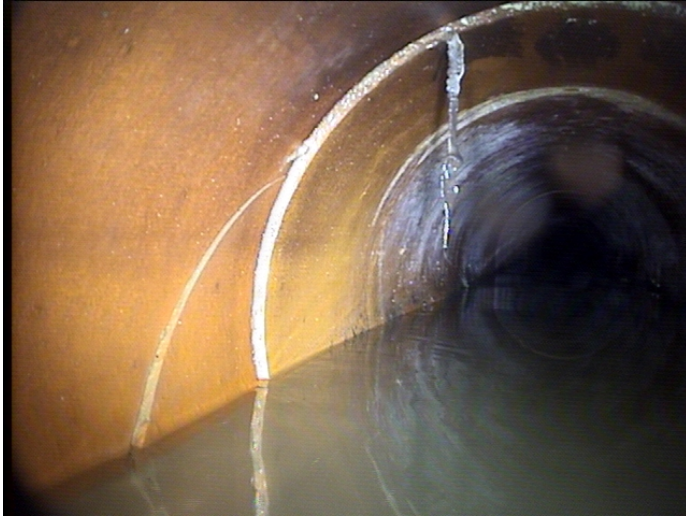
Code:	FS
Description:	Fracture Spiral
Distance (ft):	93.6
Structural Grade:	3
O&M Grade:	0
Clock Start/From:	7
Clock To:	9
1st Value:	
2nd Value:	
Value Percent:	
Continuous Index:	
Within 8" of Joint:	NO
Remarks:

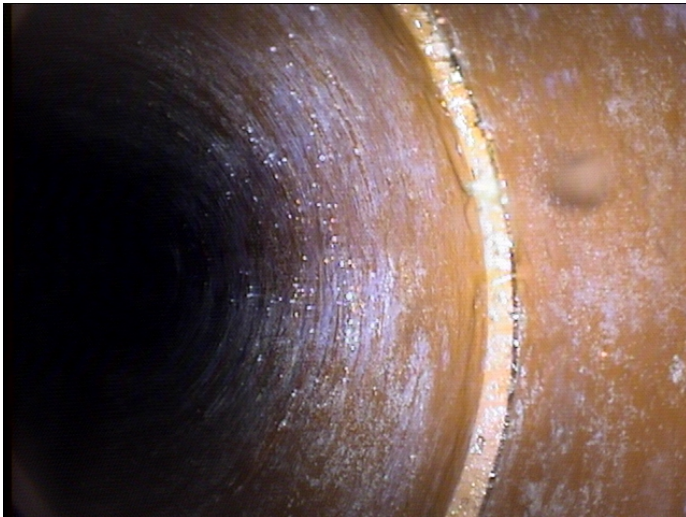
Code:	ID
Description:	Infil Dripper
Distance (ft):	179.0
Structural Grade:	0
O&M Grade:	3
Clock Start/From:	12
Clock To:	
1st Value:	
2nd Value:	
Value Percent:	
Continuous Index:	
Within 8" of Joint:	YES
Remarks:

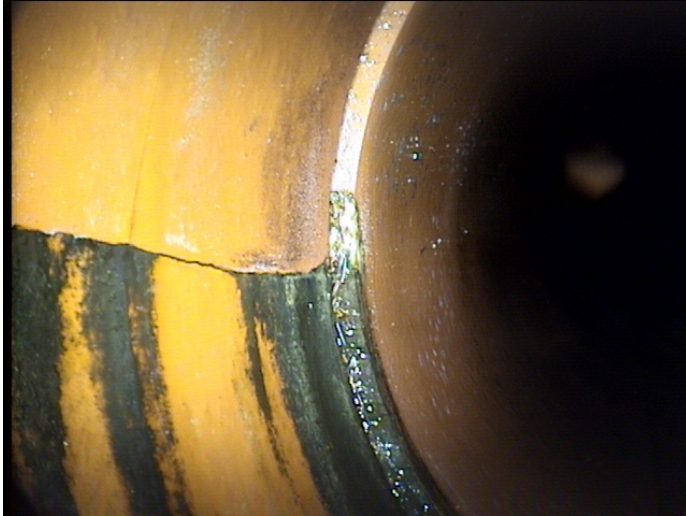
Code:	FL
Description:	Fracture Longitudinal
Distance (ft):	221.0
Structural Grade:	3
O&M Grade:	0
Clock Start/From:	11
Clock To:	
1st Value:	
2nd Value:	
Value Percent:	
Continuous Index:	
Within 8" of Joint:	NO
Remarks:

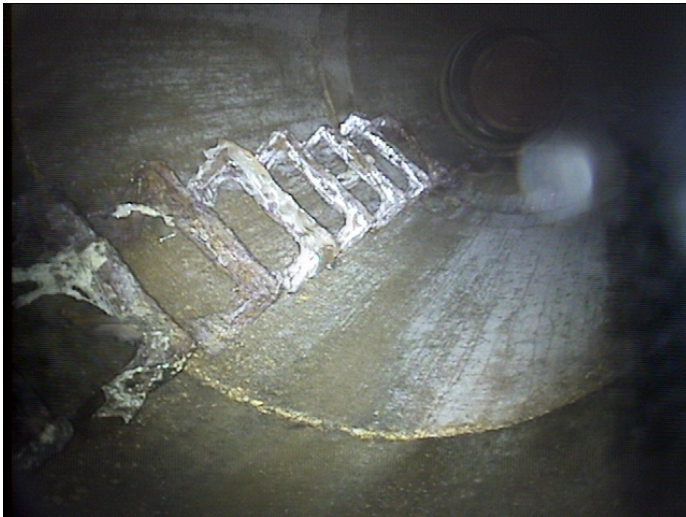
Code:	DSF
Description:	Deposits Settled Fine
Distance (ft):	236.8
Structural Grade:	0
O&M Grade:	2
Clock Start/From:	5
Clock To:	7
1st Value:	
2nd Value:	
Value Percent:	5.000
Continuous Index:	F01
Within 8" of Joint:	NO
Remarks:

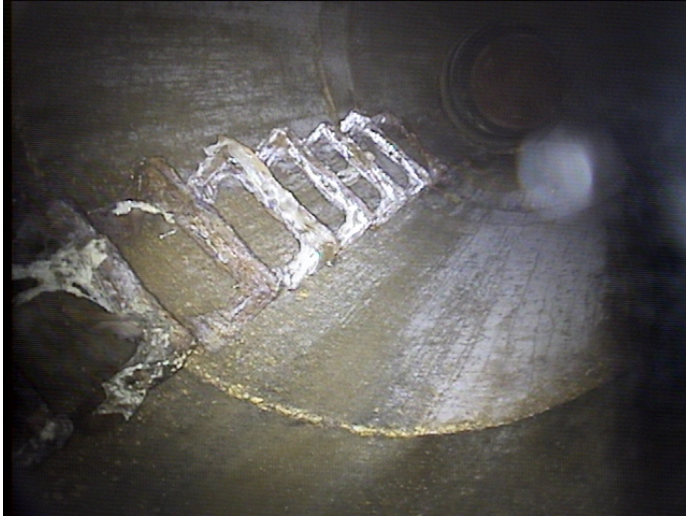
Code:	AMH
Description:	Manhole
Distance (ft):	236.8
Structural Grade:	0
O&M Grade:	0
Clock Start/From:	
Clock To:	
1st Value:	
2nd Value:	
Value Percent:	
Continuous Index:	
Within 8" of Joint:	NO
Remarks:	M-607-010
