Profile/Photo Observation Report

Date:	05/04/2018	Weather:		Coding:	PACP 6.0
Pipe Length (ft):		Owner:	City of Hobart	Pre Clean:	Not Known
P.O.#:	294	Surveyor:	B. Helbling	PSR:	P-607-011-012
Customer:	City of Hobart	Clean Date:		Shape:	C

Street:	South Lake Park	Flow Control:	Not Controlled
City:	Hobart, IN	Year Renewed:	
Location:	Yard	Tape/Media #:	DEP294
Purpose:	Routine Assessment	Dia/Height:	18"
Use:	Sanitary	Material:	VCP
Drain Area:		Lining:	
Category:	NA		
Comment:	5-21-2018		
Location Details:		Direction of Survey:	Upstream
US MH:	M-607-012	DS MH:	M-607-011
		Total Length Surveyed (ft):	193.1

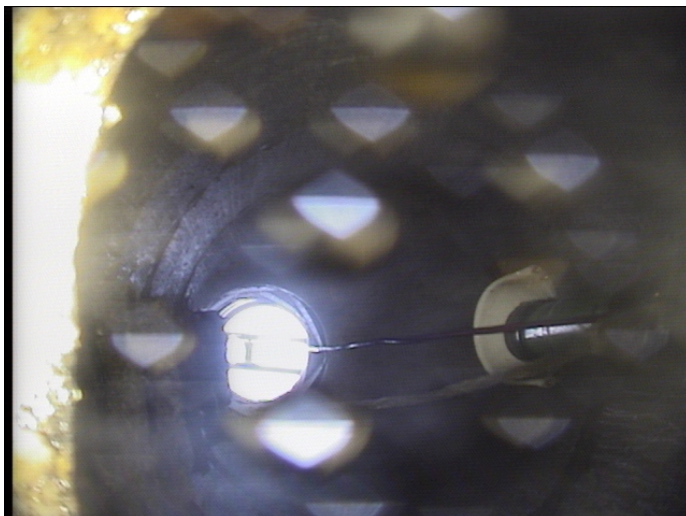
Code: **AMH**
Description: **Manhole**

Distance (ft): **.0**
Structural Grade: **0**
O&M Grade: **0**
Clock Start/From:
Clock To:
1st Value:
2nd Value:
Value Percent:
Continuous Index:
Within 8" of Joint: **NO**
Remarks: **M-607-012**

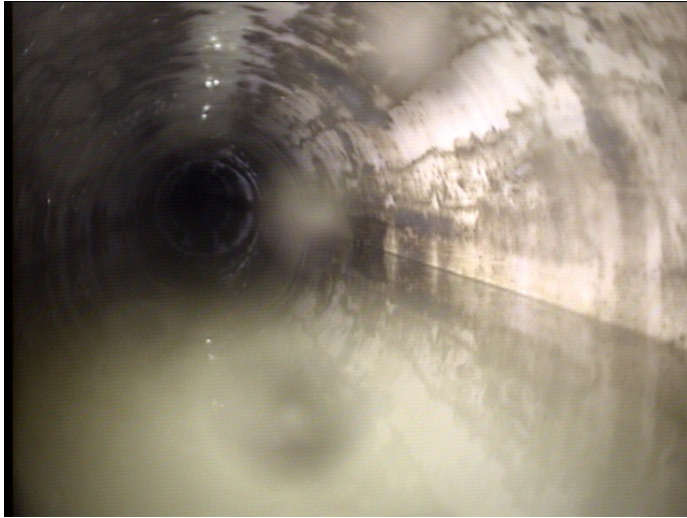
Code: **MWL**
Description: **Water Level**

Distance (ft): **.0**
Structural Grade: **0**
O&M Grade: **0**
Clock Start/From:
Clock To:
1st Value:
2nd Value:
Value Percent: **35.000**
Continuous Index:
Within 8" of Joint: **NO**
Remarks:

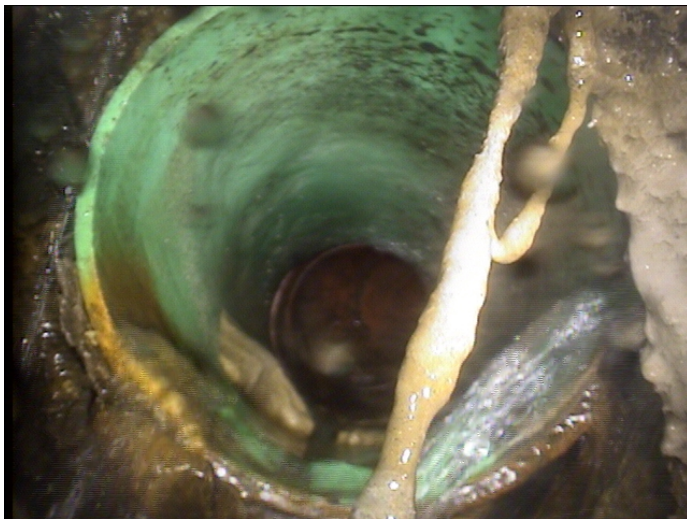
Code: **TBD**
Description: **Tap Break-in Defective**

Distance (ft): **75.6**
Structural Grade: **0**
O&M Grade: **3**
Clock Start/From: **2**
Clock To:
1st Value: **6.000**
2nd Value:
Value Percent:
Continuous Index:
Within 8" of Joint: **NO**
Remarks: **Defective**

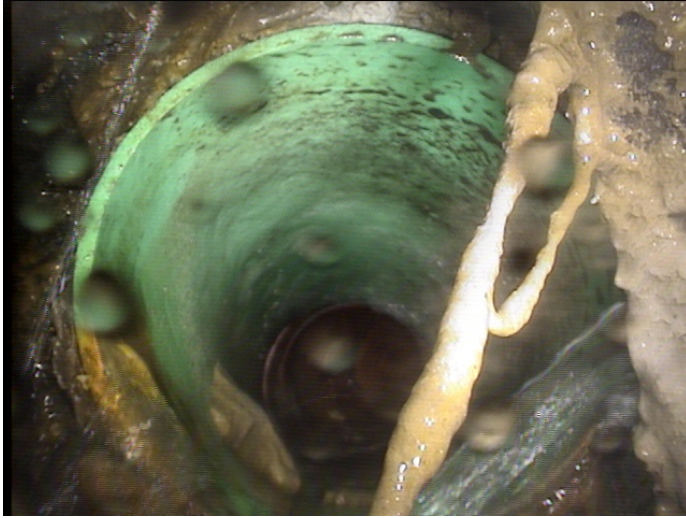
Code: **IG**
Description: **Infil Gusher**

Distance (ft): **75.6**
Structural Grade: **0**
O&M Grade: **5**
Clock Start/From: **2**
Clock To:
1st Value:
2nd Value:
Value Percent:
Continuous Index:
Within 8" of Joint: **NO**
Remarks:

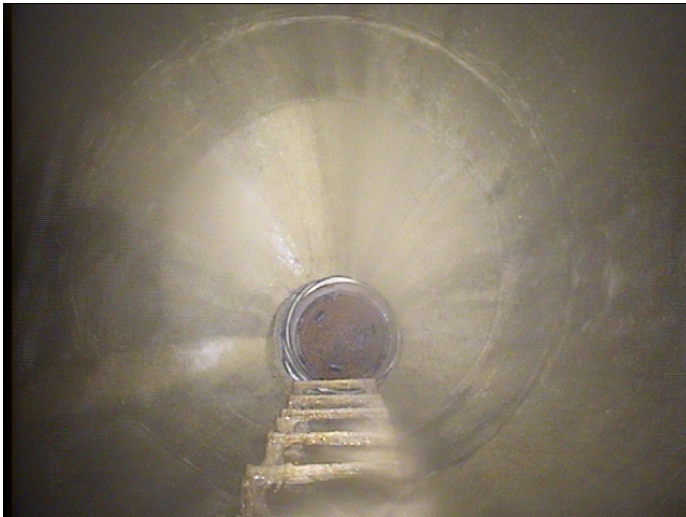
Code: **AMH**
Description: **Manhole**

Distance (ft): **193.1**
Structural Grade: **0**
O&M Grade: **0**
Clock Start/From:
Clock To:
1st Value:
2nd Value:
Value Percent:
Continuous Index:
Within 8" of Joint: **NO**
Remarks: **M-607-011**
