Profile/Photo Observation Report

Date:	05/04/2018	Weather:		Coding:	PACP 6.0
Pipe Length (ft):		Owner:	City of Hobart	Pre Clean:	Not Known
P.O.#:	293	Surveyor:	B. Helbling	PSR:	P-607-012-014
Customer:	City of Hobart	Clean Date:		Shape:	C

Street:	South Lake Park	Flow Control:	Not Controlled
City:	Hobart, IN	Year Renewed:	
Location:	Yard	Tape/Media #:	DEP293
Purpose:	Routine Assessment	Dia/Height:	18"
Use:	Sanitary	Material:	VCP
Drain Area:		Lining:	
Category:	NA		
Comment:	5-21-2018

Location Details:		Direction of Survey:	Downstream
US MH:	M-607-014	DS MH:	M-607-012
		Total Length Surveyed (ft):	175.8

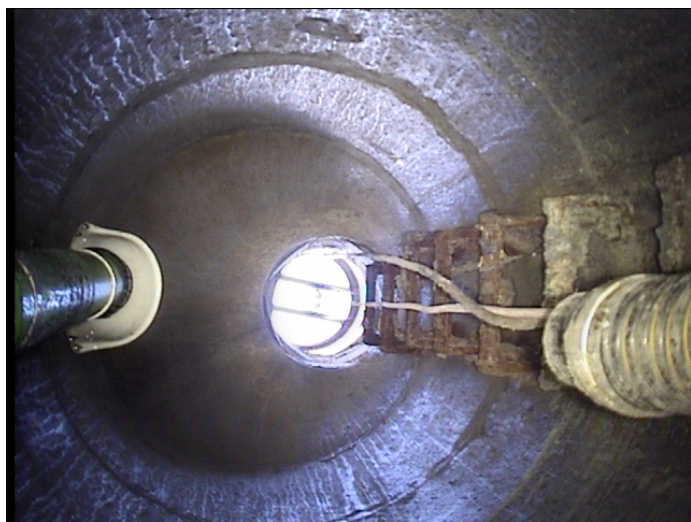
Code: **AMH**
Description: **Manhole**

Distance (ft): **.0**
Structural Grade: **0**
O&M Grade: **0**
Clock Start/From:
Clock To:
1st Value:
2nd Value:
Value Percent:
Continuous Index:
Within 8" of Joint: **NO**
Remarks: **M-607-012**

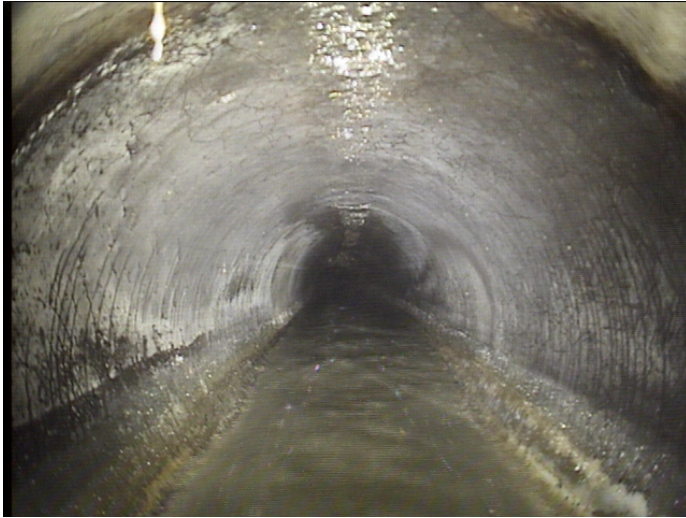
Code: **MWL**
Description: **Water Level**

Distance (ft): **.0**
Structural Grade: **0**
O&M Grade: **0**
Clock Start/From:
Clock To:
1st Value:
2nd Value:
Value Percent: **15.000**
Continuous Index:
Within 8" of Joint: **NO**
Remarks:

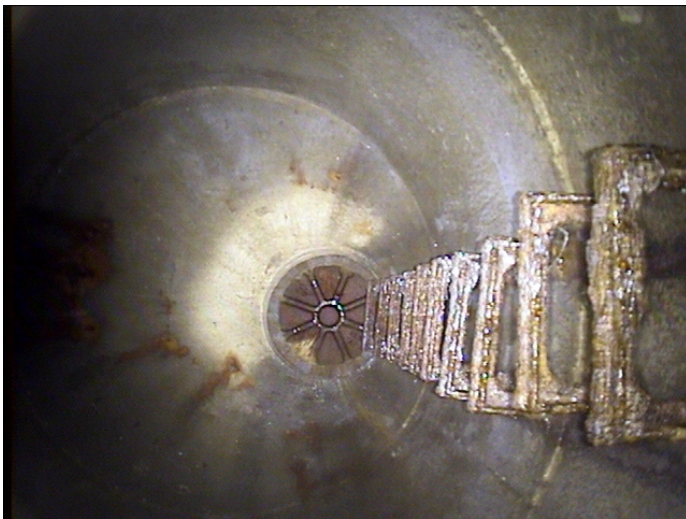
Code: **AMH**
Description: **Manhole**

Distance (ft): **175.8**
Structural Grade: **0**
O&M Grade: **0**
Clock Start/From:
Clock To:
1st Value:
2nd Value:
Value Percent:
Continuous Index:
Within 8" of Joint: **NO**
Remarks: **M-607-014**
