## Profile/Photo Observation Report

Street:	<b>FOXCROFT STREET</b>	Flow Control:	<b>Not Controlled</b>
City:	<b>Hobart, IN</b>	Year Renewed:	
Location:	<b>Yard</b>	Tape/Media #:	
Purpose:	<b>Routine Assessment</b>	Dia/Height:	<b>8"</b>
Use:	<b>Sanitary</b>	Material:	<b>PVC</b>
Drain Area:	<b>NA</b>	Lining:	
Category:	<b>NA</b>		
Comment:

Location Details:		Direction of Survey:	<b>Upstream</b>
US MH:	<b>M-607-023</b>	DS MH:	<b>M-607-025</b>
		Total Length Surveyed (ft):	<b>27.9</b>

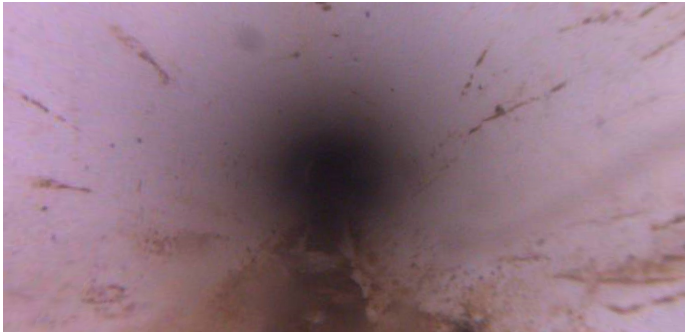
Code:	<b>MWL</b>
Description:	<b>Water Level</b>

Distance (ft):	<b>.0</b>
Structural Grade:	<b>0</b>
O&M Grade:	<b>0</b>
Clock Start/From:	
Clock To:	
1st Value:	
2nd Value:	
Value Percent:	<b>5.000</b>
Continuous Index:	
Within 8" of Joint:	<b>NO</b>
Remarks:

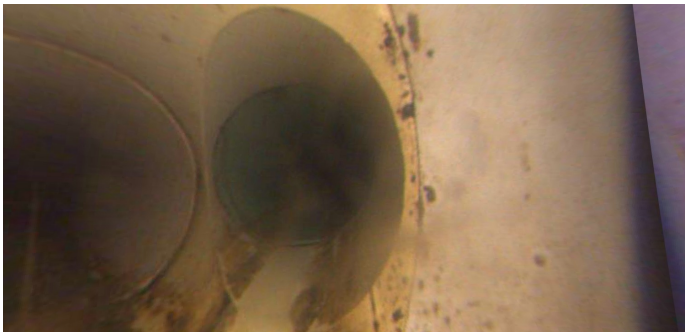
Code:	<b>TFA</b>
Description:	<b>Tap Factory Active</b>

Distance (ft):	<b>5.3</b>
Structural Grade:	<b>0</b>
O&M Grade:	<b>0</b>
Clock Start/From:	<b>9</b>
Clock To:	
1st Value:	<b>4.000</b>
2nd Value:	
Value Percent:	
Continuous Index:	
Within 8" of Joint:	
Remarks:

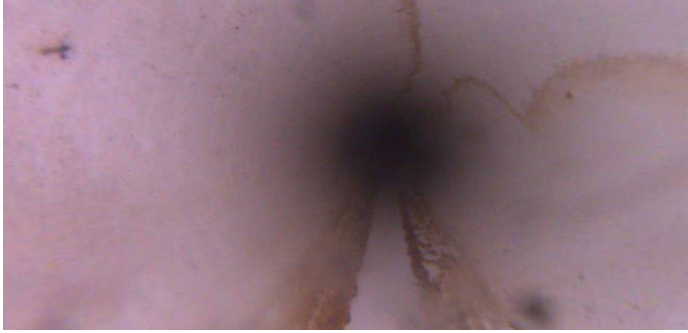
Code:	<b>MSA</b>
Description:	<b>Abandoned Survey</b>
Distance (ft):	<b>27.9</b>
Structural Grade:	<b>0</b>
O&M Grade:	<b>0</b>
Clock Start/From:	
Clock To:	
1st Value:	
2nd Value:	
Value Percent:	
Continuous Index:	
Within 8" of Joint:	<b>NO</b>
Remarks:	<b>unknown</b>
