Profile/Photo Observation Report

Street:	POLLY LN	Flow Control:	Not Controlled
City:	Hobart, IN	Year Renewed:	
Location:	Yard	Tape/Media #:	
Purpose:	Routine Assessment	Dia/Height:	8"
Use:	Sanitary	Material:	PVC
Drain Area:	NA	Lining:	
Category:	NA		
Comment:

Location Details:		Direction of Survey:	Upstream
US MH:	M-607-023	DS MH:	M-607-025
		Total Length Surveyed (ft):	7.1

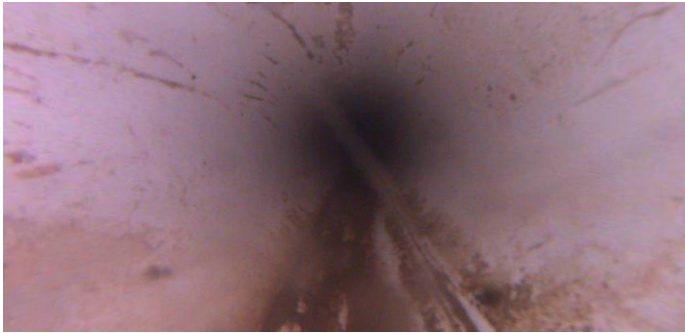
Code:	MWL
Description:	Water Level

Distance (ft):	.0
Structural Grade:	0
O&M Grade:	0
Clock Start/From:	
Clock To:	
1st Value:	
2nd Value:	
Value Percent:	5.000
Continuous Index:	
Within 8" of Joint:	NO
Remarks:

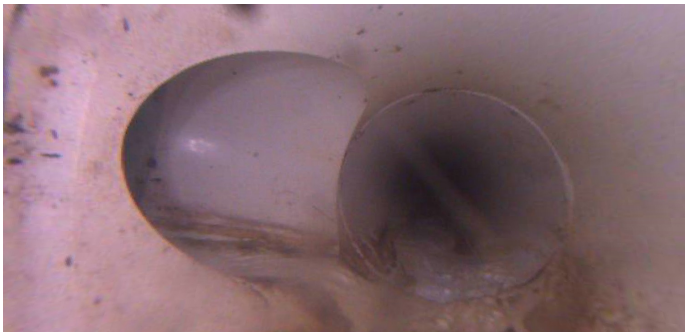
Code:	TFA
Description:	Tap Factory Active

Distance (ft):	4.8
Structural Grade:	0
O&M Grade:	0
Clock Start/From:	9
Clock To:	
1st Value:	4.000
2nd Value:	
Value Percent:	
Continuous Index:	
Within 8" of Joint:	
Remarks:

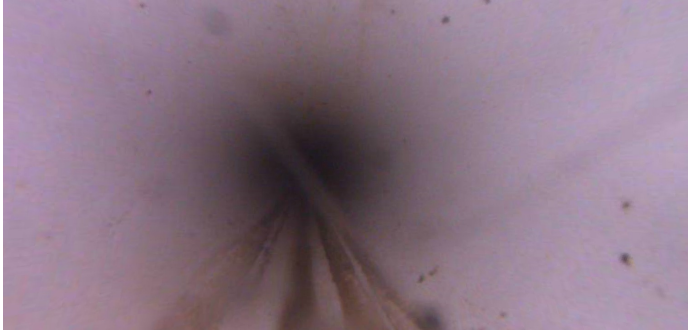
Code:	MSA
Description:	Abandoned Survey
Distance (ft):	7.1
Structural Grade:	0
O&M Grade:	0
Clock Start/From:	
Clock To:	
1st Value:	
2nd Value:	
Value Percent:	
Continuous Index:	
Within 8" of Joint:	NO
Remarks:	unknown
