Profile/Photo Observation Report

| Street: | FOXCROFT STREET | Flow Control: | Not Controlled |
| City: | Hobart, IN | Year Renewed: | |

| US MH: | M-607-023 | DS MH: | M-607-025 |

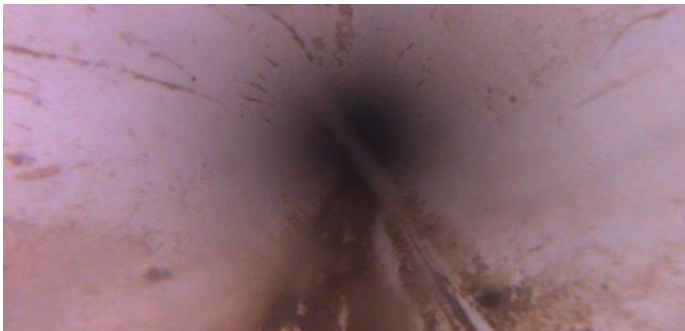
Code: **AMH**
Description: **Manhole**

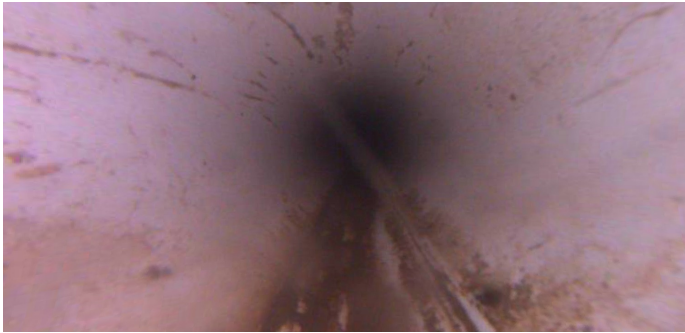
| Code: | MWL |
| Description: | Water Level |

| Value Percent: | 5.000 |

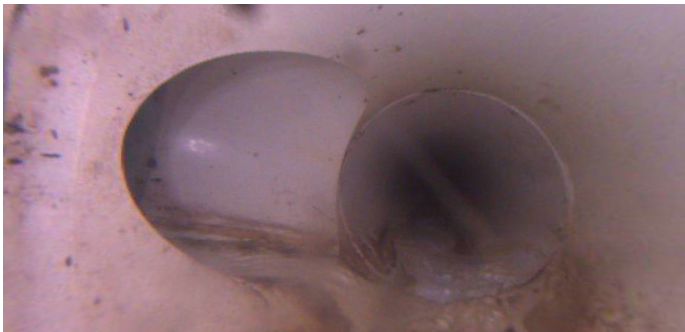
| Code: | TFA |
| Description: | Tap Factory Active |

| Distance (ft): | 4.8 |
| Clock Start/From: | 9 |

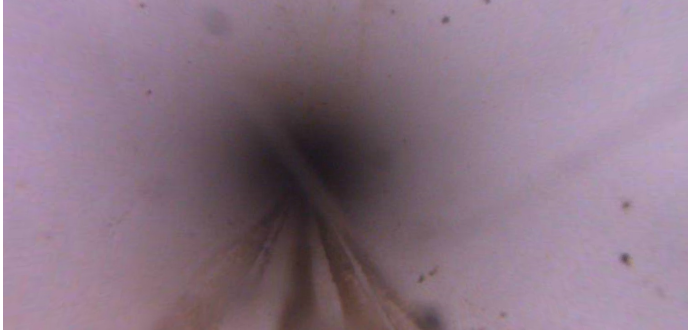
| Code: | MSA |
| Description: | Abandoned Survey |
| Distance (ft): | 7.1 |
| Remarks: | unknown |
